Investigation report on the fire and explosion accident of the

"M" ship in Ningbo, Zhejiang Province on August 9

At around 1346 on August 9, 2024, the Liberian container ship "M"

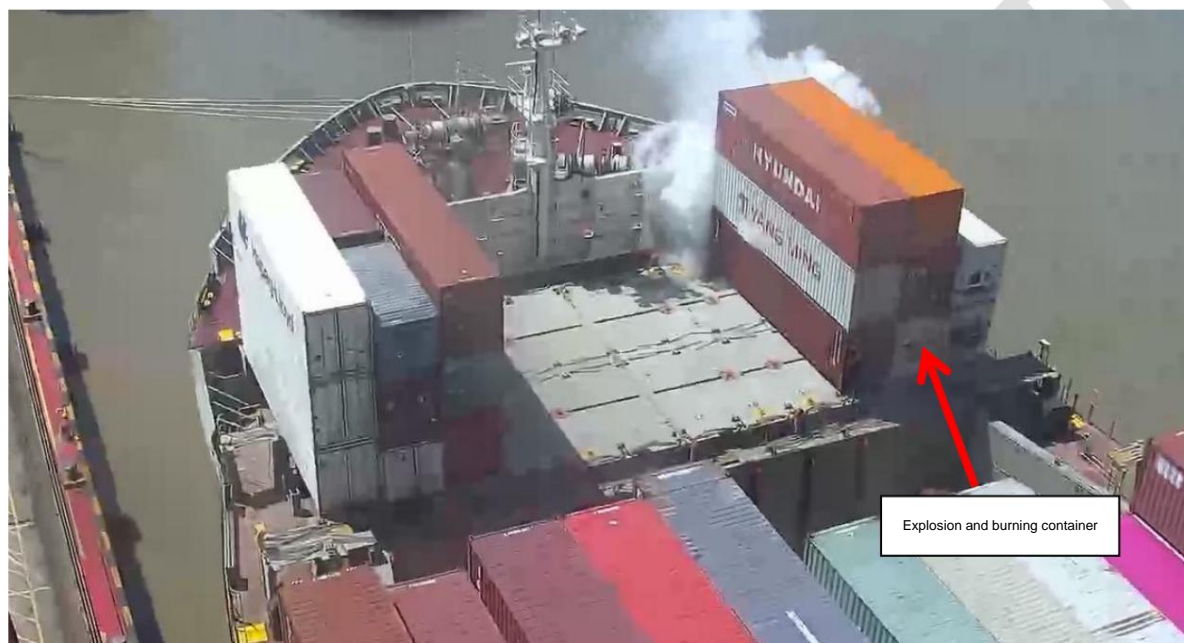
Figure 2: Cargo loading situation at bay 01-03 at the time of the incident

The dangerous goods are located at 011082, 031082, 031084, 031086,

020982, except for the container in question which was loaded on the starboard side, the other four dangerous goods containers were loaded on the port.

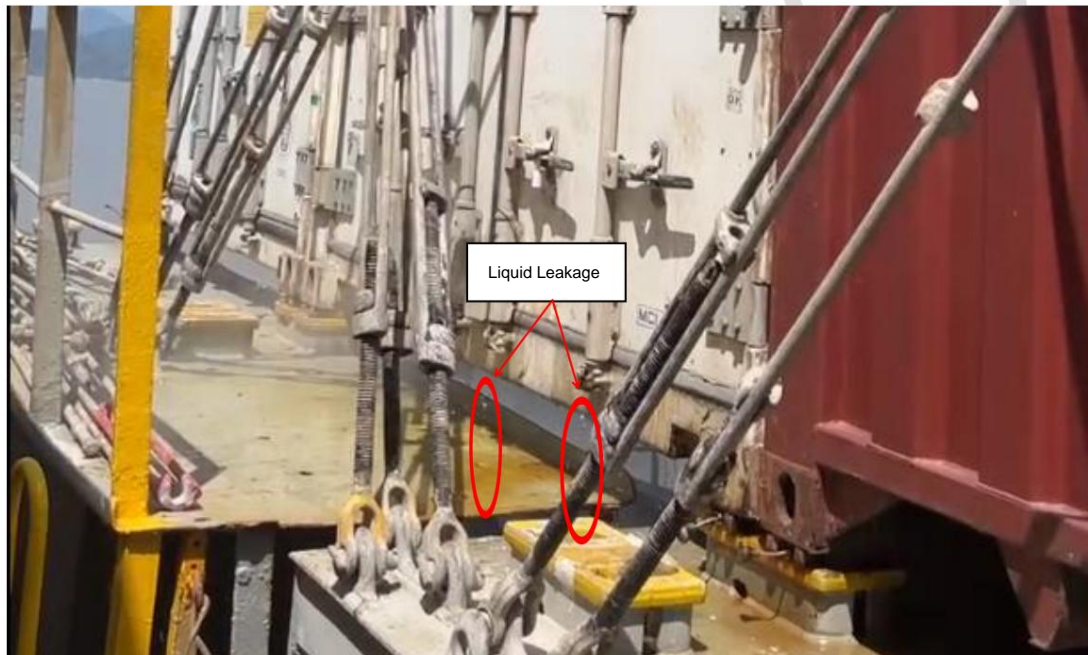
At around 1331, the sailor on duty found the container involved in position 02 (Container No.: MW

CU6639680, loading position: 020982) Slight white smoke, transparent

Slightly yellow liquid leaked, accompanied by white smoke and a "hissing" sound.

Figure 5: Liquid cargo leaking onto the deck

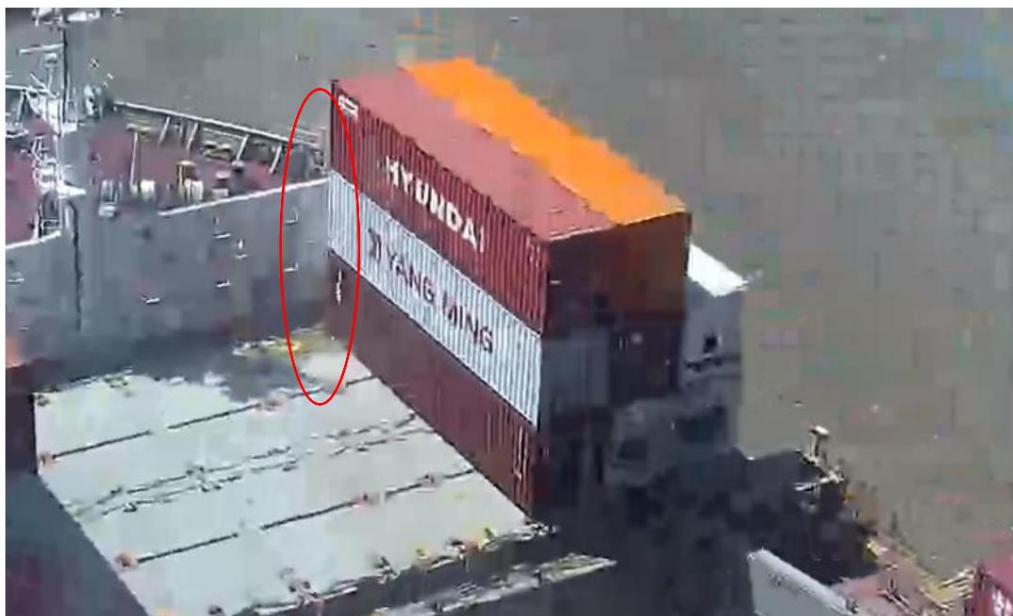
At 1338:12, CCTV at the on-site terminal showed that the direction of the container door in question was

A small amount of smoke was seen.

Figure 6: A small amount of smoke from the bow

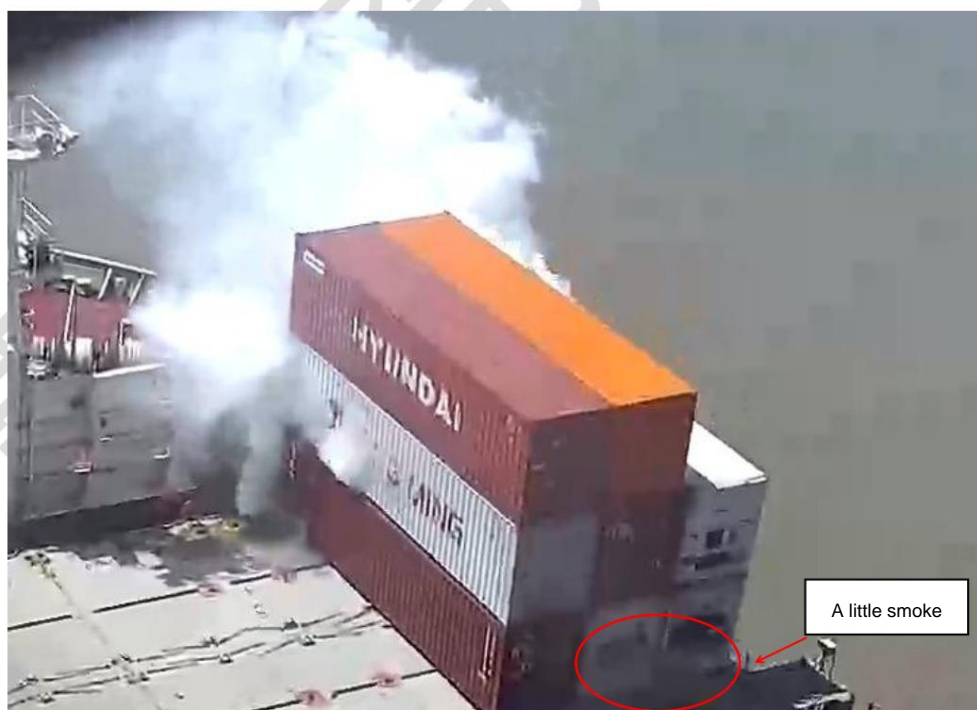
At 1338:30, the speed of the white smoke eruption increased, and the starboard bow was covered by smoke.

A small amount of white smoke overflowed from the exhaust fan of the container compressor involved.

Figure 7: The starboard bow is covered by smoke

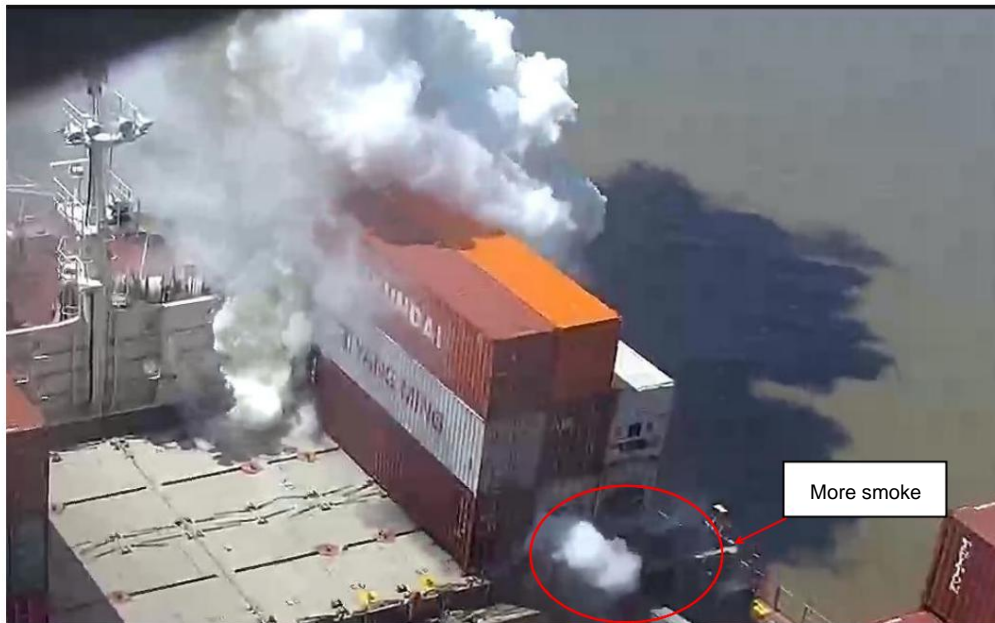
At 1339:00, a large amount of smoke erupted over the bow of the ship. The container compressor involved

The amount of white smoke overflowing from the exhaust fan increased.

Figure 8: Increased smoke from the compressor exhaust fan

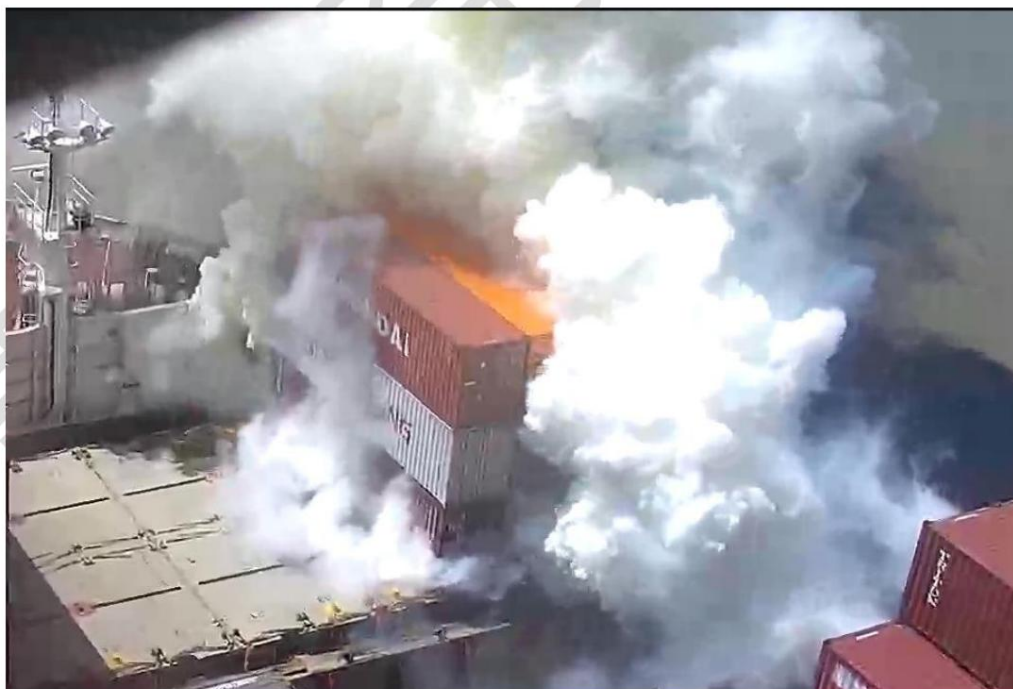
At 1339:20, a large amount of white smoke erupted into the air, covering the starboard side of the bow.

Figure 9: Smoke covering the starboard bow

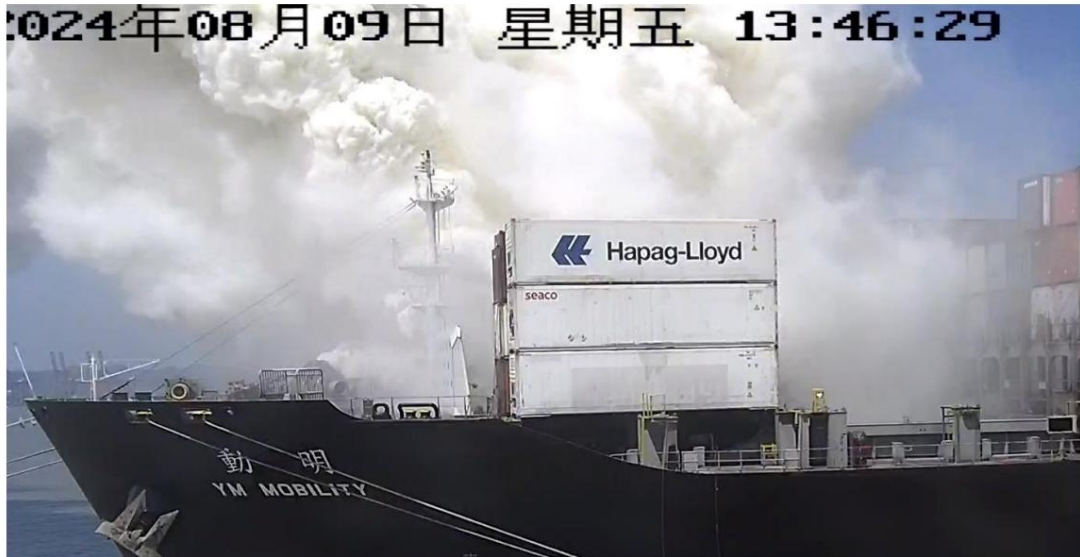
From 1339:20 to 1346:29, white smoke mixed with light yellow continued to spray in large quantities.

Covering the entire bow position.

Figure 10: Bow situation at 1346:29

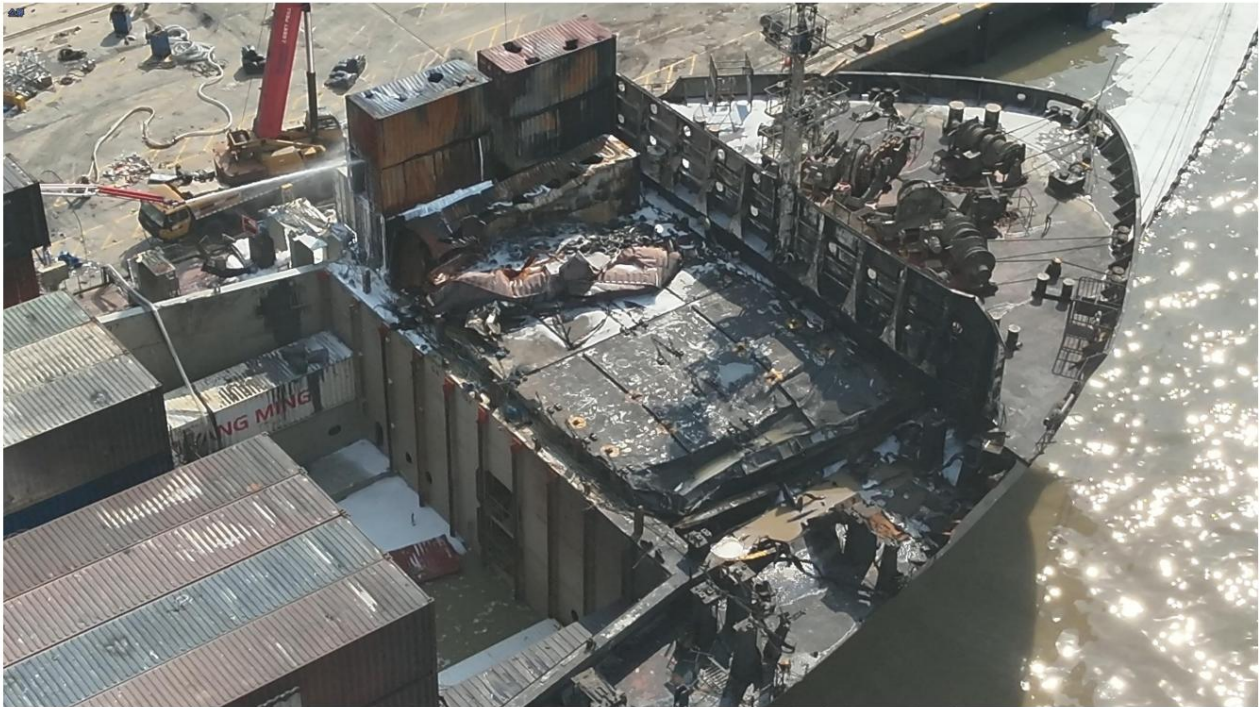
The investigation team conducted an on-site inspection of the "M" ship on August 11, 2024 and found

The explosion caused the containers on the starboard deck of hold 1 to disintegrate or fly away, and the containers on the port side to burn.

The damage was serious, the hatch cover of cabin 1 was seriously deformed, and the nearby deck and hull were damaged and deformed.

Some of the loaded containers caught fire and some of the containers in holds 1-4 were flooded.

Figure 11: Overall situation on site

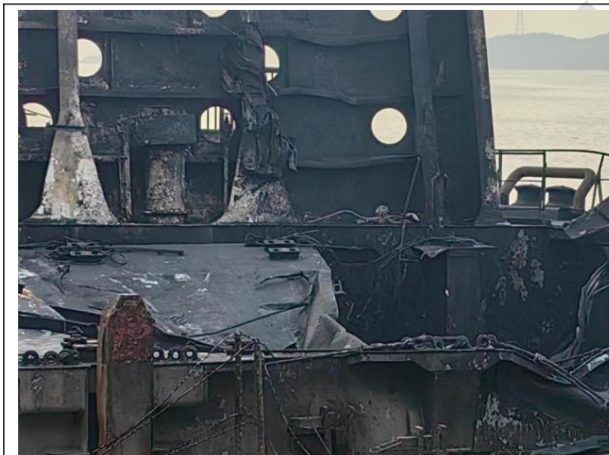
1. The hatch cover of the cabin was seriously damaged.

Fire or flooding damage; the hatch cover of the No. 1 compartment of the "M" ship and the nearby hull were damaged and deformed.

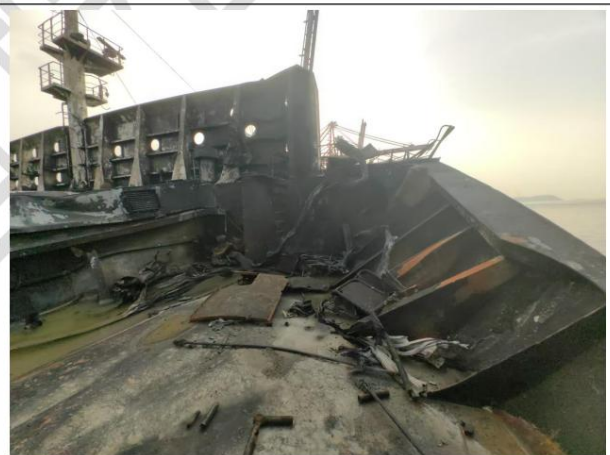
The starboard side of the ship was damaged and deformed
