# Collision between container ship *Maersk Shekou* and tall ship *STS Leeuwin II*

Fremantle, Western Australia, on 30 August 2024

## ATSB Transport Safety Report

MO-2024-001

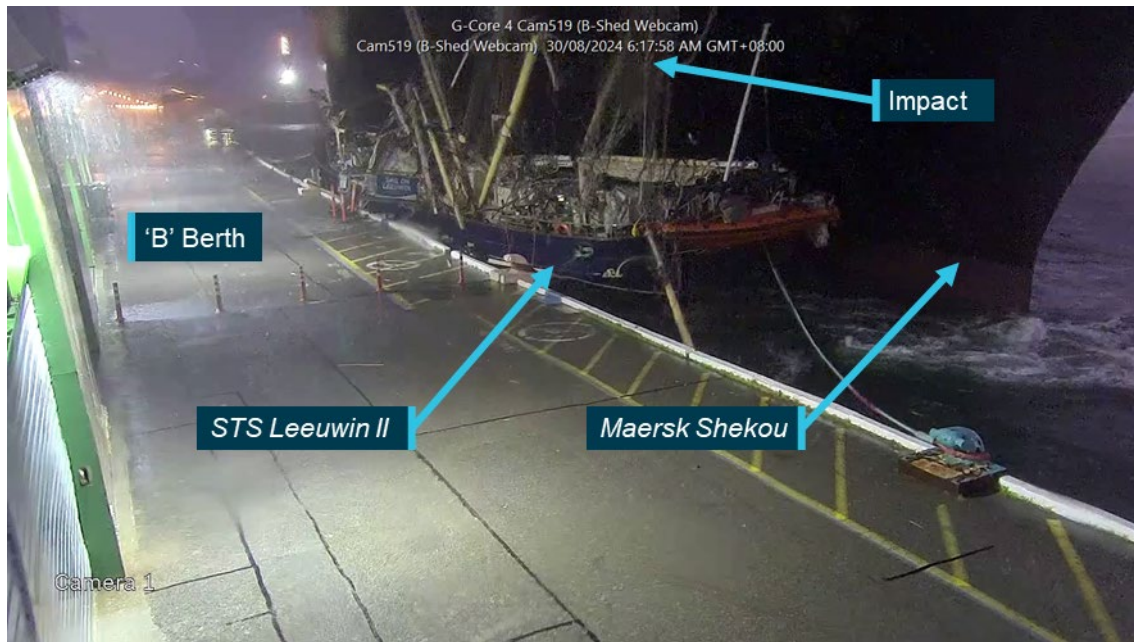
**Figure 4: CCTV footage showing collision between *Maersk Shekou* and *STS Leeuwin II***

Due to the action of the tugs and bow thrusters, the *Maersk Shekou* continued to maintain a port swing of about 10°/min, away from the direct path of the *STS Leeuwin II*. However, *Maersk Shekou* did not make a clear turn, and moments later, its starboard bow flare collided with the *STS Leeuwin II*, dismasting the latter (Figure 4). Two crew members, on board the tall ship at the time, escaped via its gangway just as the collision occurred.

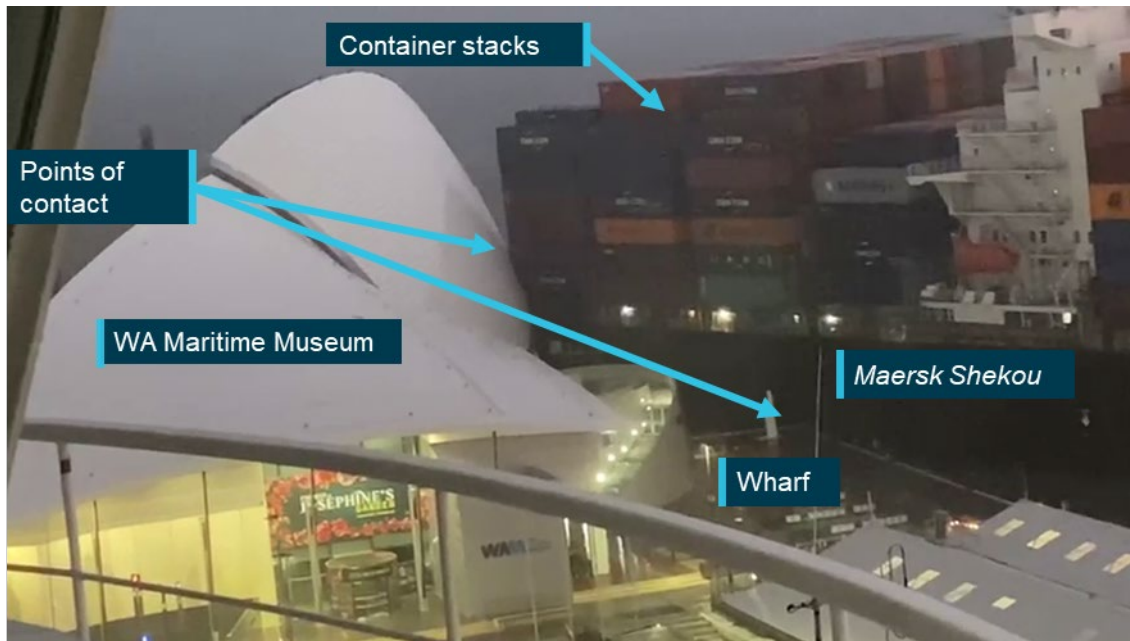
**Figure 5: Footage showing contact of *Maersk Shekou* with the shore**

At 0620:09, the helm was brought to midship. The ship's rate of turn continued to decrease to nearly zero, but its stern continued to drift towards the wharf. At 0620:23, the pilot ordered the bow thrusters to be put full to starboard, however, the outermost stack of containers on the *Maersk Shekou's* poop deck collided with the roof of the museum, and the ship's starboard quarter contacted the wharf (Figure 5).

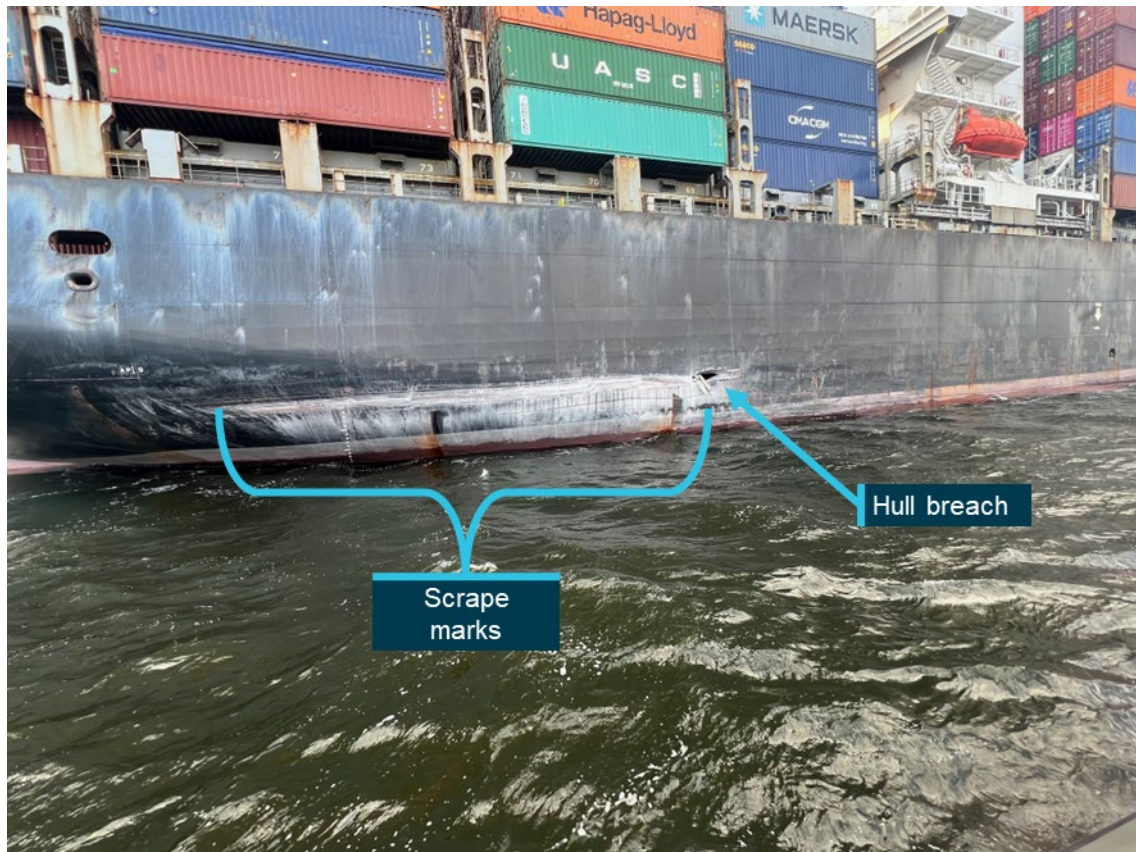
**Figure 6: Contact damage to *Maersk Shekou*'s hull**

Thereafter, the ship developed a slight forward motion and starboard swing, resulting in the edge of the wharf scraping against and rupturing the ship's hull by approximately 1.8 m x 0.5 m. The breach was situated above the waterline, and no ingress or egress resulted. Concrete and timber debris from the wharf lodged within the breached section of the hull as the ship pulled away from the wharf (Figure 6).

The *Maersk Shekou* sustained minor damage. The *STS Leeuwin II* sustained substantial damage and 2 of its crew members sustained minor physical injuries during the accident. At the time of writing, major repair works were underway on the *STS Leeuwin II*.

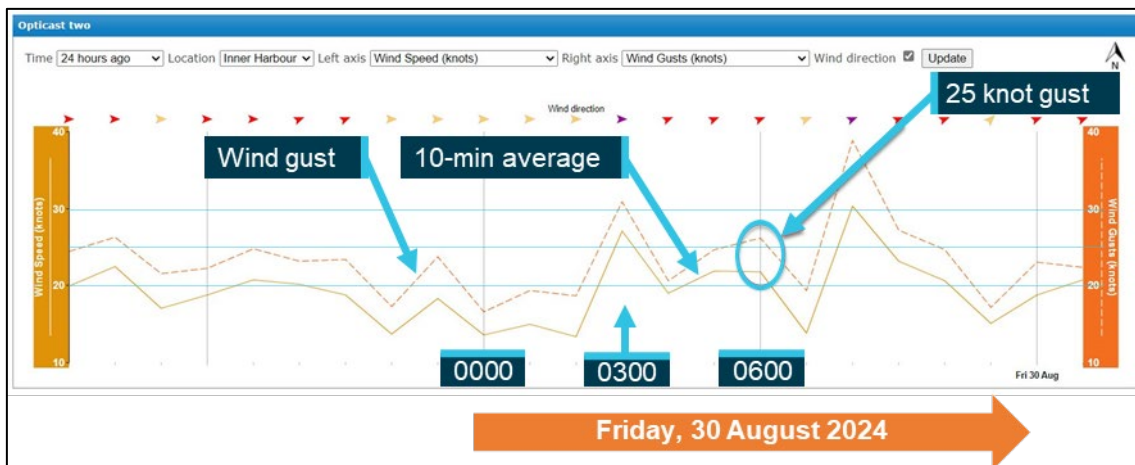
**Figure 10: Weatherzone forecast for 30 August 2024**

The *Weatherzone* forecast for 30 August 2024 (Figure 10) contained evidence of strong wind conditions, including squall activity.<sup>43</sup> The following considerations were relevant to the timing of the *Maersk Shekou's* transit:

- the 10-minute average wind was above the 20-knot maximum limit
- an approximately 25-knot wind gust was expected at 0600, which coincided with *Maersk Shekou* approaching the IHEC entrance.

- Implemented:
  - improved squall alerts through service provider '*Weatherzone*'
  - addition of a virtual wind gauge at Outer Pilot Boarding Ground
  - reduction of wind parameters for LCVs to 15–20 kts
  - reduction of maximum wind speed for vessels 275–310 m to 30 kts from 34 kts.
- Pending implementation - Addition of a fixed wind meteorological station at the Halls Bank beacon to provide decision support regarding prevailing wind conditions prior to the 'abort point'.

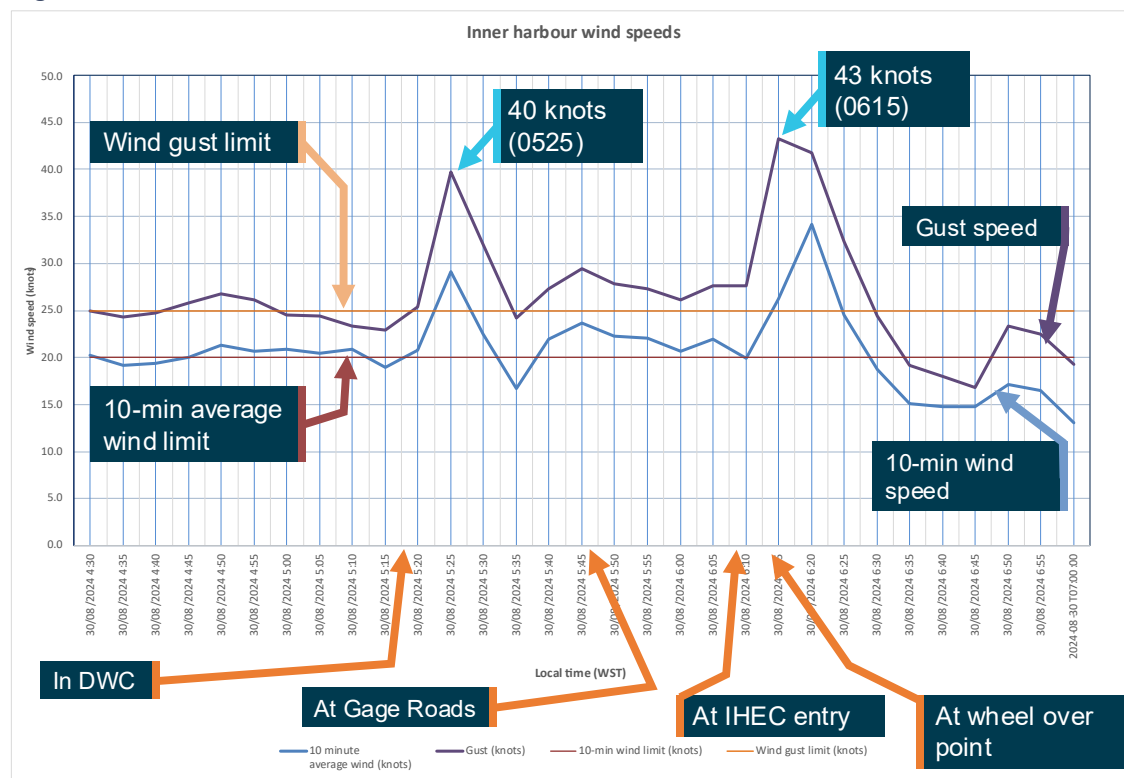
**Figure 11: Actual wind observations from Inner Harbour sensor**

A record of wind observations from 30 August 2024, from the ‘Inner Harbour’ sensor at the Fremantle Ports Building (close to the accident location) is depicted in Figure 11. Annotations along the bottom of the graph denote the representative position of the *Maersk Shekou* on its inbound voyage.
