Panama Maritime Authority
Directorate General of Merchant Marine
Marine Accident investigation Department

REPORT: M/V "SAGE SAGITTARIUS" R- 020-13- DIAM

CASUALTY INVESTIGATION REPORT

M/V "SAGE SAGITTARIUS"

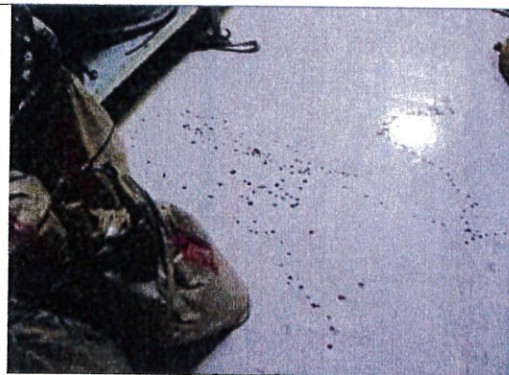
Blood spots in the Engine Store Room

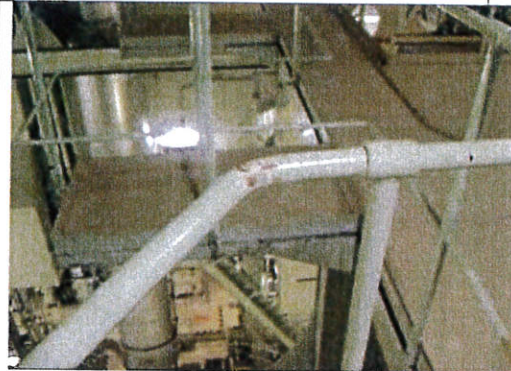
Blood spots on the Railings

1. There were NO issues of Human Errors, Cargo related factors and technical failures of machinery/equipments.
2. Design Failure were noted as follows:
 - a. The design of the railing height is abt 0.8M
 - b. The height of Engine Room Deck that separate on each section is too high at 10.4M.

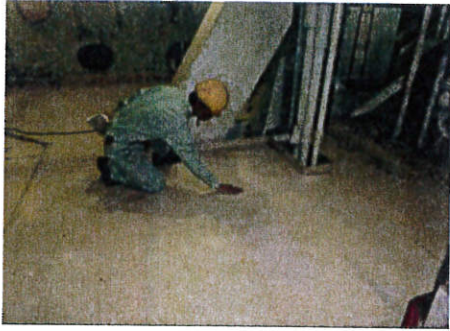
<p>Location to where the C/E was found dead (4th Floor)</p>		<p>Height from 2nd Deck where CE was drop (10.7M)</p>

The vessel did not make any Risk Management on the Engine Room railing to which might cause the C/E to fall after he might loss his consciousness.

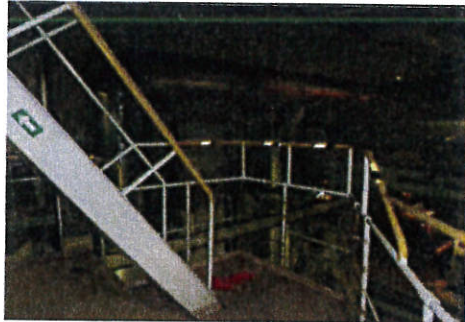
<p>ECR</p>		<p>Stairways to Engine Room with Additional Railings</p>
