Container Ship Accident Analysis due to Container Stacked on Deck as an Attempt to Improve Maritime Logistic System

Gafero Priapalla Rahim and Sunaryo*

Department of Mechanical Engineering, Universitas Indonesia. Kampus UI Depok 16424 Indonesia

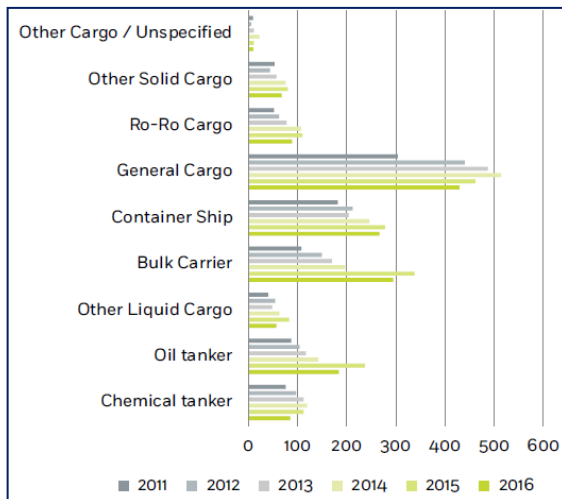
Fig. 1. Distribution of cargo ships involved

According to data from the European Maritime Safety Agency, from 2011 to 2015 there was 6 403 cargo ship involved in 5 942 cases of ship accidents, the number was increasing every year. For container ships, there are more than 1 101 cases in the period of 2011 to 2015. Distribution of the number of accidents every year and the type of ship involved is presented in Figure 1.

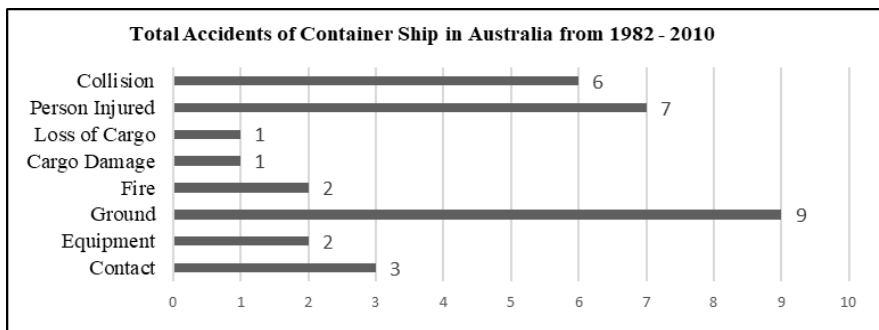
Fig. 2 Total accidents of container ship in Australia from 1982 to 2010

ATSB or Australian Transport Safety Bureau is an Australian bureau that having a specific duty to transportation accident in Australia [6]. The data by ATSB are container ship accidents data from 1982 to 2010.

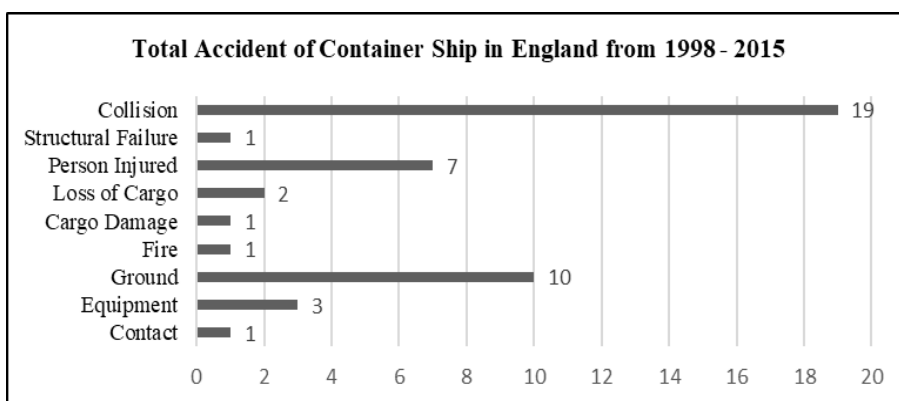
Fig. 3. Total accidents of container ship in England from 1998 to 2015

MAIB or Marine Accident Investigation Branch is an accident investigation agency at sea involving British ships all over the world as well as all ships located in British territorial waters [7]. The following data occurred during an accident from 1998 to 2015 presented in graphical form:

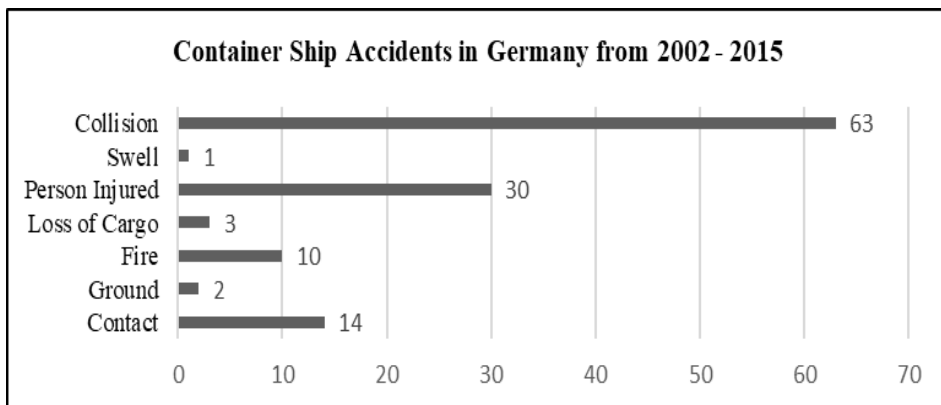
Fig. 4. Container ship accidents in Germany from 2002 to 2015

BSU (*Bundesstelle für Seeunfalluntersuchung*) or can be called the "Federal Bureau of Maritime Casualty Investigation" is a sea-based accident investigation agency from Germany [8].

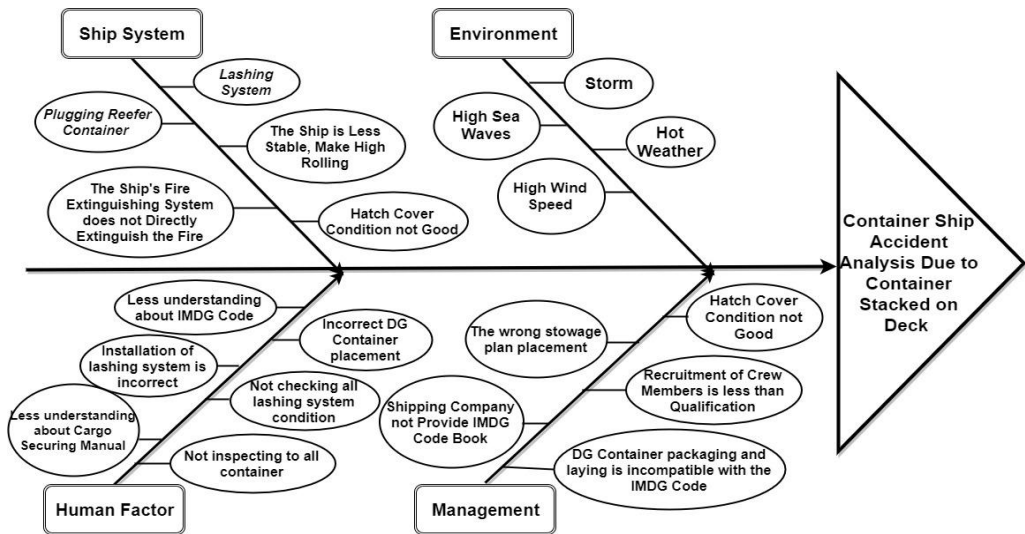
Fig. 6. Fish Bone Diagram Analysis

In order to identify the main sources of accidents occurred to containers stacked on deck, cause and effect or “fish bone” analysis was used. The causes are classified into four categories, including: ship system, the environment, human factors, and management as shown in Figure 6.

Some analysis of the ship system including the lashing system, plugging reefer container, the ship is less stable resulting in high rolling, ship extinguishing system that does not immediately extinguish the fire and hatch cover conditions are less good [10]. The lashing system is one of the important things in the safety of container load, especially the load on the deck [11]. In the case of the accidents described above, the shipwreck of the Pacific Adventurer, the Annabella ship, the P & O Nedlloyd Genoa ship, the CMV Yorkshire ships, the JRS Canis ship, and the Duncan Island vessel are examples of accidents due to the inadequate lashing system used on board. The triggers of accidents on these vessels because it is not a strong lashing system, not a good use of lashing system is applied and the lack of maintenance lashing system.

Some environmental factors that can cause shipwreck accidents due to cargo on the deck include storms, high sea waves, hot weather, and high wind speed. Hurricane weather backed by high sea waves and strong winds causes the ship to experience high rolling and can make a container load regardless of its pile. Conditions like this will make the ship experience loss of cargo. Examples of accidents caused by stormy weather, high ocean waves and high winds include the case of Pacific Passenger Adventurer crashes, Annabella ships, P & O Nedlloyd Genoa ships, CMV Yorkshire ships, JRS Canis ships, and Duncan Island ships.

Human factors causing this type of accident include lack of understanding of the IMDG Code, putting inaccurate DG Container, incorrectly installed lashing system, not checking the condition of all lashing systems, lack of understanding of manual cargo and non-inspection of containers. Understanding of the IMDG Code concerns the treatment of container loads that are dangerous goods. During a field study with the Tanjung Priok Syahbandar party, it was found that a chief officer did not understand the IMDG Code. Though the IMDG Code is very important, especially if there are dangerous goods that he brought a container. Things like this can potentially lead to the accident of a container vessel.

Several management factors that may affect the crash of container vessels due to cargo on deck are container conditions that are not compliant with ISO standards, incorrect stowage plan placement, less qualified crew recruitment, shipping does not provide IMDG Code book, and packaging and placement of DG Container do not comply with IMDG Code.
