Costa Concordia

Anatomy of an organisational accident

Capt. Antonio Di Lieto

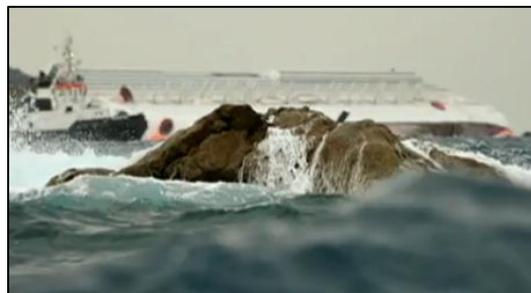
Fig.2 - Rocks "*Le Scole*", near Giglio Island, Italy

The safety margin initially established by the Captain was of 0.5 nautical miles (about 1 kilometre) from the furthestmost point of a group of small islands (*Le Scole*), just south of the main port (*Giglio Porto*) of Giglio Island. From that point on, a *touristic navigation* should have gone parallel to the coast, saluting the islanders and sounding the ship's horn. However, the Costa Concordia got as close as 100 meters from the furthestmost point taken as reference by the Captain, striking an underwater rock with a charted depth of 7,3 meters (fig.4).

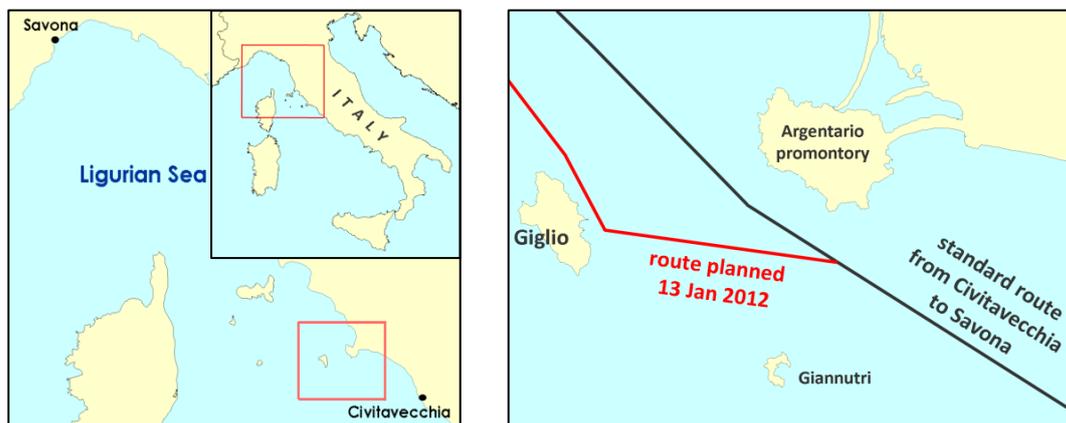
Fig.3 – Standard route from Civitavecchia to Savona, and deviation planned on the 13th of January 2012

The ship left Civitavecchia in the late afternoon of January 13th, 2012, sailing along the passage plan prepared by the 2nd Officer and approved by the Captain. However, the plan included a deviation from the standard route to Savona, which usually takes the ship through the channel - 7 nautical miles wide - between Giglio Island and the mainland (fig.3). The deviation was meant to carry out a *sail-past* Giglio Island and it was decided by the Captain upon request of the restaurant manager, native of the island. The Captain's consent was allegedly given also as a sign of respect for his mentor, a retired Costa Captain who lived on the island. The deviation was discussed with the 2nd Officer, who was responsible for drawing the new route on nautical charts.

On the 13th of January 2012, Costa Concordia left Civitavecchia, bound to Savona. The voyage plan prepared by the Planning Officer and approved by the Captain was to navigate with north-westerly routes through Tyrrhenian Sea and Ligurian Sea (fig.3). There were no significant navigational hazards in the vicinity of the traditional routes from Civitavecchia to Savona, and no other threats to safety of navigation. The traffic² was regular, and the meteorological conditions³ were favourable, with gentle breeze from North East and smooth sea. At about 9pm the ship deviated from its original plan, following a new route decided by the Captain a few hours before. The intention was to carry out a sail-past keeping at a distance of 0.5 nautical miles from Giglio Island. On the new route, a small group of underwater and awash rocks known as *Le Scole*, represented a navigational hazard for the Concordia, whose draught was approximately 8.2 meters. In fact, the furthestmost underwater rock has a shallowest depth of 7.3 meters⁴ (see fig.4).

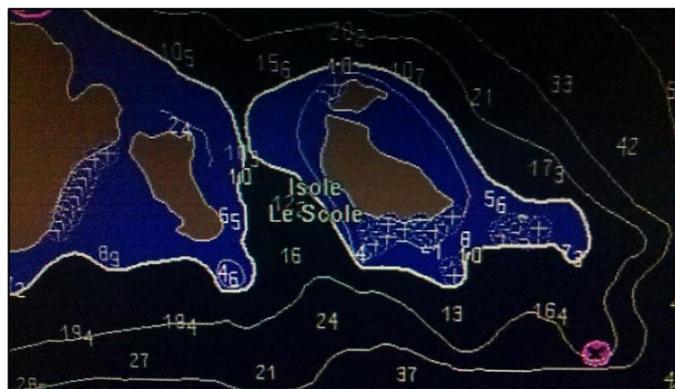
The fourth error also relates to route monitoring. In contrast to the third error, this involved the INS, to be officially used only as an aid to navigation. The equipment was operated by the SOOW, who used the radar distances and the electronic chart overlay to monitor the approach to the island. The error consisted in assessing the distance from the furthestmost radar echo of *Le Scole* rocks, and not from the limit of the *no-go area*, that is the 10 meters bathymetric line. Such line is also known as a *safety contour*, and the INS provides a functionality to set a warning zone ahead of the ship's bow in order to generate a *chart alarm* (fig.10). Nobody within the team realised that between the furthestmost echo radar used as reference, and the limit of the safety contour, there were two significant navigational hazards not detectable by the radar: a small rock about 1 meter above the sea level, and an underwater rock with a shallowest depth of 7.3 meters (fig.11). The dry rock was sighted by the Captain only when it was too late.

depositions to answer these questions. However, given that the sail-past was not a novel situation to deal with, and assuming the lack of use of safety contour alarm as an informal practice, the overall erroneous route monitoring on INS might be considered at both rule and skill based level. The rule based component might concern the mismanagement of *chart alarms*, whereas the skill based component might refer to an attentional slip in overseeing the mentioned navigational hazards on the electronic chart overlay. If the hypothesis of informal practice were true, the rule based component would be both non-functional to organisational goals, and not correct with regard to risk assessment.
