**MARINE INVESTIGATION REPORT
M13N0001**

LOSS OF TOW

**TUG *CHARLENE HUNT* WITH
PASSENGER VESSEL *LYUBOV ORLOVA*
OFF CAPE RACE, NEWFOUNDLAND AND LABRADOR
24 JANUARY 2013**

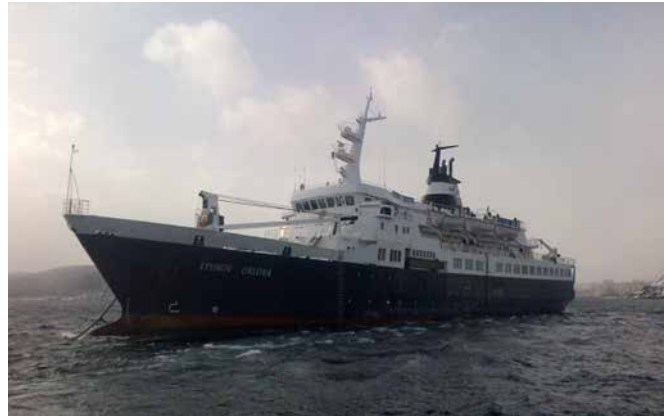
The *Lyubov Orlova* was of typical passenger vessel construction (Photo 2). It was ice-strengthened and had been used for charter adventure cruises in the Arctic prior to being decommissioned in 2010 for financial reasons. The vessel's superstructure extended three-quarters the length of the vessel. The vessel had 2 fixed-pitch propellers and 2 rudders. There was no power on board, and the vessel's dead weight was 4160 tons.

Photo 2. *Lyubov Orlova*, January 2013
