# National Transportation Safety Board

## Marine Accident Brief

### Sinking of Towing Vessel *Nalani*

<b>Accident no.</b>	DCA15LM011
<b>Vessel name</b>	<i>Nalani</i>
<b>Accident type</b>	Sinking
<b>Location</b>	About 1.5 miles west of Barbers Point, Honolulu, Oahu, Hawaii 21° 18.5' N, 158° 09.4' W
<b>Date</b>	January 22, 2015
<b>Time</b>	1510 Hawaii standard time (coordinated universal time – 10 hours)
<b>Injuries</b>	None
<b>Damage</b>	Total loss of vessel, valued at \$200,000
<b>Environmental damage</b>	Oil sheen observed
<b>Weather</b>	Clear skies, winds about 10 knots, 6–8-foot seas, water temperature 77.2°F
<b>Waterway information</b>	Pacific Ocean, about 1.5 miles west of Barbers Point Harbor, water depth about 2,200 feet

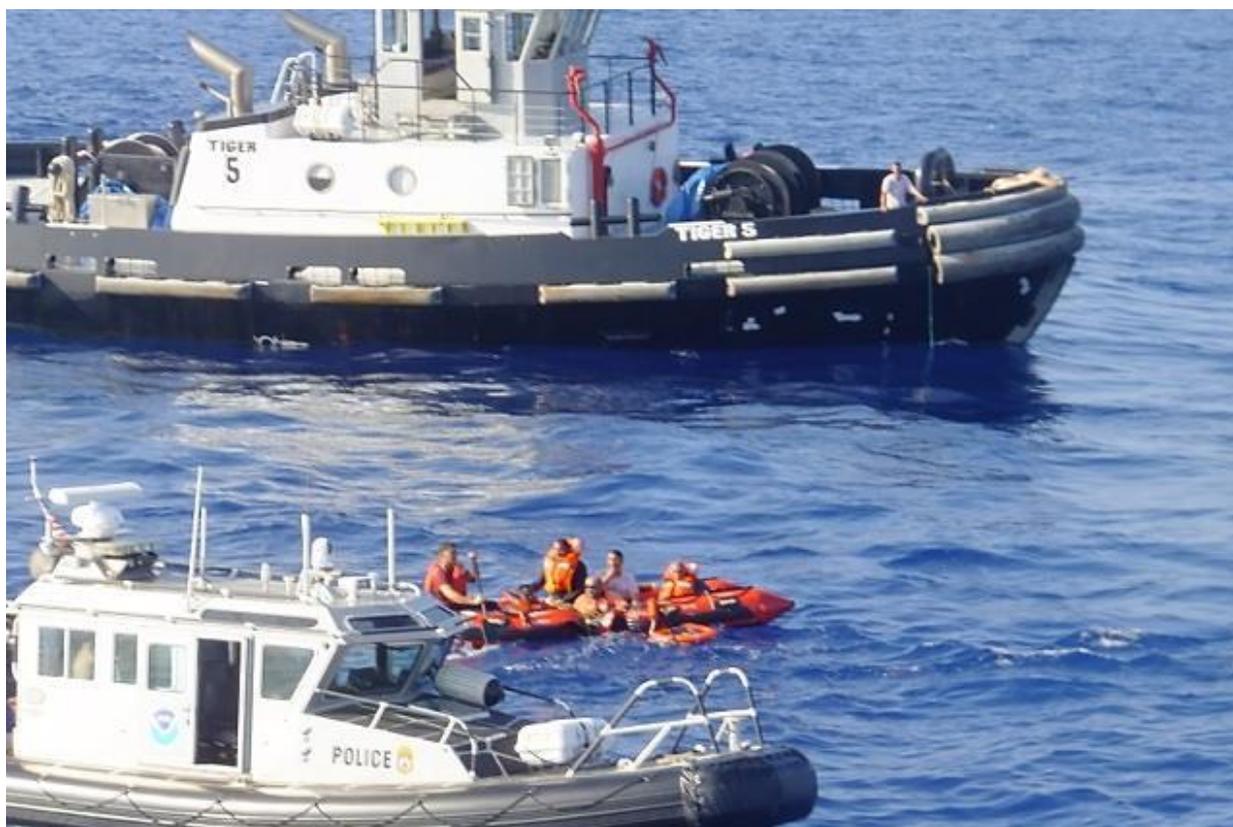
Crewmembers in the newly installed inflatable boat before being rescued by assist vessels. (Photo by *Clean Islands* crewmember)

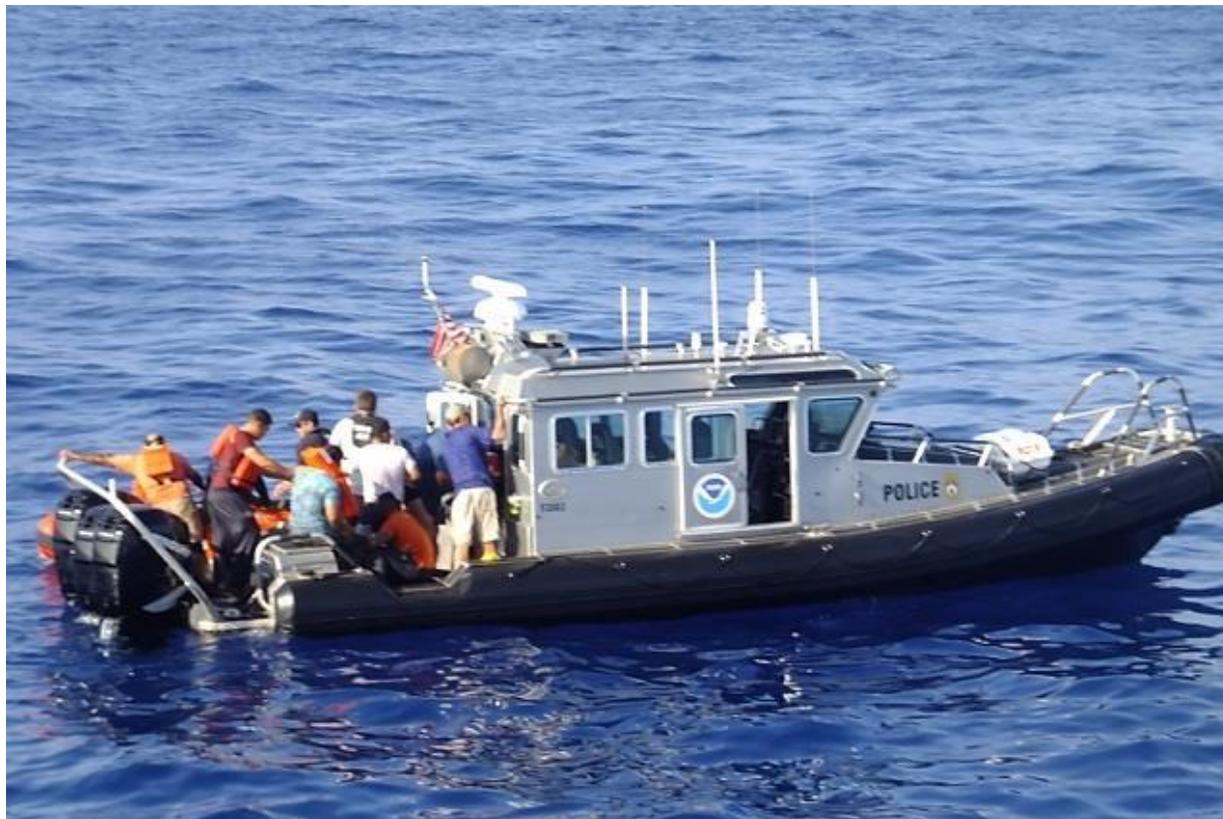
Rescued crew on board NOAA patrol boat F3503. (Photo by *Clean Islands* crewmember)
