Bahamas Maritime Authority

Report of the investigation into the loss of
the Bahamian registered tanker "Prestige"
off the northwest coast of Spain
on 19th November 2002

Report of the investigation into the loss of the
Bahamian registered tanker "Prestige" off the
northwest coast of Spain on 19 November 2002

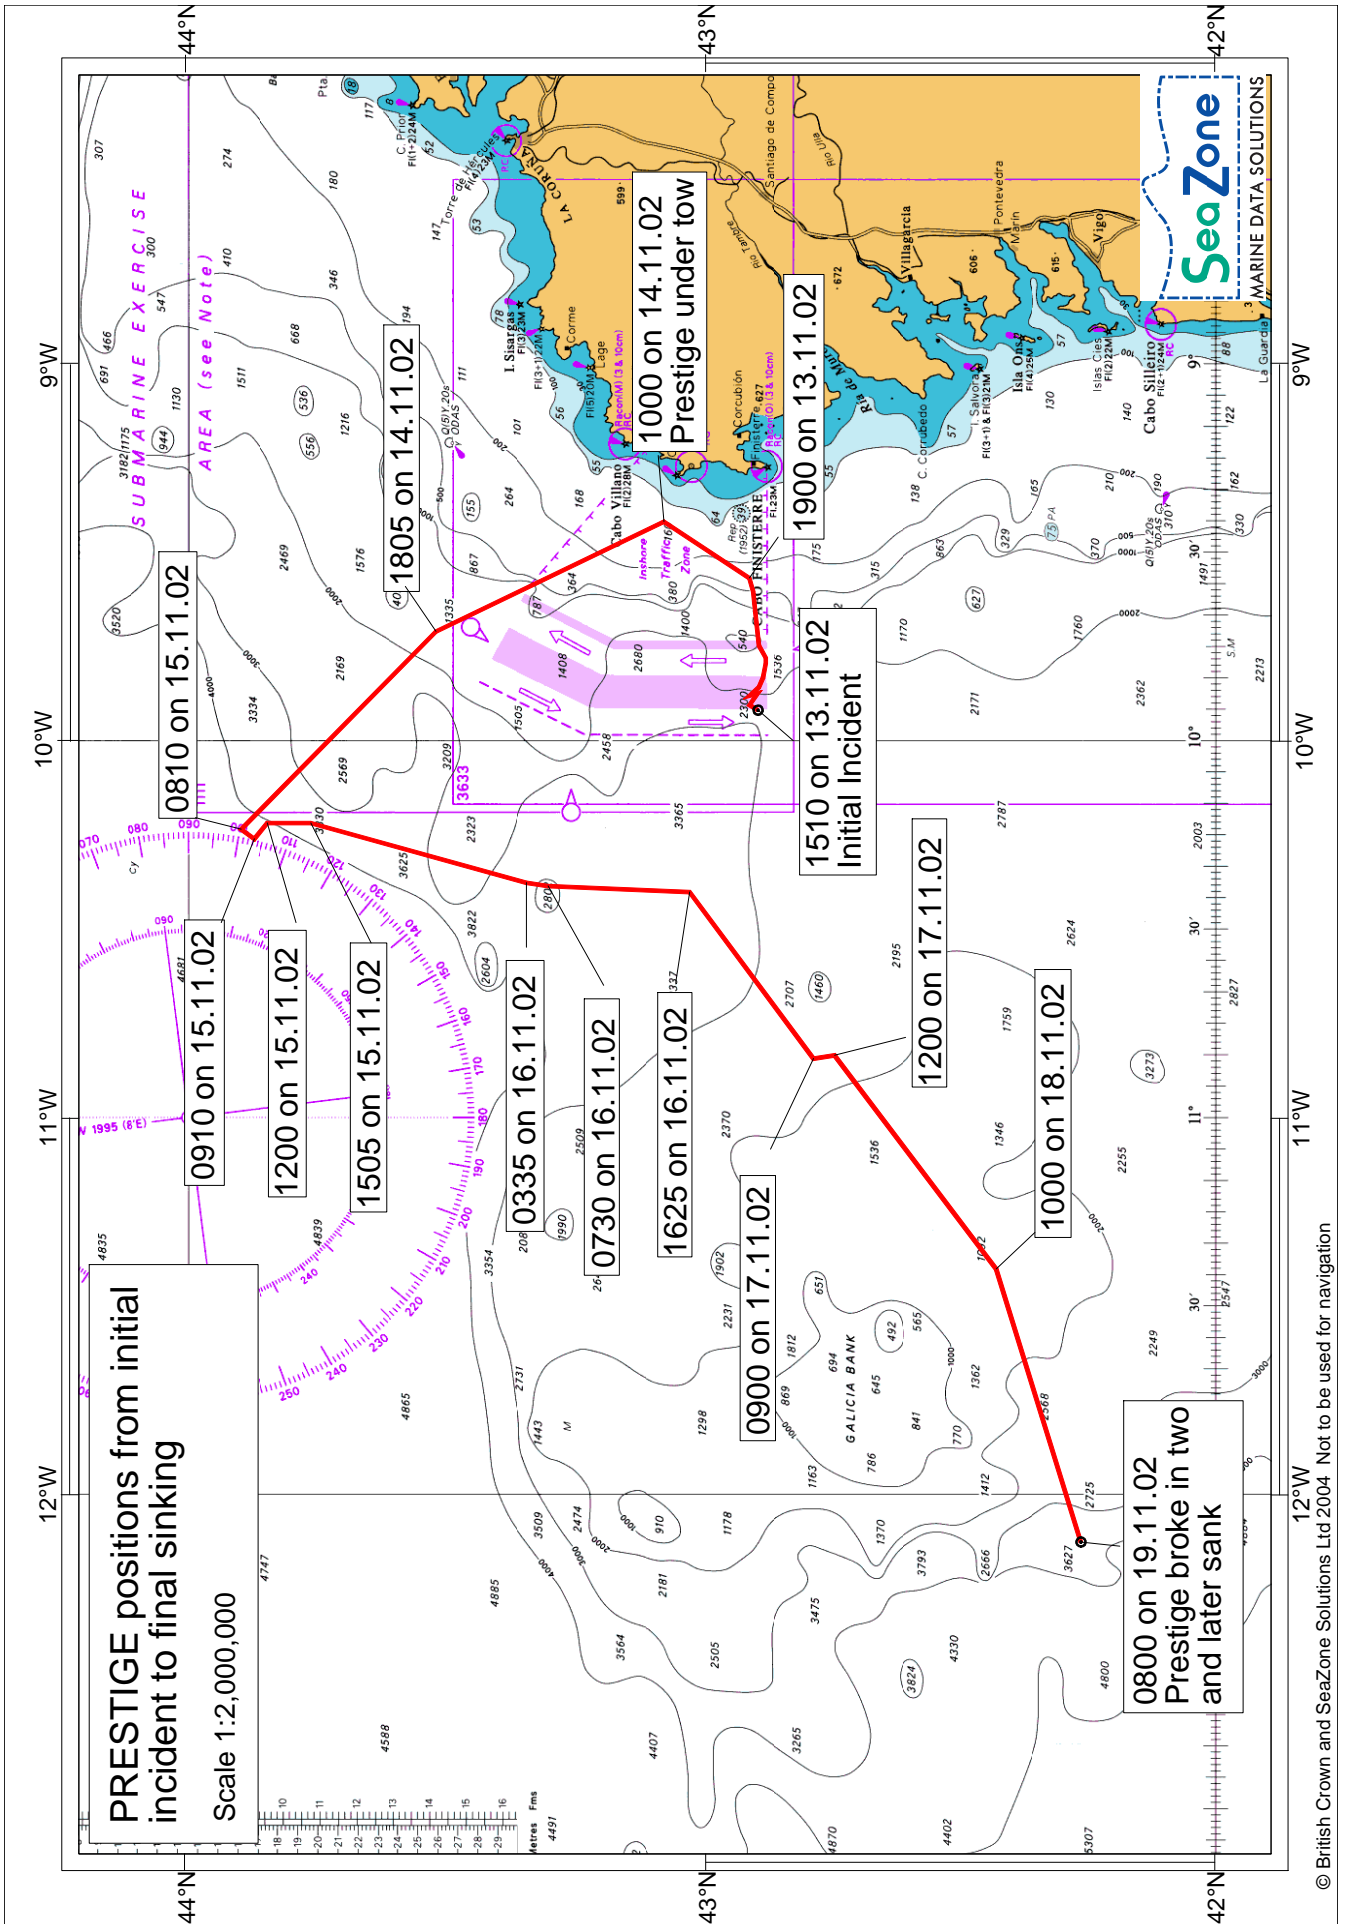
Figure 3

Vigo arrived in the vicinity of the Prestige around 1830 on 13 November, but did not remain in close proximity. The Masters of the Prestige and Ria de Vigo were in VHF radio contact. Radar plots from the Finisterre Traffic System indicated that Ria de Vigo was 4.4 miles south-east of the Prestige at 1800 and 3.3 miles WNW of the Prestige at 1900. No offer to provide towage of the Prestige was made at this time. (A plot of the Prestige's movements after the initial incident is provided at figure 3)

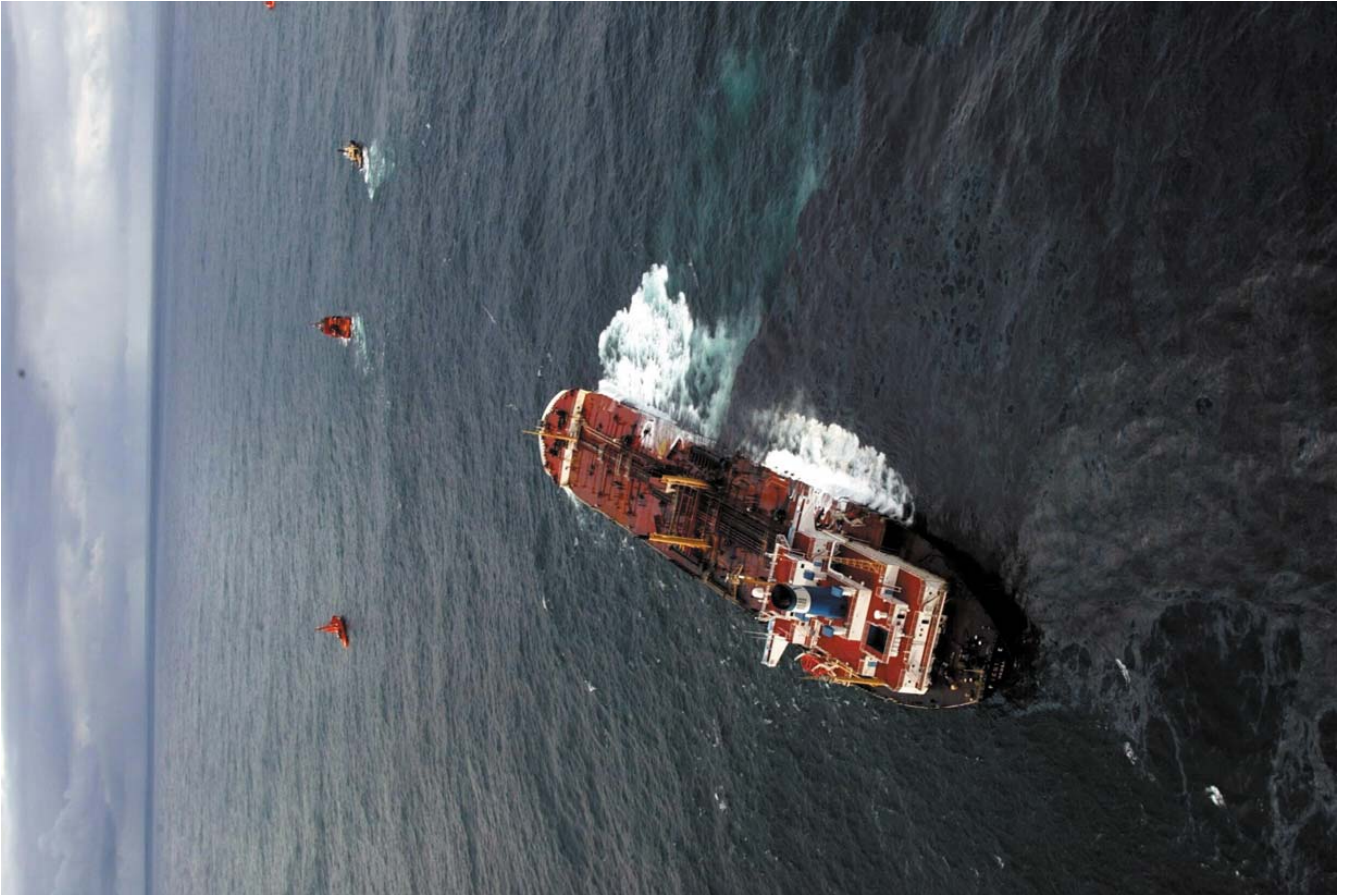
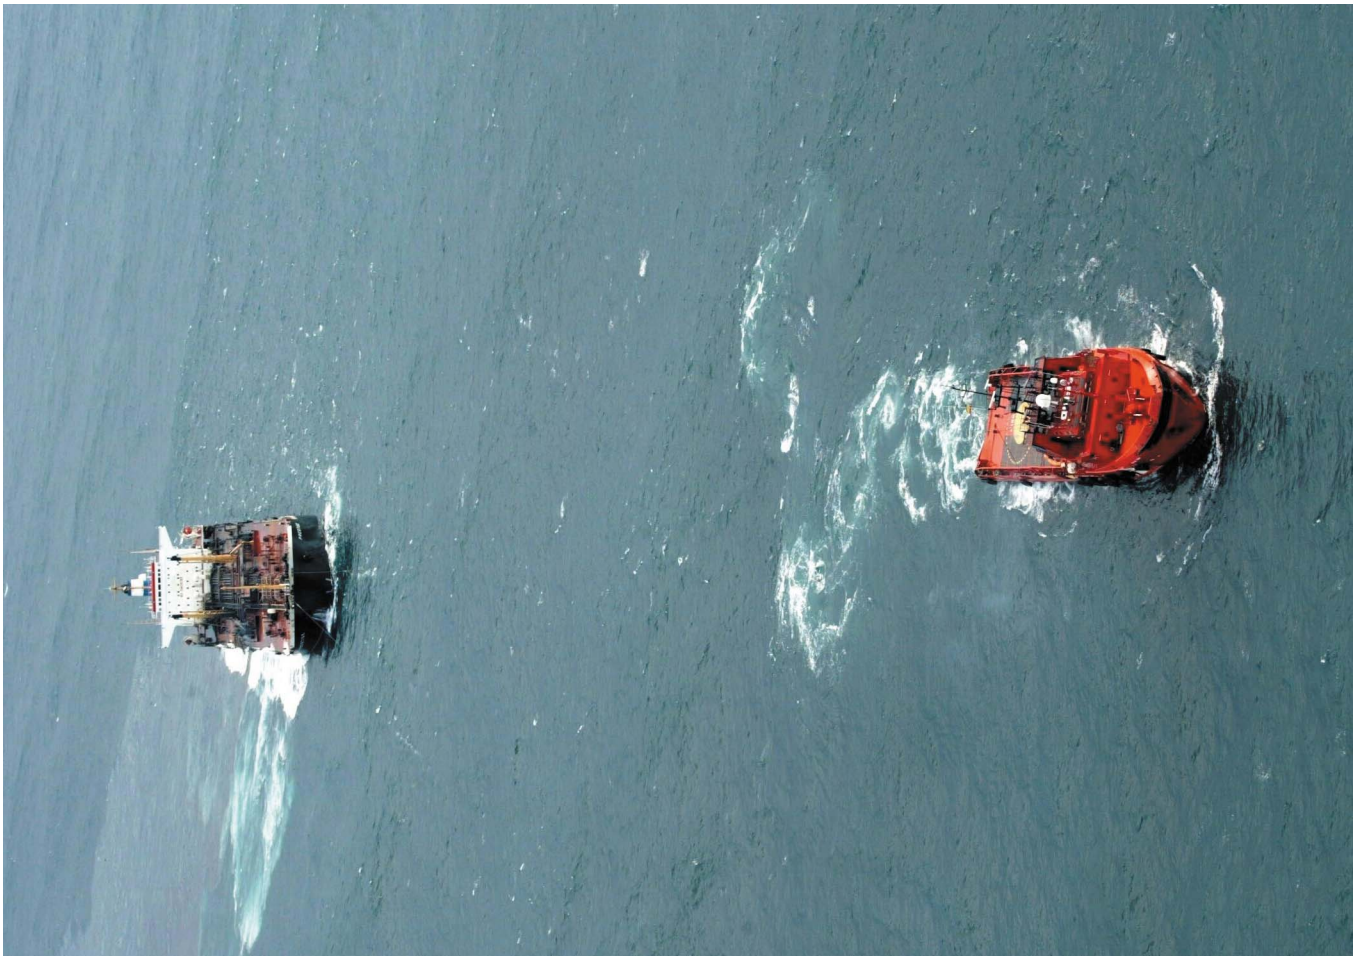
Under tow
Figure 6

2.6.17 Ria de Vigo began shortening her towline at 1035 on 18 November and remained in attendance after disconnecting. At about the same time, the Spanish authorities advised the owners of the Ria de Vigo that Ria de Vigo should be released immediately. The Salvage Master advised that Ria de Vigo was required on site and could not be released. It was agreed by SASEMAR at 1120 that Ria de Vigo could remain in attendance. Sertosa 32 and Alonso de Chaves were released and returned to port. Deda resumed towing the Prestige stern first at around 1800 in a SW'ly direction at a speed of about 3 knots. The position of the Prestige at 1904 on 18 November was reported by Ria de Vigo to be latitude 42° 26'N longitude 11° 28.7'W.(Figure 6 shows the Prestige under tow)

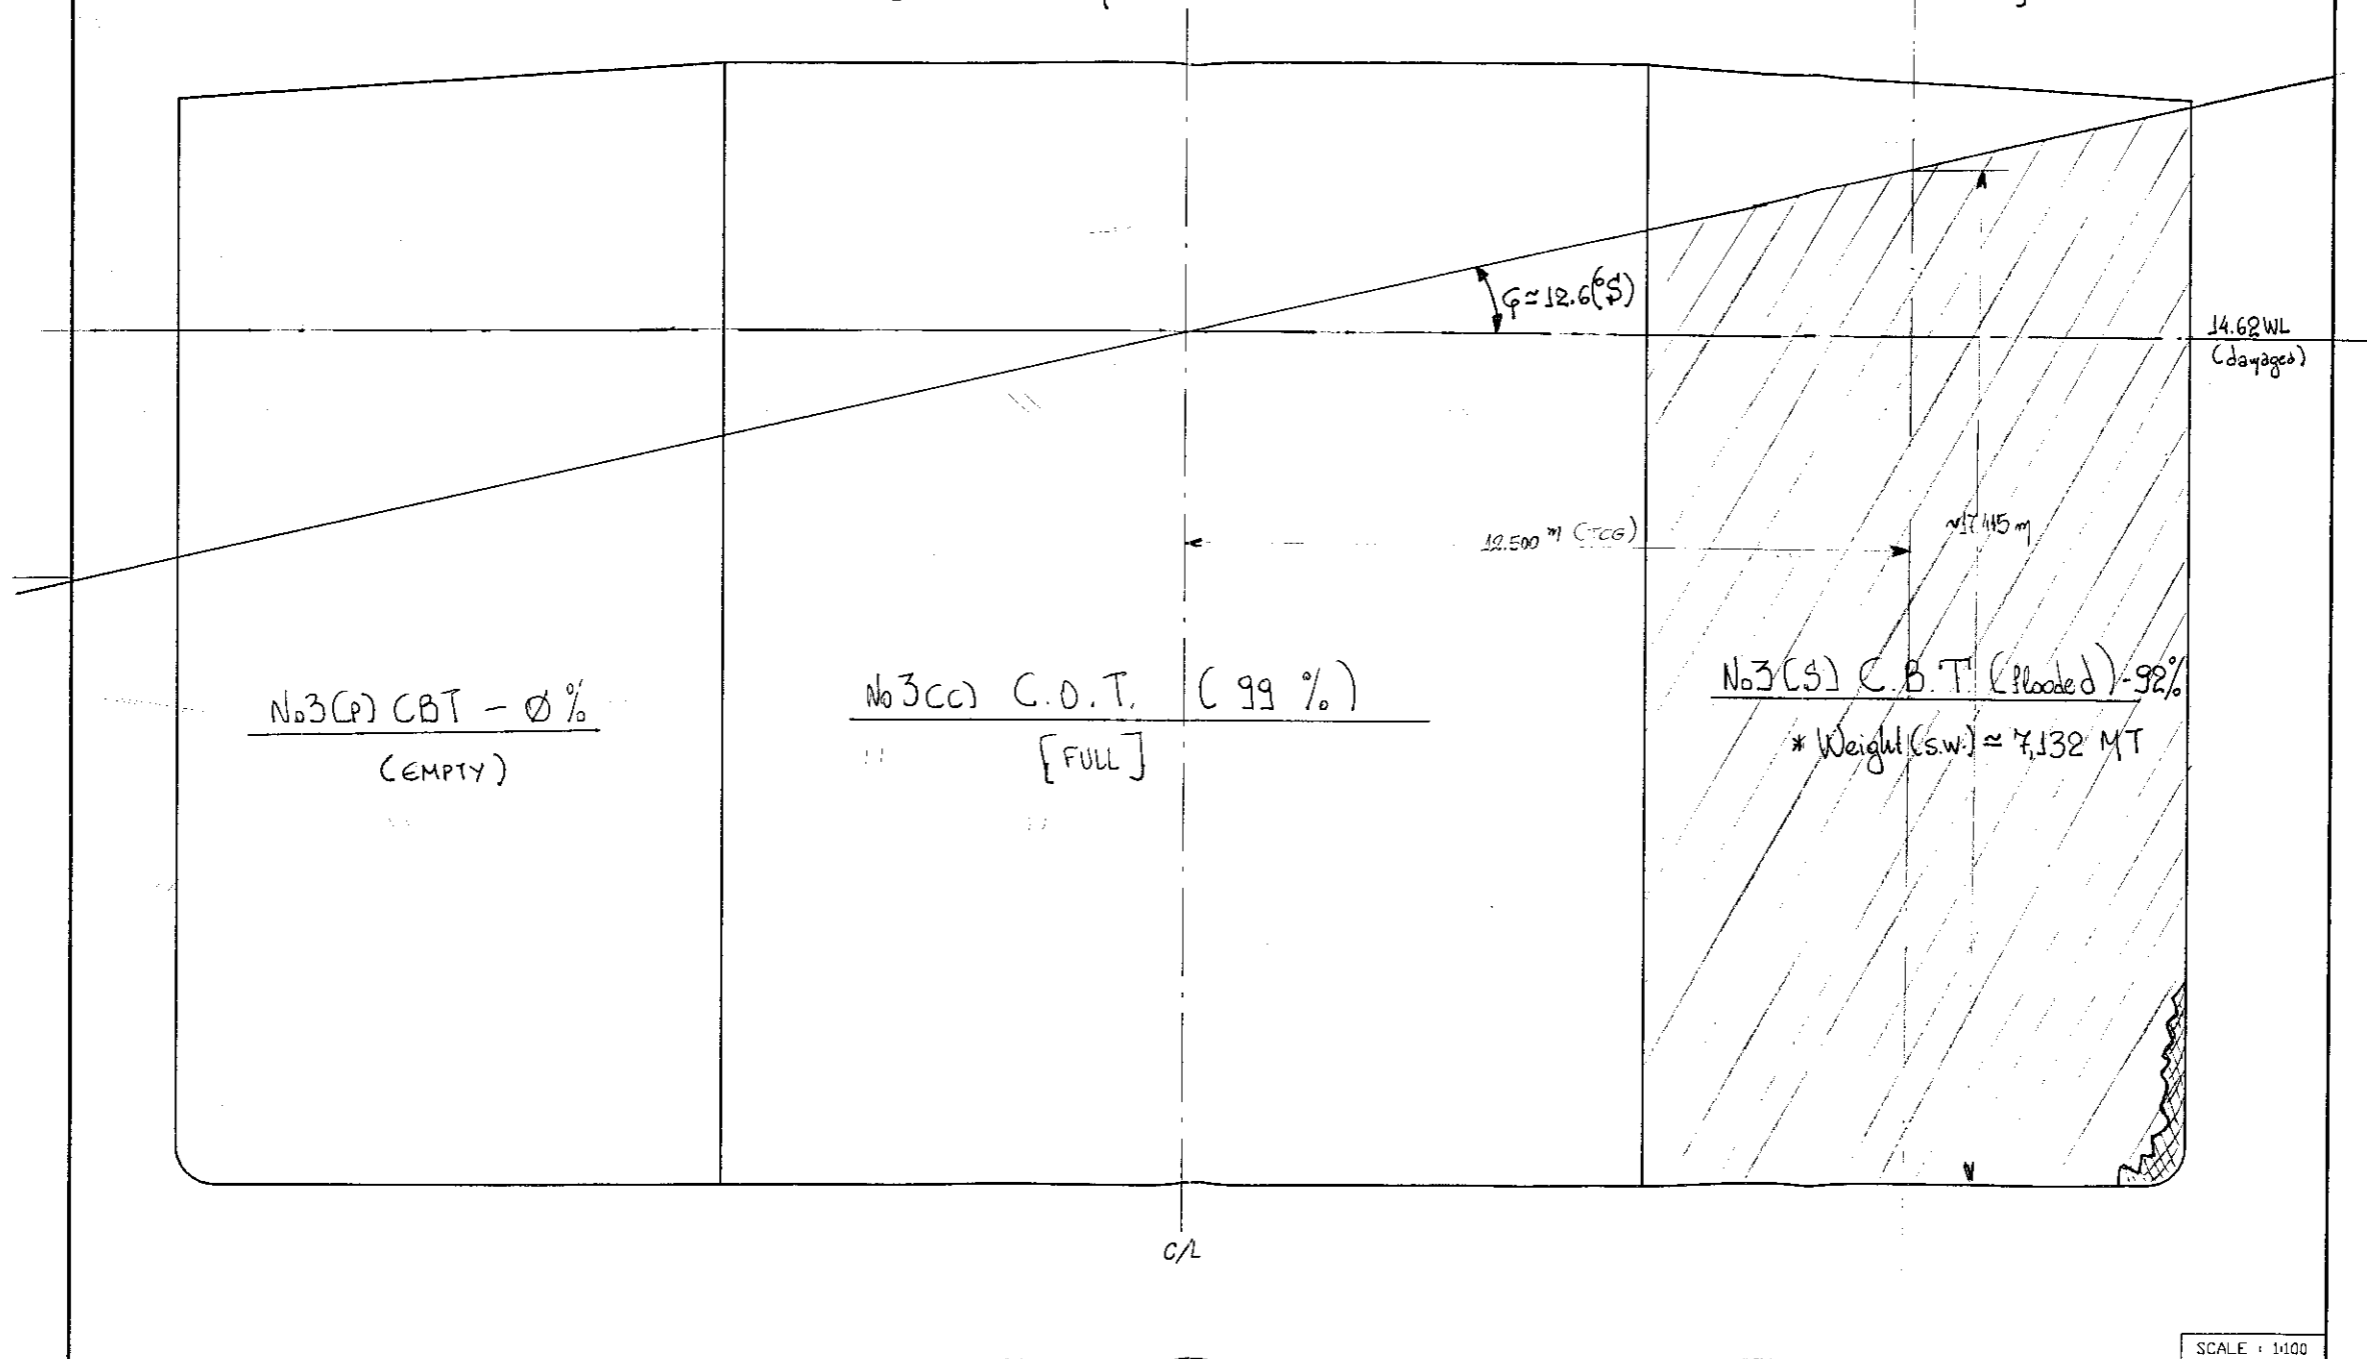
SF max -5834 (MT) (Excess Buoyancy) at Frame 51 80% of Max Perm
 BM max -170285 (MT-m) (Sagging) at Frame 59 96% of Max Perm
 Estimated Deflection Amidships = -11 cm SAGGING

Damaged Condition: $\{ \Delta(MT) = 100,896, T_H(WL) = 14.62, t(WL) = 0.52, SF = 80\% (r.51), BM = 96\% (r.59) \}$

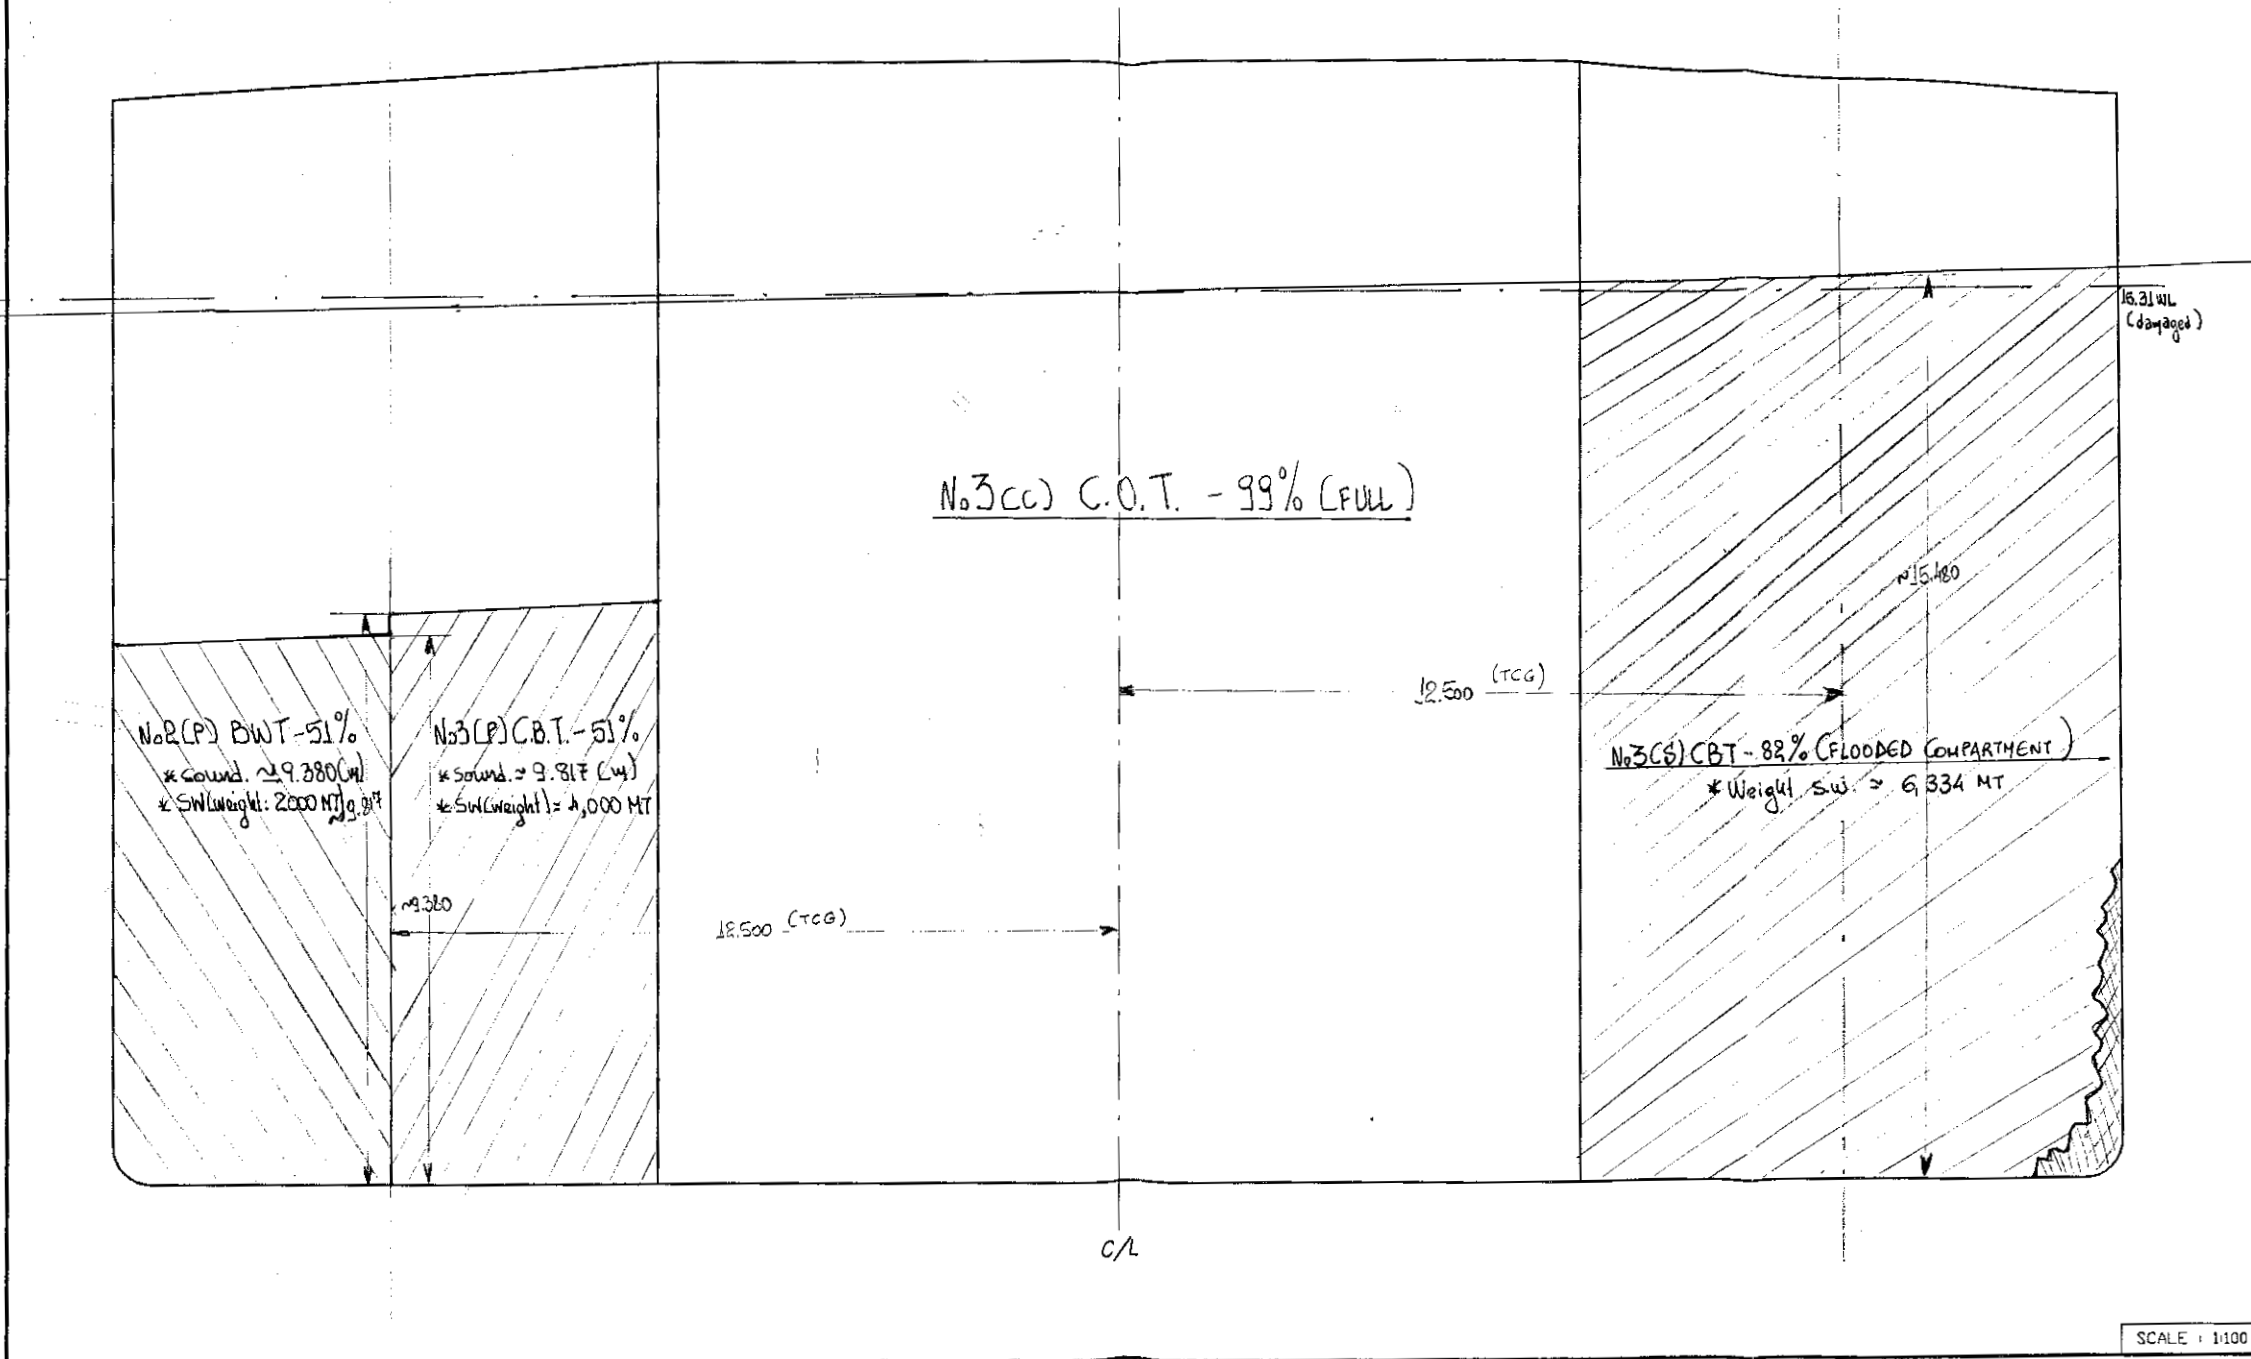
SF max -6604 (MT) (Excess Buoyancy) at Frame 51 90% of Max Perm
 BM max -237926 (MT-m) (Sagging) at Frame 62 132% of Max Perm
 Estimated Deflection Amidships = -16 cm SAGGING

Adjust heel with No 2 BWT (P) & No 3 CBT (P) : $\left\{ \Delta(\text{MT}) : 106,099, T_M(\text{m}) : 15.31, t = 0.30(\text{m}), SF = 90\%, BM = 132\% \right\}$
 $\varphi = 0.8(^{\circ})$
