MARINE SAFETY INVESTIGATION REPORT

Safety investigation into the allision involving the
Maltese registered bulk carrier

CAPRI

MARINE SAFETY INVESTIGATION REPORT NO. 12/2016

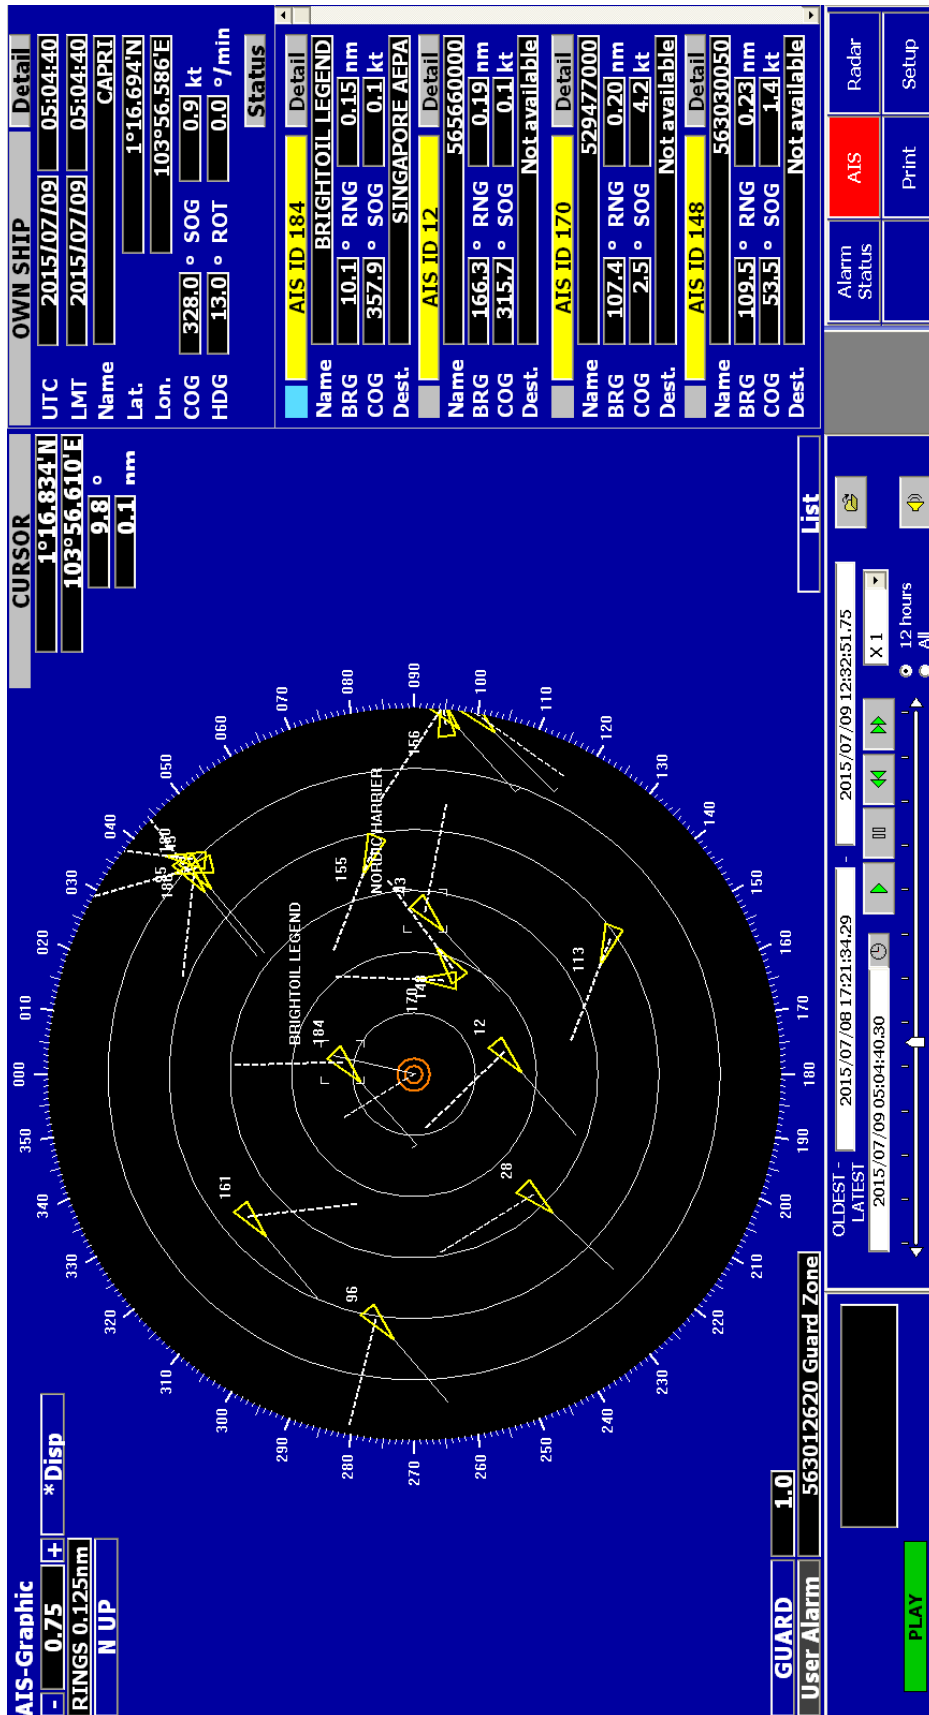
Figure 5: VDR image of Capri at 1304/40 s

Relative position of *Tai health*, *Nordic Harrier* and *Brightoil Legend* at 1301 is shown Figure 4. At 1303, the starboard anchor was dropped to lessen the impact of the allision, which was now inevitable. Shortly afterwards, the port bow of *Capri* made contact at an angle with *Brightoil Legend* at 2.5 knots in the Eastern Special Purposes Anchorage A, in position 01° 16.842' N 103° 56.612' E (Figures 5 and 6).

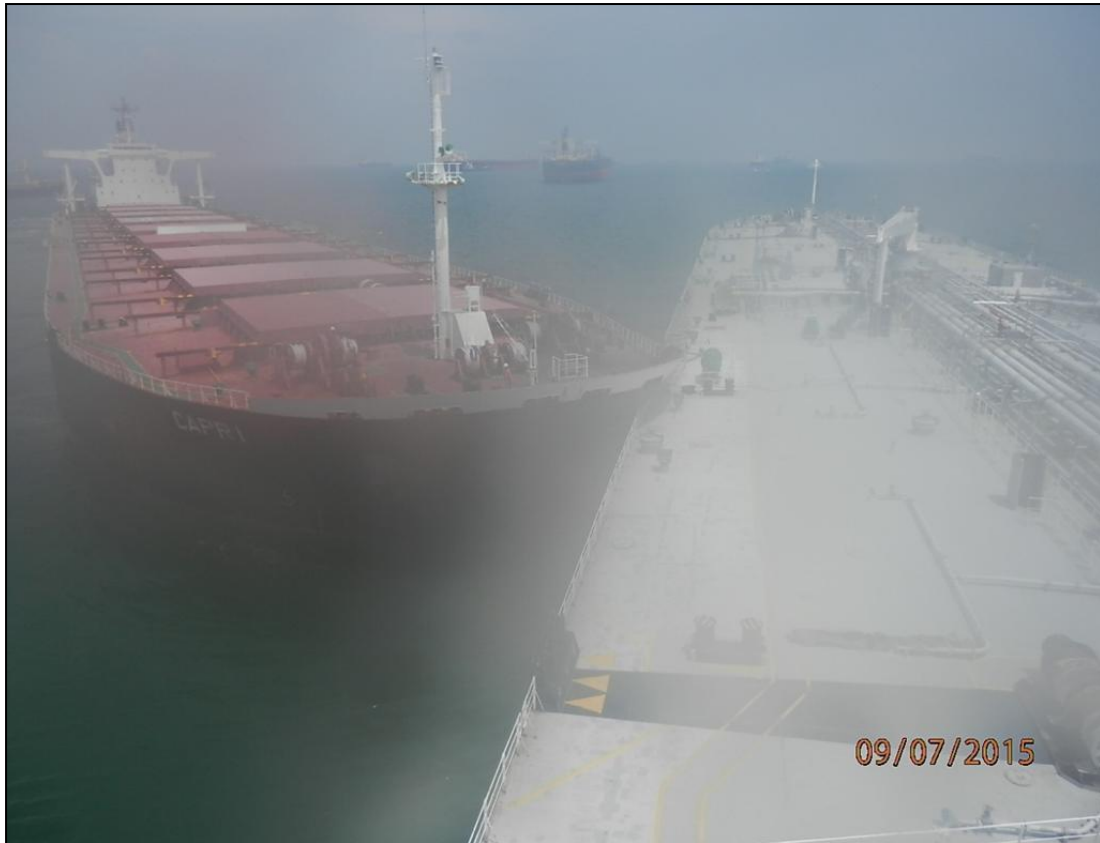
Figure 6: *Capri* and *Brightoil Legend* several minutes after the allision

Both vessels reported structural damage above the waterline, although there were neither injuries nor pollution.

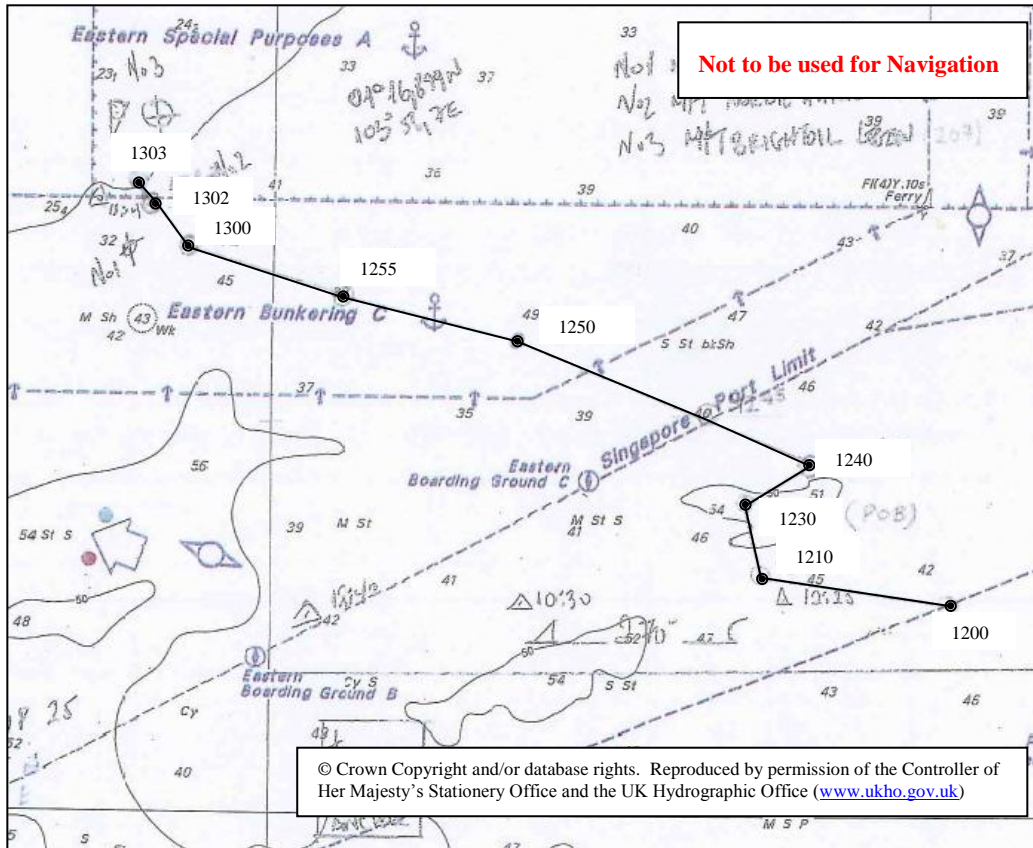
Capri's positions and track as captured by the AIS are shown in Figure 7. A hand-drawn copy of track submitted by *Capri* is reproduced as Figure 8.

Figure 7: Capri's track compiled from the positions captured from the AIS

During the course of the investigation, the master explained that since the manoeuvre was a simple anchoring operation and which did not involve mooring the vessel, no essential information was exchanged. The perception of the actual risk was also indicative in the limited number of positions which were plotted on the chart. A copy of vessel's track (Figure 8) submitted as documentary evidence of navigational progress was found unreliable when compared with the actual positions extracted from the VDR data. The fact that both the track and plotted positions sharply vary with *Capri's* true AIS positions and VTS recorded track (Figure 7) was indicative of inadequate monitoring and inaccurate situational awareness.
