Collision between Bulk Carrier *Summer Wind*
and the *Miss Susan* Tow
Houston Ship Channel, Lower Galveston Bay, Texas
March 22, 2014

Marine Accident Report
NTSB/MAR-15/01
PB2015-104888

**National
Transportation
Safety Board**

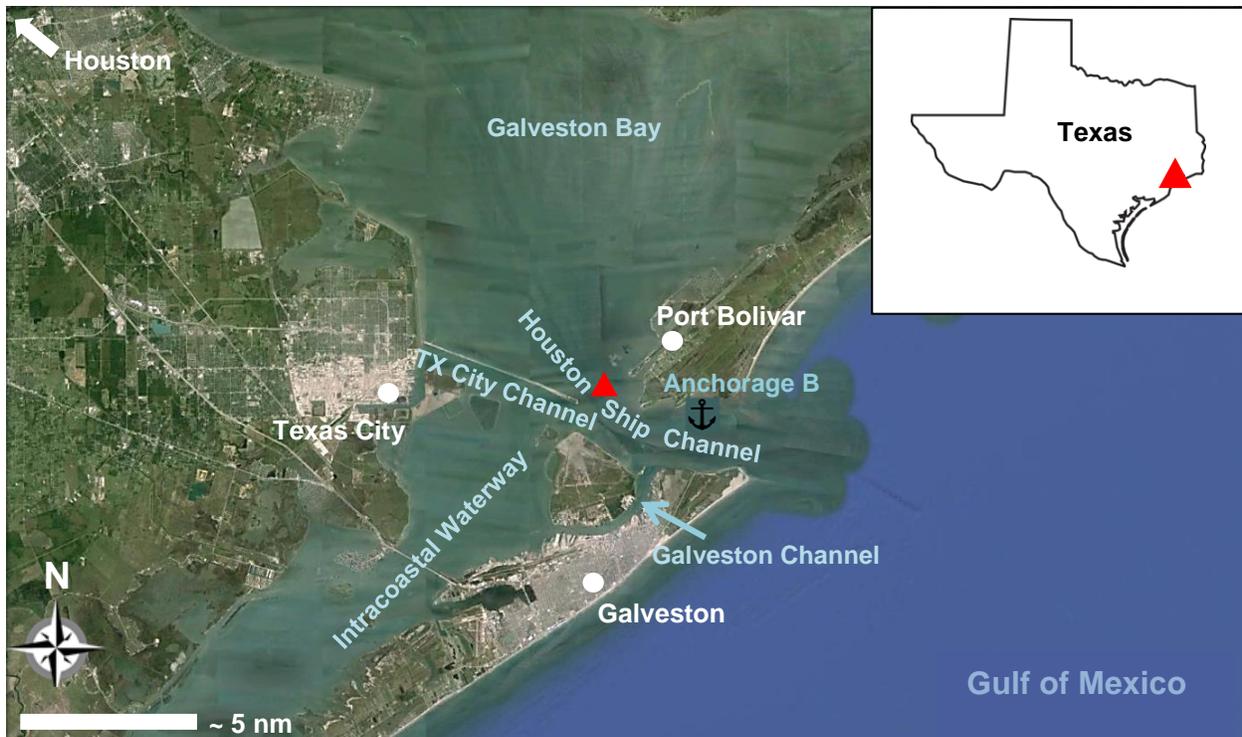
Figure 2. Satellite image of the collision site. (Background by Google Earth)

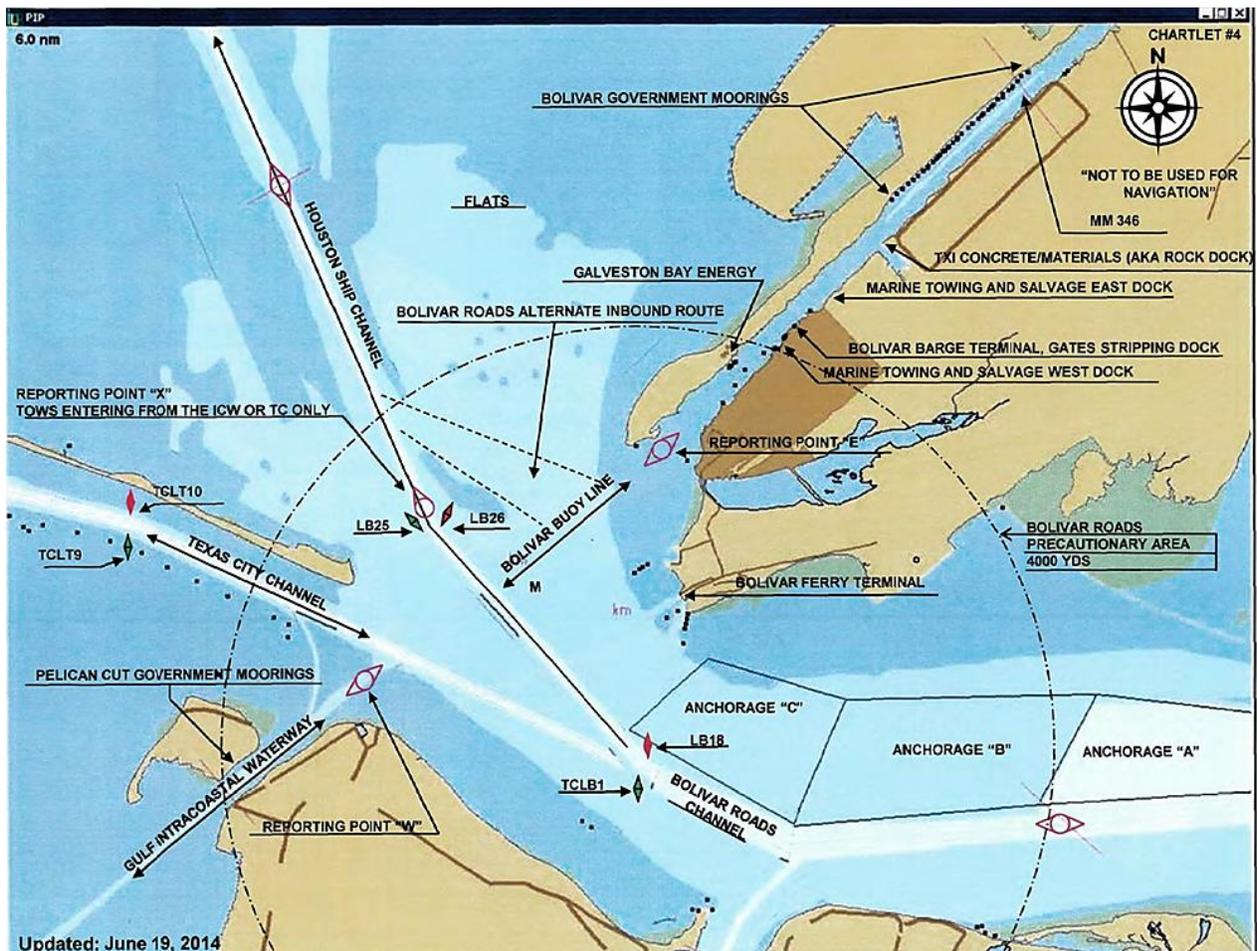
The *Summer Wind* was in an area the Coast Guard designates as the "Bolivar Roads Precautionary Area" (figure 3), which includes several intersecting waterways. Title 33 *Code of Federal Regulations* (CFR) 161.2 defines precautionary areas as geographic sectors in which "vessels must navigate with particular caution." Nautical charts for the Houston Ship Channel do not graphically depict the Bolivar Roads Precautionary Area (figure 4).⁶

Figure 3. Image of the Bolivar Roads Precautionary Area (circled), including part of the Houston Ship Channel, the Texas City Channel, the Intracoastal Waterway, and, in the lower center of the image, the Galveston Channel. (Image in Vessel Traffic Service Houston/Galveston's Ports and Waterways Safety System Chartlet #4)

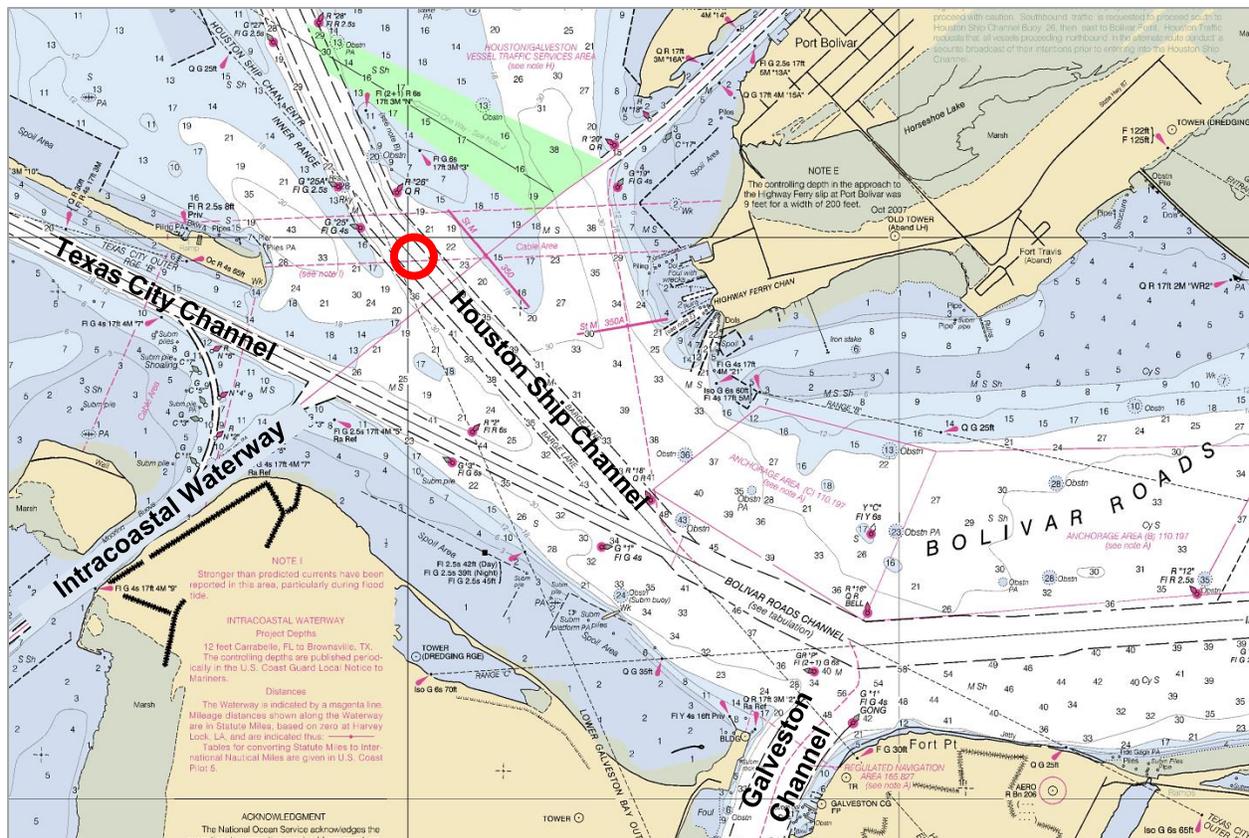
Figure 4. Section of nautical chart 11324, showing portions of the Houston Ship Channel, the Texas City Channel, the Intracoastal Waterway, and the Galveston Channel, with overlaid channel labels. The collision site is overlaid by a red circle. The Coast Guard-designated Bolivar Roads Precautionary Area, which was shown as a large circle in the previous image, is not depicted on this chart.

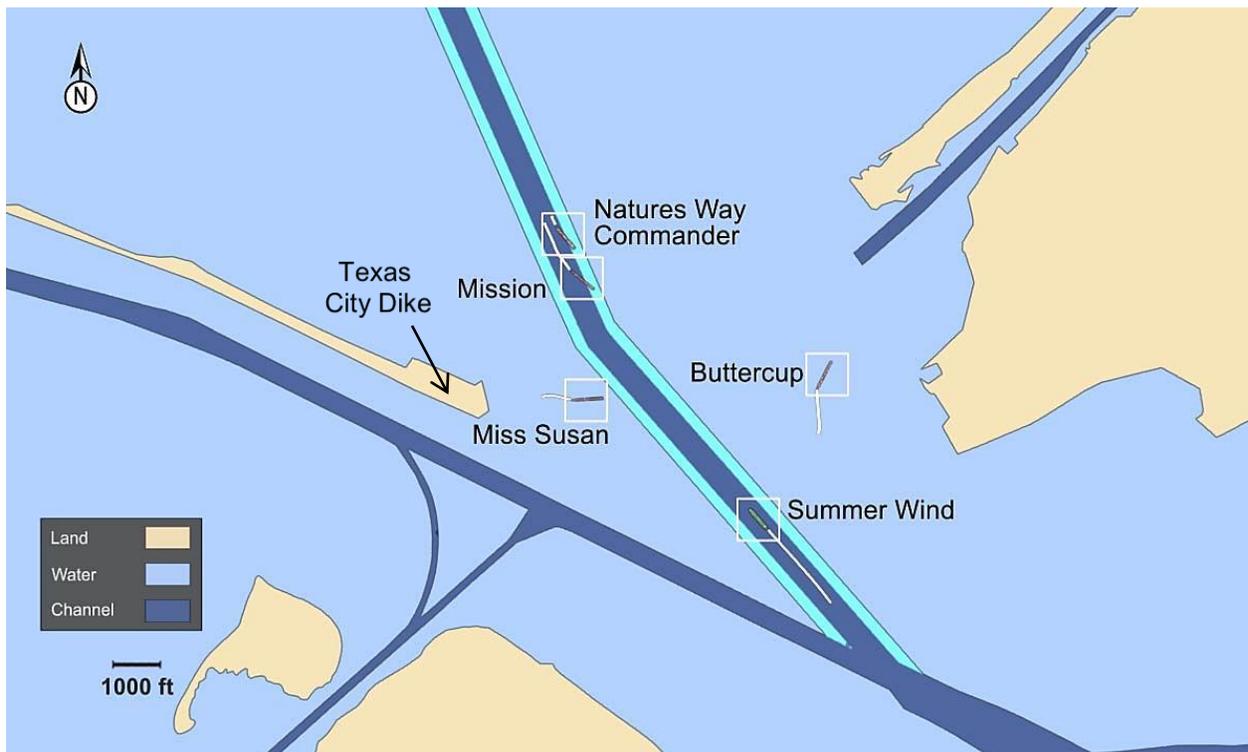
The *Miss Susan* captain told investigators that, about the same time as the *Mission* captain’s radio call, she realized by looking at her AIS that the *Summer Wind*’s speed had increased. At this point, the *Miss Susan* was at the tip of the Texas City Dike, on the west side of the Houston Ship Channel (figure 6). The *Miss Susan* captain told investigators that the *Summer Wind*’s speed increase was unexpected; however, she also acknowledged that inbound and outbound deep-draft vessels in the Houston Ship Channel routinely transited at full-ahead speed (12–13 knots), including during restricted visibility. Her own vessel’s speed at that point was about 5.4 knots, according to AIS data.¹³

Figure 6. Illustration, based on AIS data, of the various vessels’ positions in the waterway about 1232, 3 minutes before the collision.

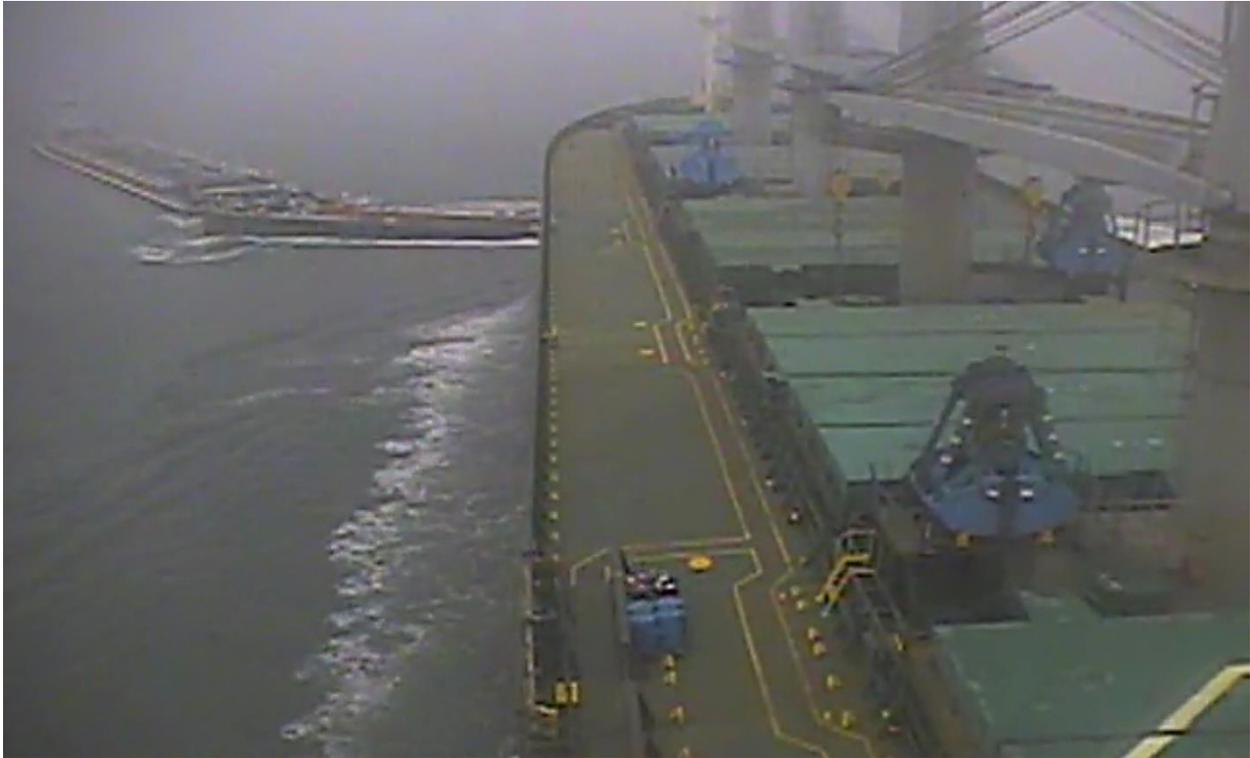
About 1235, the *Summer Wind*'s bulbous bow struck the *Miss Susan*'s lead barge, *Kirby 27706*, half way down its starboard side (figures 7 and 8). The impact punctured the barge's double hull and released about 4,000 barrels (168,000 gallons) of RMG 380 into the waterway. The collision occurred about 3.2 nautical miles from where the *Summer Wind* had left anchorage some 25 minutes earlier.

Figure 7. Screen capture from the *Summer Wind*'s port bridge wing video, which began recording automatically from the motion caused by the collision. The image shows the scene immediately after the impact. In the upper left of the image is the *Miss Susan* tow.

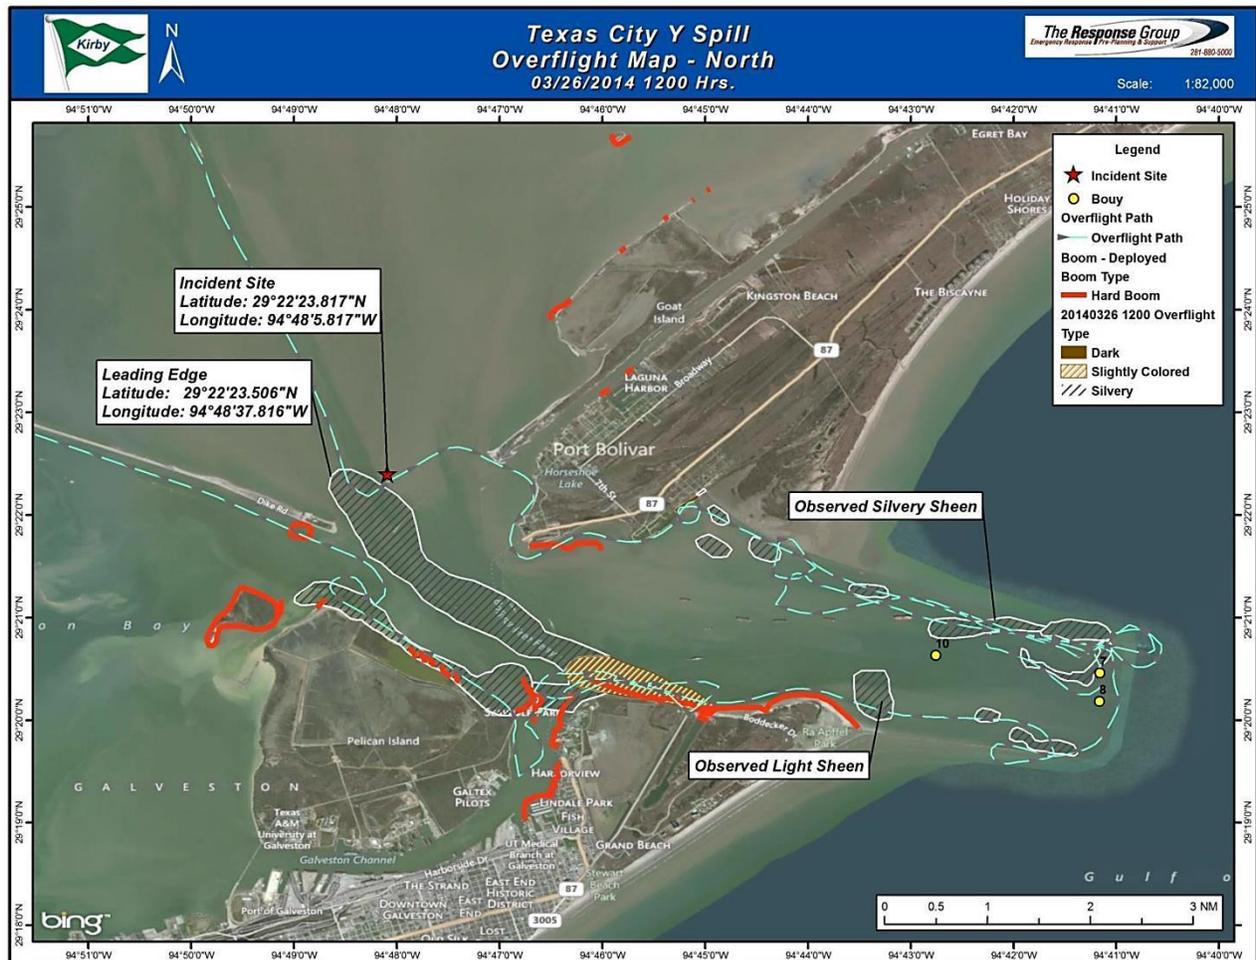
The area contingency plan for a major oil spill was activated.²² Before dark on March 22, more than 3,000 feet of boom was in place to try to prevent the oil from spreading with the tides. However, changing currents, winds, and weather conditions necessitated extension of containment and oil recovery operations into the Gulf of Mexico and south along Galveston Island (figure 11).

Figure 11. Overflight map, produced by Kirby Inland Marine, showing the locations of boom deployment and oil sightings in Galveston Bay on March 26, 2014, 4 days after the accident.

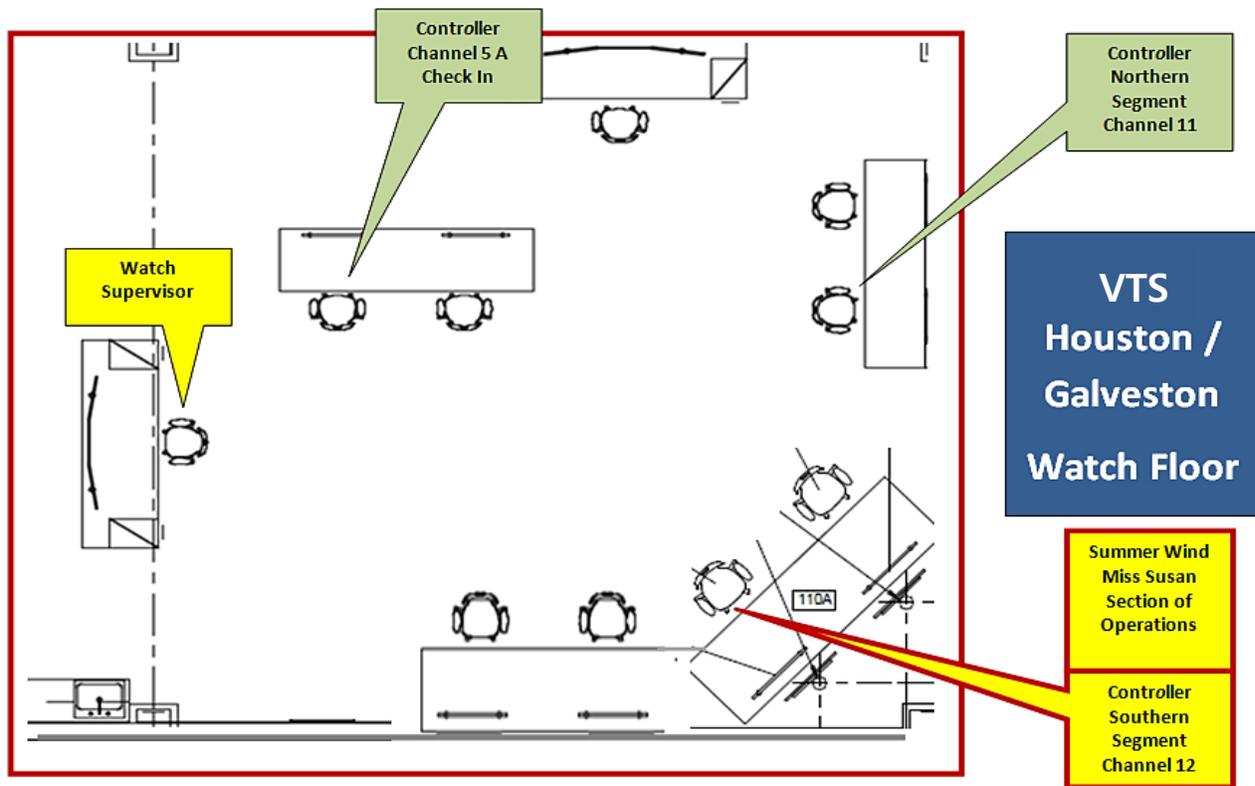
Figure 12. Layout of the vessel traffic control room at VTS Houston/Galveston. (Image by the Coast Guard)

According to internal operating procedures, VTS Houston/Galveston watchstanders were required to “guard” four radio channels; that is, listen and be ready to transmit. The radio channels that required guarding were 5A (for vessel check-in and checkout), 11 (northern Sector III’s working frequency to communicate with vessels), 12 (southern Sector I & II’s working frequency to communicate with vessels), and 13 (the primary radio channel used by mariners in the waterway to communicate vessel-to-vessel). However, despite the requirement to guard channel 13, none of the watchstanders did so. According to the VTS director and as confirmed by NTSB investigators, channel 13 was being broadcast on speaker in the vessel traffic control room. However, the three watchstanders were wearing headphones and listening to the other three channels. It was by way of channel 13 that the various towing vessel captains were arranging their approaches into Bolivar, and on which the *Mission* captain questioned the *Miss Susan* captain as to whether her tow would have enough time to cross the Houston Ship Channel before the *Summer Wind*’s passage. It was also on channel 13 that the *Miss Susan* captain and the pilot on the *Summer Wind* were communicating about the developing close-quarters situation between their two vessels and the evasive maneuvers they were making in the final couple of minutes to try to resolve it. Despite these audible radio communications, VTS watchstanders never interacted with the vessels, which indicates that they were not guarding channel 13. In fact, one of the watchstanders told investigators that VTS was unaware of the accident until the *Mission* captain reported it. The NTSB therefore concludes that VTS Houston/Galveston did not effectively follow its own internal operating procedures to guard channel 13.
