Editorial

Flash fire – welding and painting

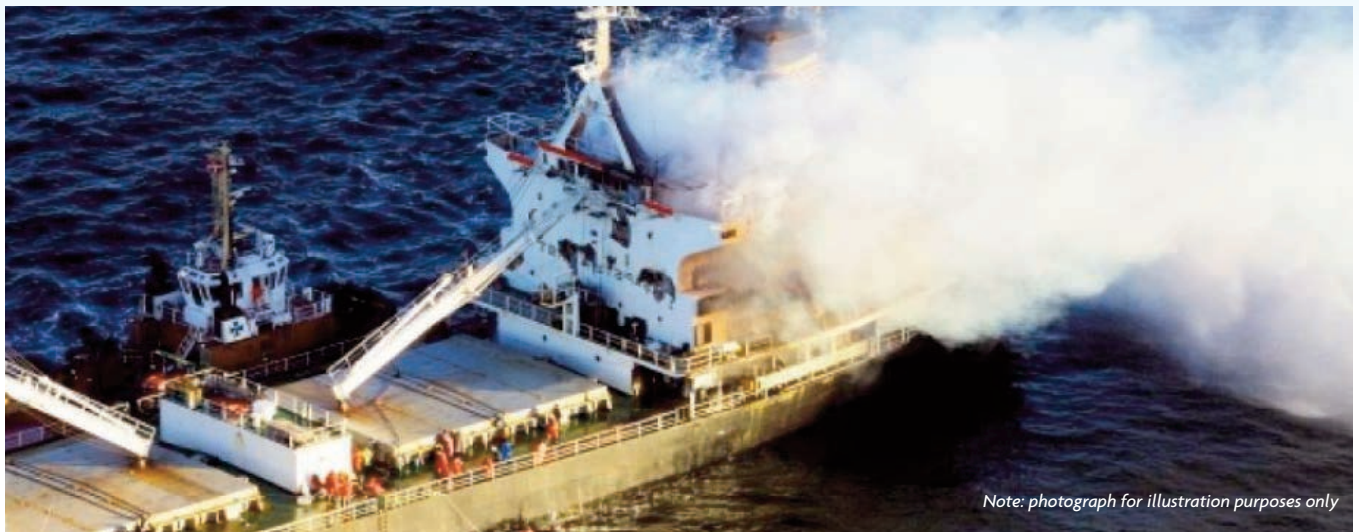
Note: photograph for illustration purposes only

This article outlines the rapid outbreak of a fire onboard a vessel in a ship yard during welding operations. Several safety lessons emerge, including the risk of multiple paint layers retaining flammable products which may act as an accelerant.

was on fire. Contributing factors are reported to have been the dozen layers of paint found to have been applied, and flammable components between the paint layers arising from allowance of inadequate time between the paint applications.

The welding was conducted on the outside of the superstructure on a deck panel. Sparks dropped into a pile of rubbish which ignited; the fire quickly spread. There was no fire watch set by either ship's staff or the repair yard. An attempt to extinguish the fire with a 'high pressure cleaner' did not work; the fire was later successfully put out.

Of particular interest is the speed and spread of the fire, apparently caused by trapped flammable products igniting within the multiple paint layers. Several of the layers were presumably not recently applied, but all or some must have retained combustible products.

We don't have details of training levels, supervision, or the 'permit to work' (PTW) arrangements in place. However it is clear that precautions against the outbreak of fire were inadequate. There was a failure to clear the area of potential fire risks, no fire watch and no fire extinguishers to hand, which infers a hotwork PTW had not been completed, nor adequate supervision provided.
