UNITED STATES COAST GUARD

**REPORT OF INVESTIGATION INTO THE
CIRCUMSTANCES SURROUNDING THE MULTIPLE
RELATED MARINE CASUALTIES AND
GROUNDING OF THE**

MODU KULLUK

ON DECEMBER 31, 2012

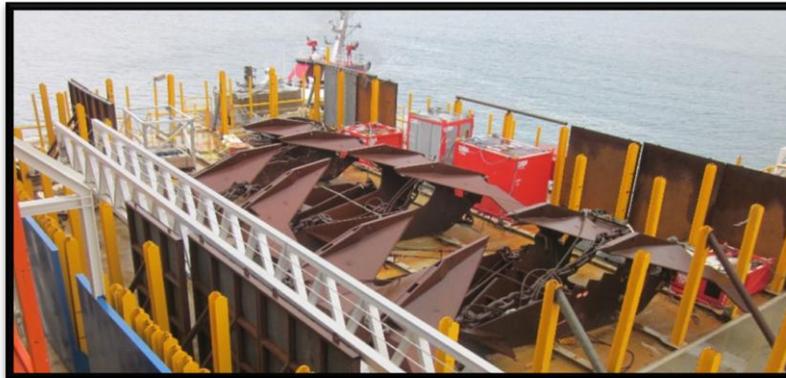
30. While not addressed in the towing plan contingencies, the KULLUK was equipped with a 15 ton “LWT” type survival anchor and the associated diesel powered anchor windlass, chain (900 feet) and ground tackle used to secure the anchor in the stored or deployed position. The additional 5 anchors specified in the plan (see above) were stored on the rig and would require the use of the onboard crane(s) for deployment. As such, they would only be available for mooring in sheltered waters or in favorable weather conditions due to the limitations in using the cranes in a higher sea state.

Figure 7: Five anchors stored aboard the KULLUK before transit. These were for use when the towing operation reached the Seattle Area while the KULLUK awaited dock space availability. (USCG Photo)

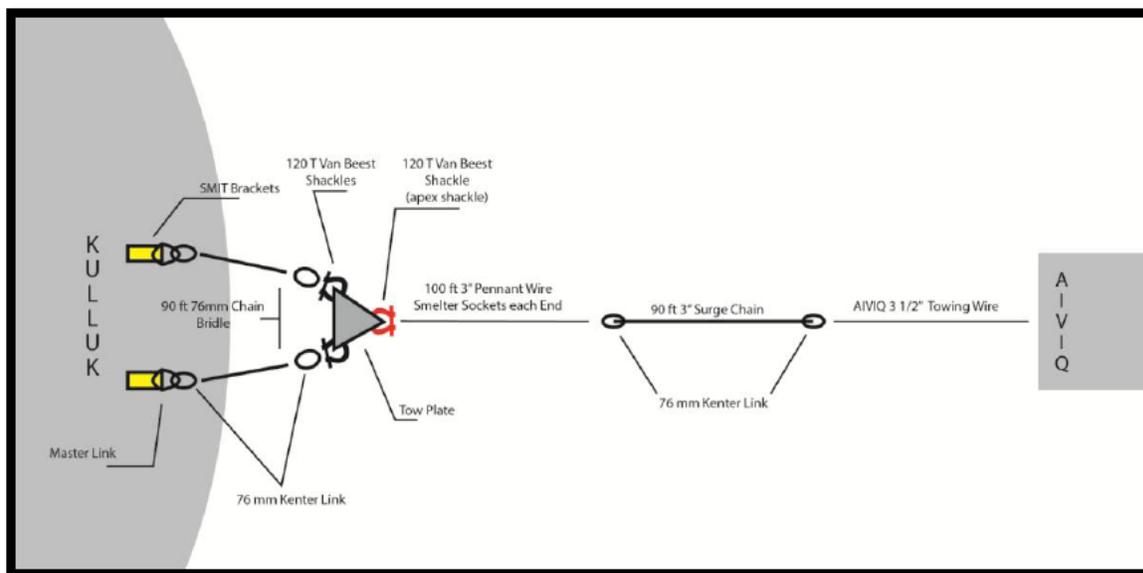
Figure 11: Diagram of towing configuration utilized in the KULLUK/ AIVIQ tows throughout 2012. (USCG developed)

40. The SWL/WLL, PL and BL for primary tow configuration between the KULLUK and AIVIQ are listed in the following table. Figure 10 is based upon the actual configuration of equipment for the tow of the KULLUK in December 2012, detailed in testimony from vessel crewmembers and inspection of the equipment utilized. The equipment below would be connected to the AIVIQ's 3 ½ inch towline using 90 feet of 3 inch chain as surge gear.³³

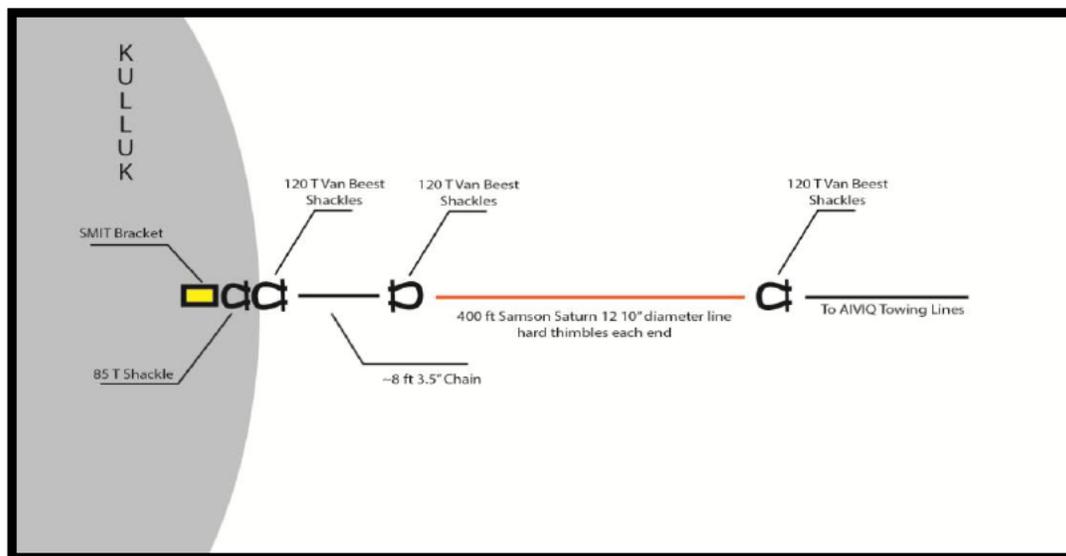
Figure 12: Diagram of Emergency Towline as designed for use when under tow. (USCG developed)

41. The KULLUK was equipped with an emergency towline, designed for use should the primary towing configuration fail. Figure 12 is based upon the actual configuration of the emergency towline configuration for the tow of the KULLUK in December 2012 as detailed in testimony from vessel crewmembers and inspection of the equipment utilized. At the terminus end of the Saturn® 12 line there is an eye with a thimble³⁷ lashed into the eye. A shackle then connected the equipment to the assisting vessels towline. The emergency towline was configured so that it could be easily deployed by the KULLUK crew as necessary.

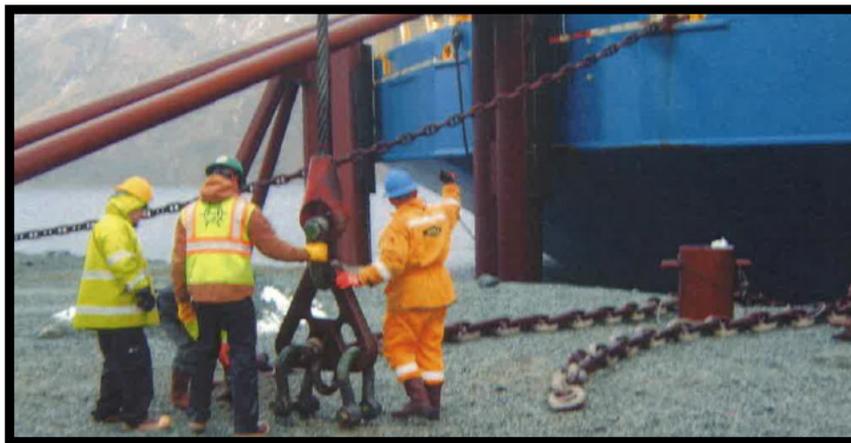
Figure 14: Preparing to Connect the Towing Plate to the Bridle Legs (Photo courtesy of GL Noble Denton, Mr. █████)

62. Using an OSI yard crane, the towing plate was maneuvered using the connected pennant wire and shackle as to allow shore side personnel to connect the two bridle chains to the towing plate, by way of shackles. Locking nuts were placed on the shackles and they were properly secured with cotter keys. See Figure 14. Once the shackles were connected, the towing configuration was raised by KULLUK's cranes into a standby position for connection to the AIVIQ once away from the dock.

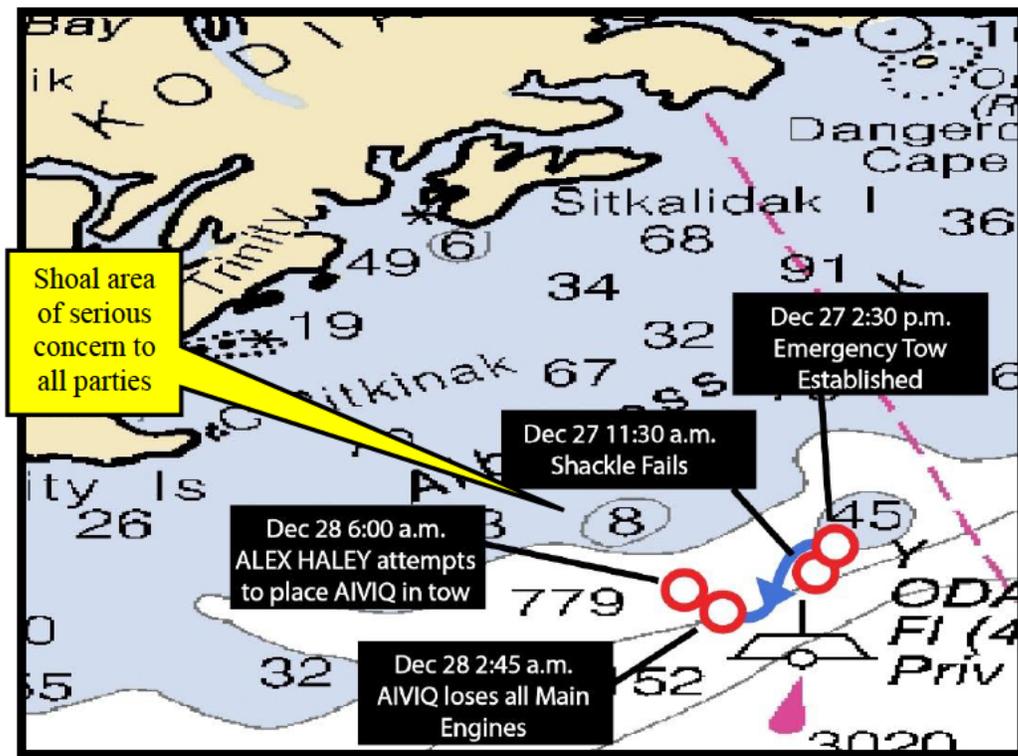
Figure 23: Diagram shows approximate locations of KULLUK between 11:30 a.m. December 27 and 6 a.m. December 28.⁶⁶ Significant events are highlighted and times are approximate. Blue line indicates general direction and location of KULLUK during this period. (USCG analysis)

96. Once the emergency tow was connected, the AIVIQ proceeded on a generally south-westerly course to keep increasing the distance away from Albatross Bank and an eight fathom shoal area (see Figure 23), which was north of their position. This shoal area was of serious concern due to the interaction of the sea and swell height and the 10.7 meter draft of the KULLUK.

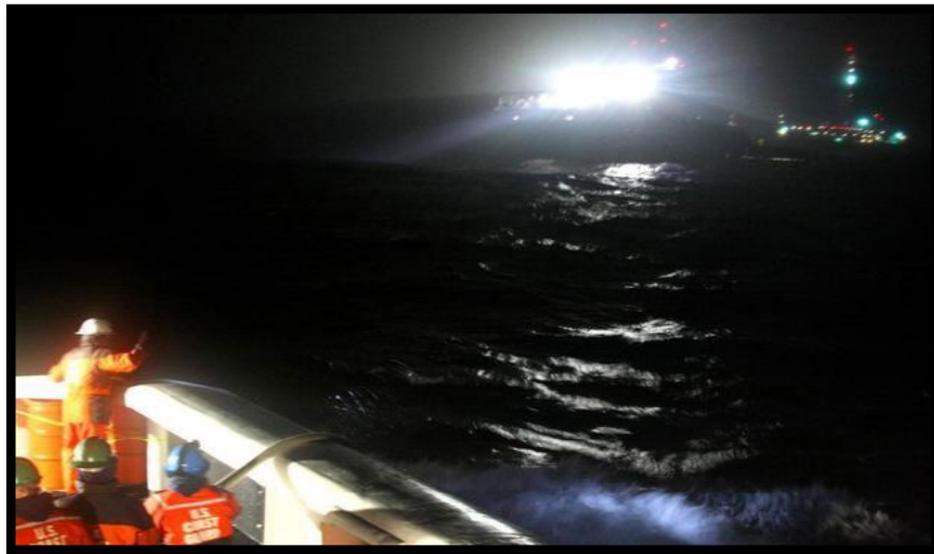
Figure 25: The crew of the USCGC Alex Haley attempt to pass the towline to the bow of the AIVIQ. Bright lights are located on the bow of the AIVIQ and the KULLUK is in the distance at the far right of the photograph. (USCG Photo)

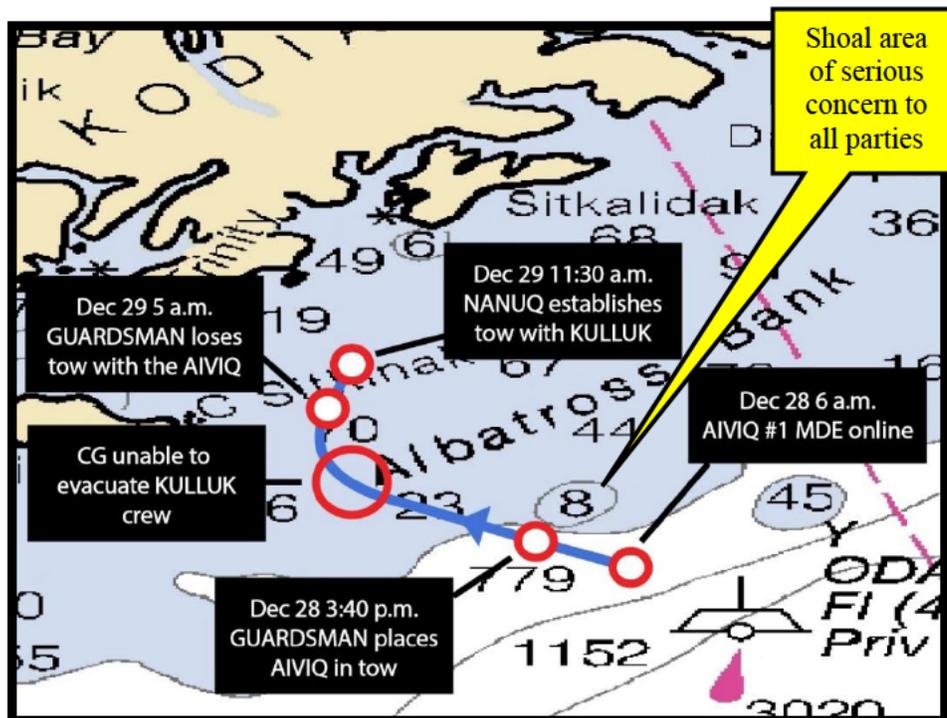
Figure 26: Diagram shows approximate locations of KULLUK between 0600 hrs December 28 and 1130 December 29. Significant events are highlighted. (USCG analysis)

113. With limited power on their #1 MDE and rotating azimuth and tunnel thrusters, the AIVIQ continued to be pulled astern by the KULLUK's wind driven drift, and the vessels were drifting slowly to the northwest. There was considerable concern that the KULLUK would drift on a marked 8 fathom area (see Figure 26), in which there was a chance that the KULLUK would ground or touch bottom in the seas. The drift of the KULLUK narrowly missed this area by approximately 8 miles, drifting to the west of this shallow bank.

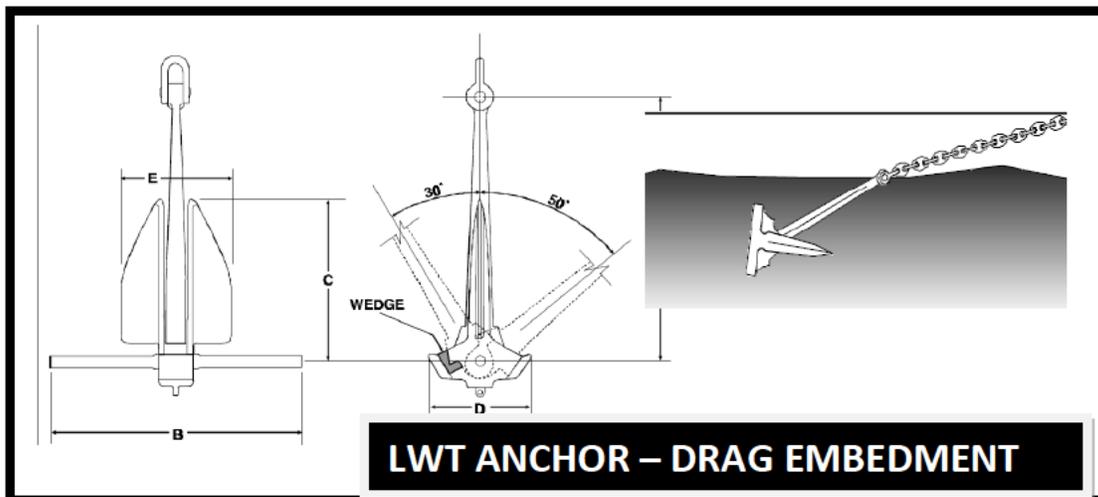
Figure 29: Diagram of a LWT anchor of a similar type carried aboard the KULLUK. The survival anchor was a 15 ton anchor. (Diagram U.S. Navy Towing Manual composite)

119. The KULLUK was fitted with one survival anchor which was fitted with the typical ground tackle for a ship's anchor such as hawsepipe, brake and securing device. The windlass for the anchor was located in a compartment on the KULLUK and the chain led out from the windlass onto the deck and then through a hawsepipe to the sea below. The anchor and windlass are located near the starboard quarter of the KULLUK, near the "stern" on the main deck in relatively close proximity to the helicopter deck area which was on the opposite end of the vessel from the main towing equipment, or the "bow" of the KULLUK.

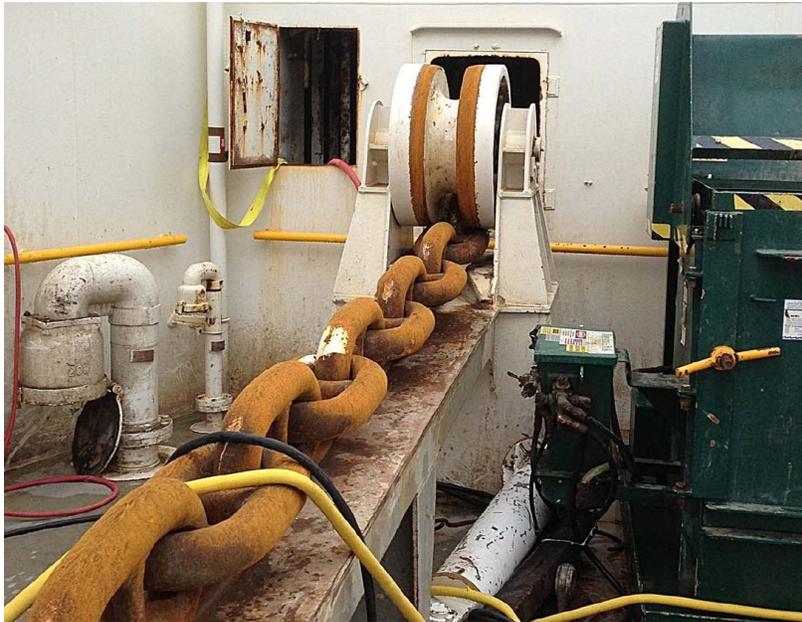
Figure 30: The anchor chain for the survival anchor leading out of the windlass room towards the hawsepipe. (Photo provided by Shell)

120. After the towing gear failure that occurred on December 27 the anchor was reported to have been dropped on two occasions. In one occasion this was as the result of a miscommunication between the KULLUK OIM and Tow Master and the crew of the KULLUK in a high stress situation. The anchor was released then quickly recovered. At this time the anchor was lowered to a reported depth of approximately two to three shots of chain or approximately 180 to 270 feet.

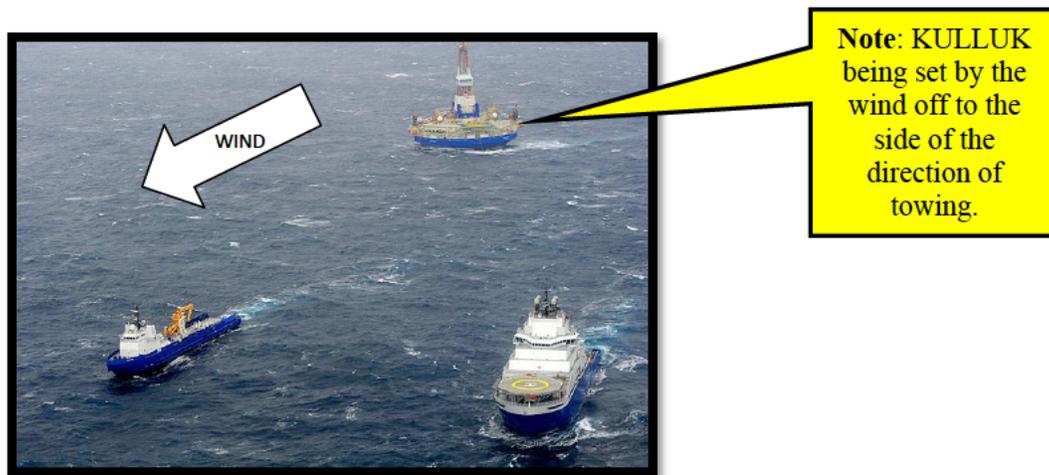
Figure 32: NANUQ on the left and AIVIQ on the right side of the photo with the KULLUK under tow in the distance (USCG Photo)

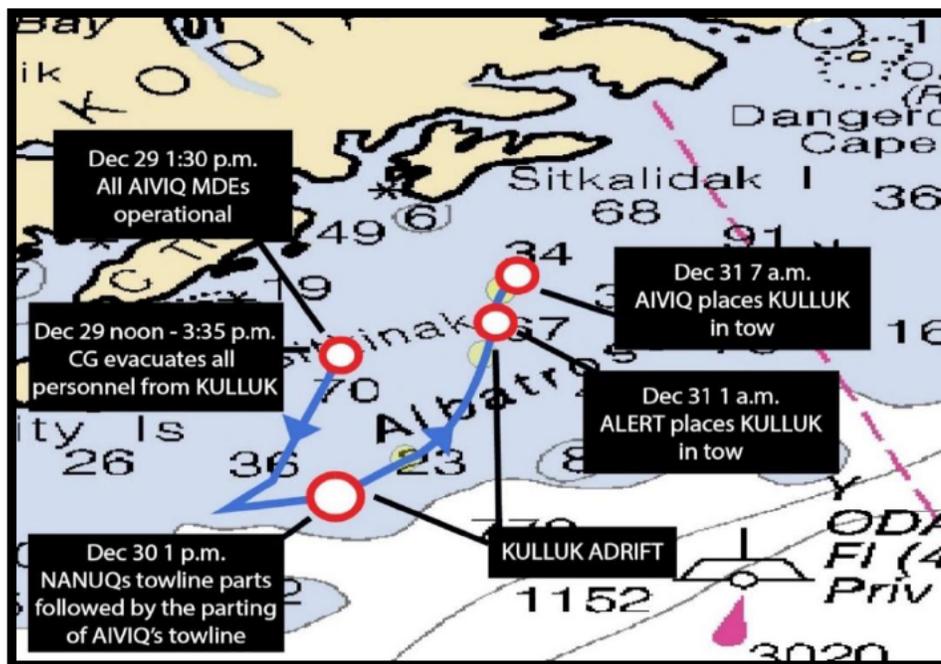
Figure 33: Diagram shows approximate locations of KULLUK between 1200 hrs December 29 and 0700 hrs December 30. The blue line indicated general direction and location of KULLUK during this period. (USCG analysis)

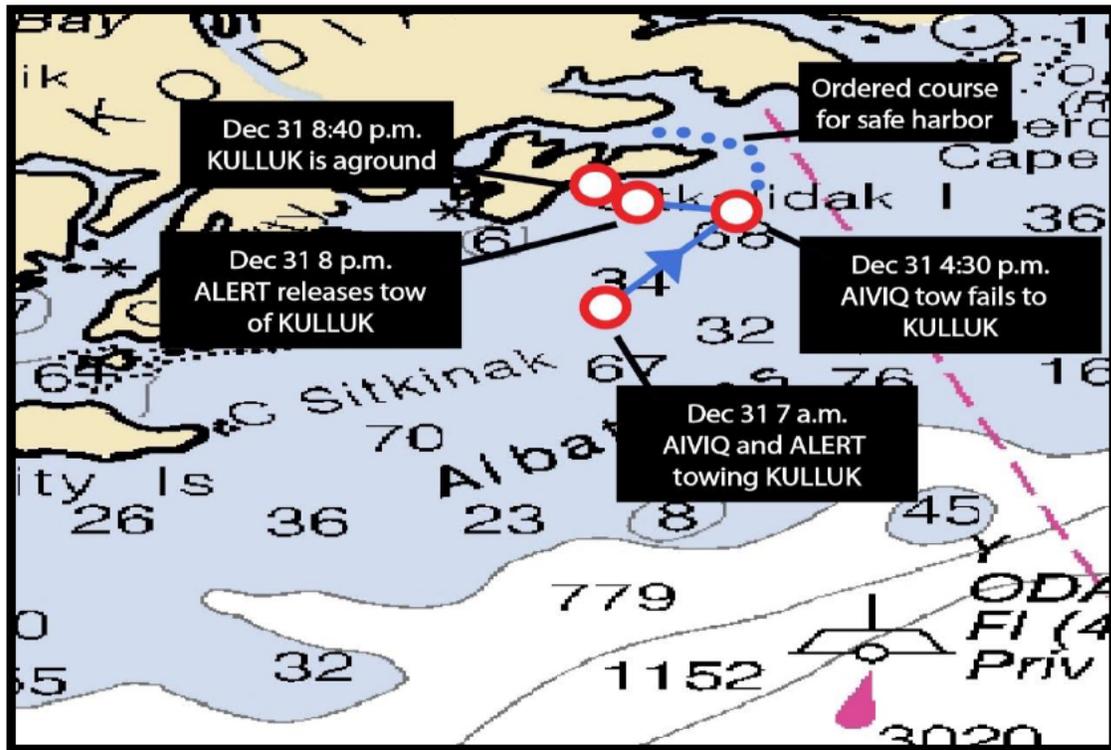
Figure 37: Diagram shows approximate locations of KULLUK between 0700 hrs AKST December 31 up to the grounding of the KULLUK. Significant events are highlighted. (USCG analysis)

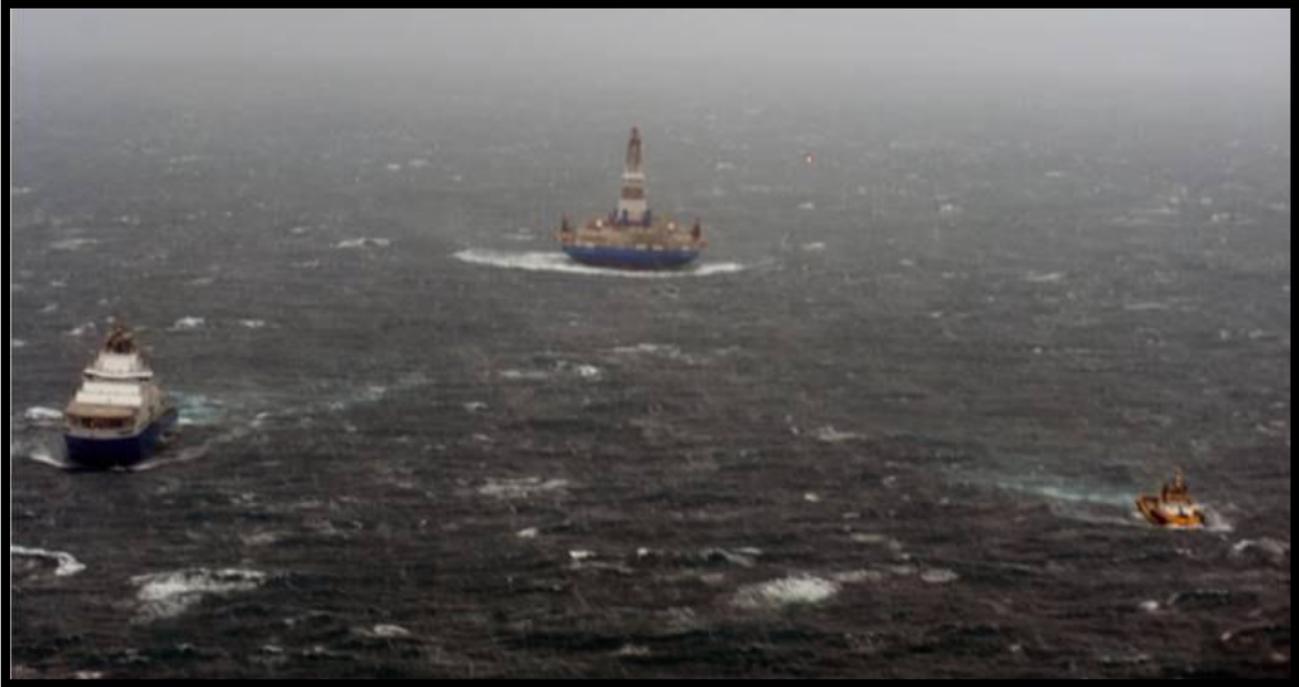
Figure 38: KULLUK under tow with the AIVIQ (left foreground) and the ALERT (right foreground) on December 31. (*USCG Photo*)

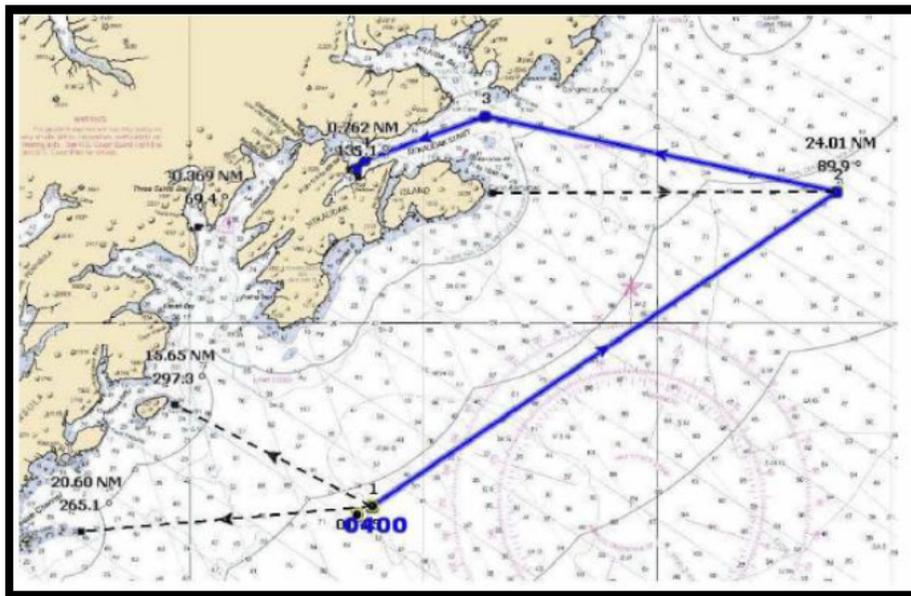
Figure 39: Tow route for the KULLUK for the destination of Port Hobron. (*Shell Tow Plan, CDU KULLUK Tow Procedure from Offshore Sitkinak Island Port Hobron PPOR*)

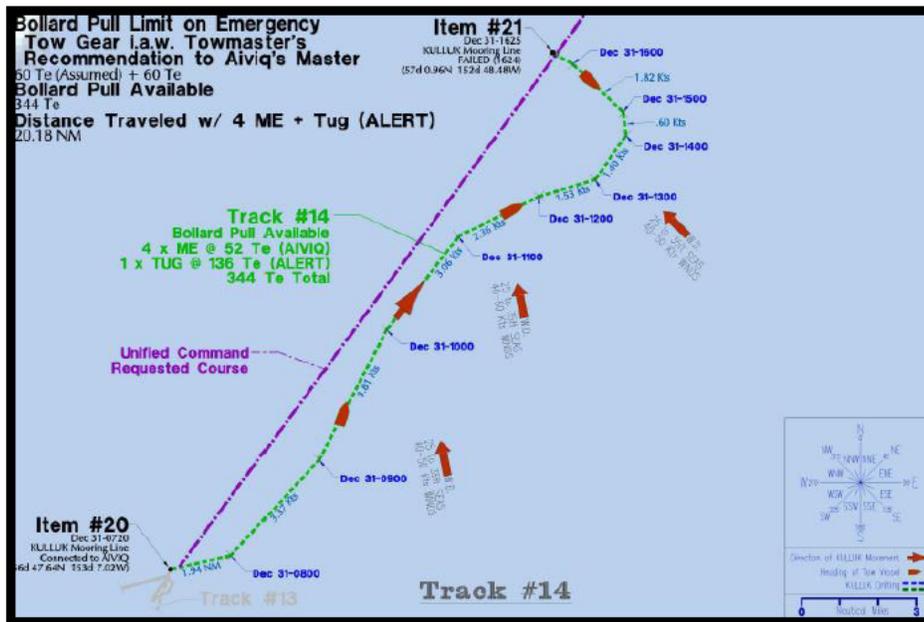
Figure 42: Position of the vessels. The purple dashed line represents the course ordered by the Unified Command. (Chartlet provided by ECO for the Declaration on AIVIQ Bollard Pull, DECLARATION OF [REDACTED] WITH RESPECT TO THE GROUNDING OF THE DRILL RIG KULLUK, presented without editing)

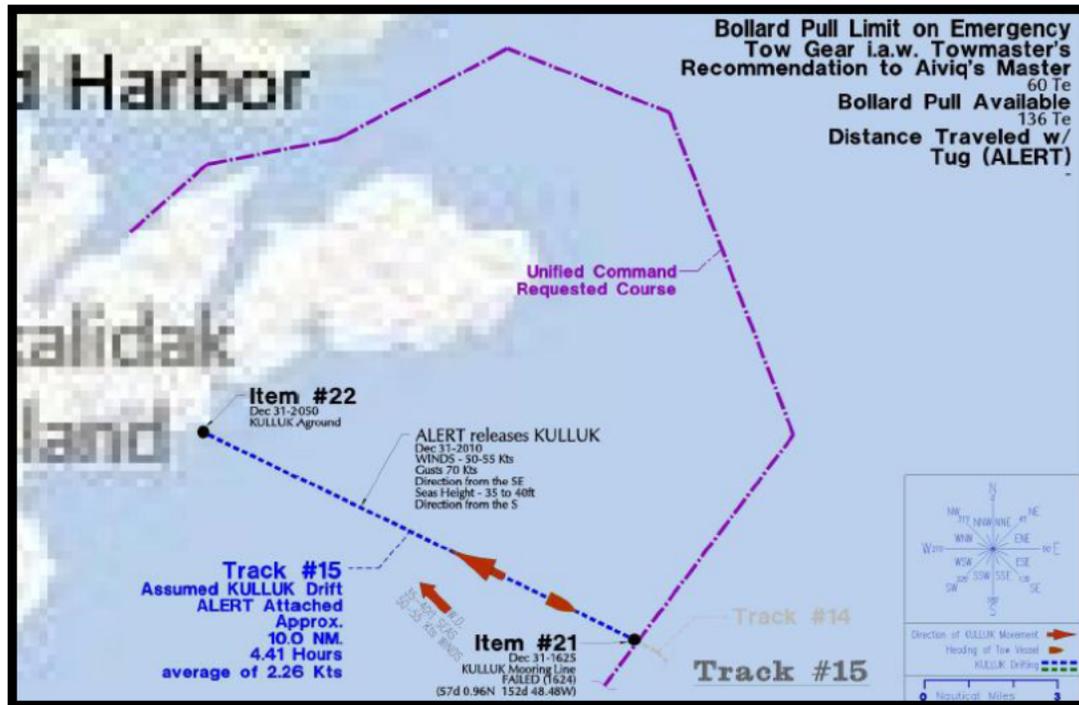
154. At approximately 1630 December 31, the AIVIQ's tow pennant failed and the ALERT became the single vessel towing the KULLUK. The AIVIQ's 3 inch 100 foot pennant wire, the same wire that was part of the original towing configuration had parted. The ALERT was now towing the KULLUK alone in extreme weather conditions.

Figure 43: Position of the vessels. The purple dashed line represents the course ordered by the Unified Command. (Chartlet provided by ECO for the Declaration on AIVIQ Bollard Pull, DECLARATION OF [REDACTED] WITH RESPECT TO THE GROUNDING OF THE DRILL RIG KULLUK, presented without editing)

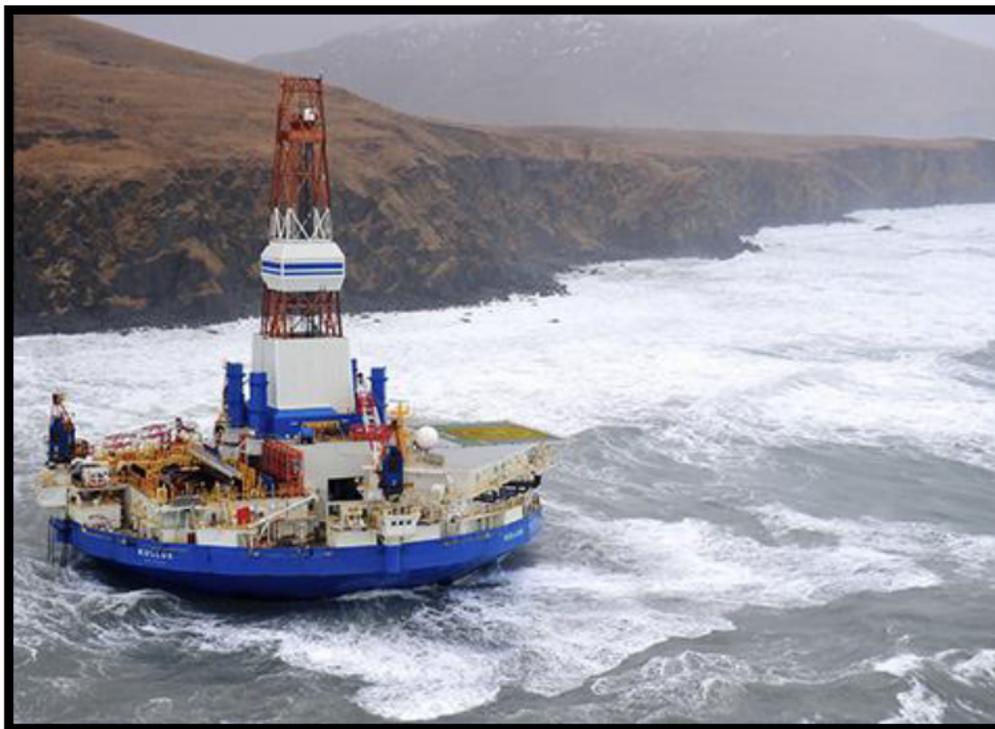
Figure 44: KULLUK grounded in Oceans Bay, Alaska. *(USCG Photo)*

164. As a result of the grounding the KULLUK sustained extensive damage. Topside and underwater inspections were conducted prior to refloating the vessel. The underwater portions of the hull sustained extensive damage due to the grounding and the action of the wave surge effects. Despite this exposure the hull retained watertight integrity. Topside damage to the rig included damage to the actual superstructure and accommodations including damaged railings, ladders, fittings, watertight doors, windows and the adjacent interior spaces. Electrical equipment

such as switchboards, distribution panels and other electrical equipment were exposed to wind driven water and immersion in seawater rendering this exposed equipment questionable for future use. Primary lifesaving equipment was torn off the rig by wave action resulting in the loss or damage to of all life rafts and most life rings. The embarkation ladders, personal flotation devices and immersion suits and firefighting equipment were also damaged. There was down flooding of seawater into numerous interior spaces including engineering spaces. The additional weight of the seawater retained aboard caused an increase in draft for the eventual move back to Dutch Harbor from Kiliuda Bay.

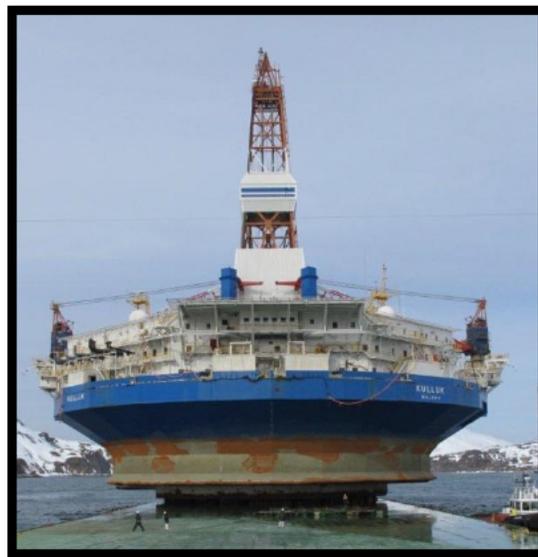
3. The KULLUK’s hull is conical in design, with no distinctive bow or stern. The design of the vessel exposes a broad expanse of the hull to hydrodynamic effects of the sea, including the effects of current and swells/ wind driven seas. The derrick, cranes, accommodation and control spaces result in significant sail area or the effects of wind on the vessel. The severe outward slope of the hull below the chine increases overall hull resistance to the seas when the vessel is pitching, rolling or heaving in heavier weather.

Figure 46: The KULLUK out of the water and loaded on the deck of a heavy lift ship. (USCG photo)

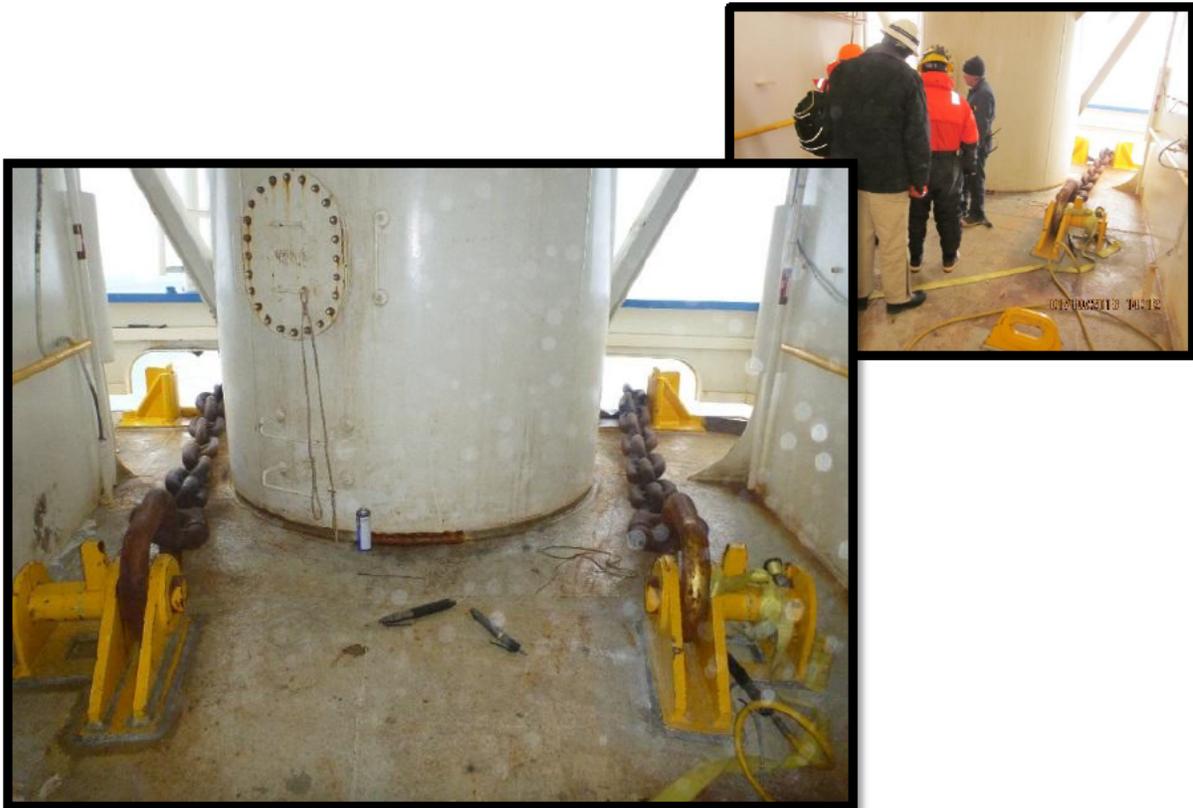
Figure 49: Photo of towing bridle connections to Smit Brackets (*USCG Photo*)

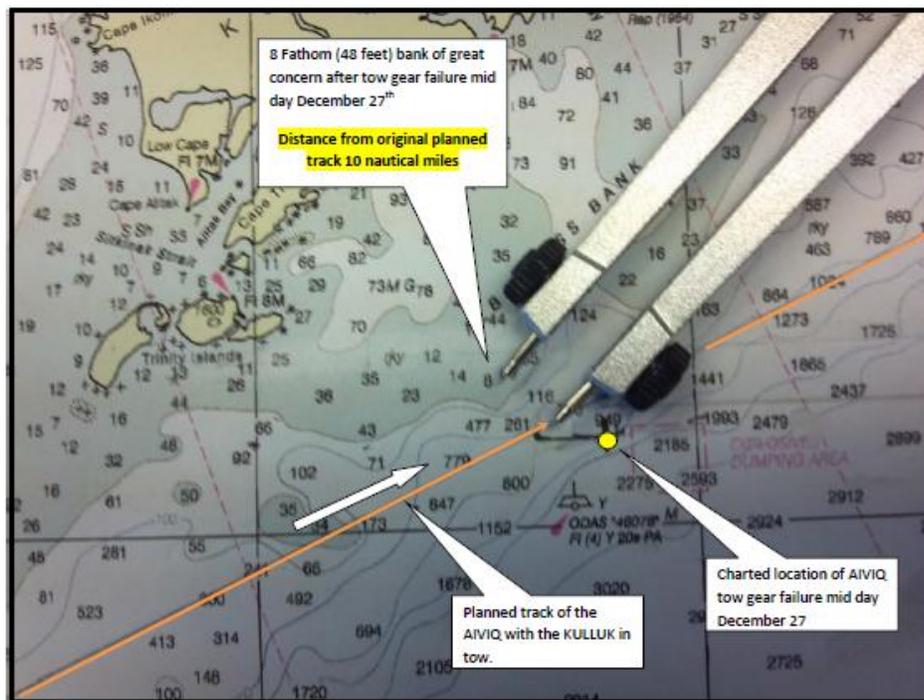
25. In hindsight, this route's proximity to shoal water and land masses proved to be a critical factor in the towing and response operations. At the time of the shackle failure, the KULLUK was approximately 40 miles from the closest point of the islands of Kodiak Island and less than 10 miles from Albatross Bank. The loss of the AIVIQ's engines and extreme weather moved the KULLUK north toward these hazards. This planned route denied the proper sea room necessary should a towline fail or the towing vessel experience a mechanical breakdown, particularly with no assistance or additional towing vessels onsite. Additionally, should the tow need to heave to in the event of a weather event, there was little safe water available to ride out storms.

Figure 50: Chart showing planned track line for towing of KULLUK demonstrating close approaches to land and other hazards. (USCG Developed)

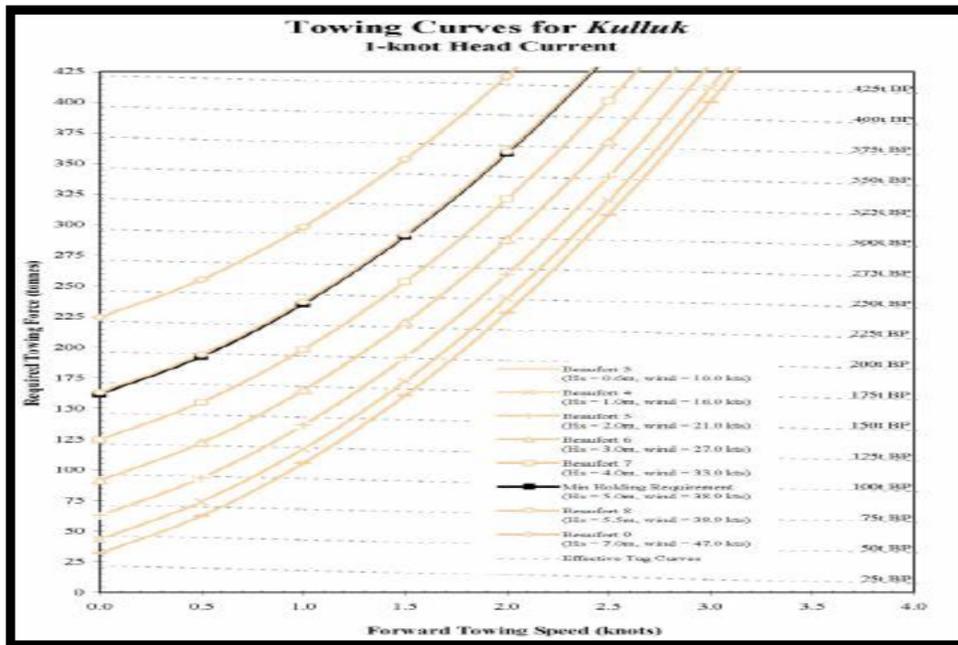
31. The 2010 study contains towing resistance curves for Beaufort 3 through 9 weather conditions. The 10% exceedance level for the December 2012 tow indicates 9.2 meter seas and 44.6 knot winds. These weather conditions are similar to Beaufort 9 storm conditions, being 2.2 meters above Beaufort 9 seas and 2.4 knots below Beaufort 9 winds. Referencing figure 52, extracted from the study, the bollard pull necessary to maintain position in a 1 knot current would require 225 tons of effective bollard pull by the towing vessel. Referencing the same document, a 200 ton effective bollard pull would be necessary under the same circumstances with no current. It should be noted that the prevailing currents along the southern coast of Alaska are out of the east, meaning that the KULLUK would most likely be towed into the current.

Figure 52: Towing Curves (Tow Resistance) for the KULLUK with 1 knot head current as provided by Global Maritime 7/6/10 (Provided by Shell, Shell Alaska "Bollard pull calculations for Towing KULLUK from McKinley Bay to OSI South Reef Dock, Captains Bay, Unalaska Island, Aleutian Islands" GMH-6565-2575)

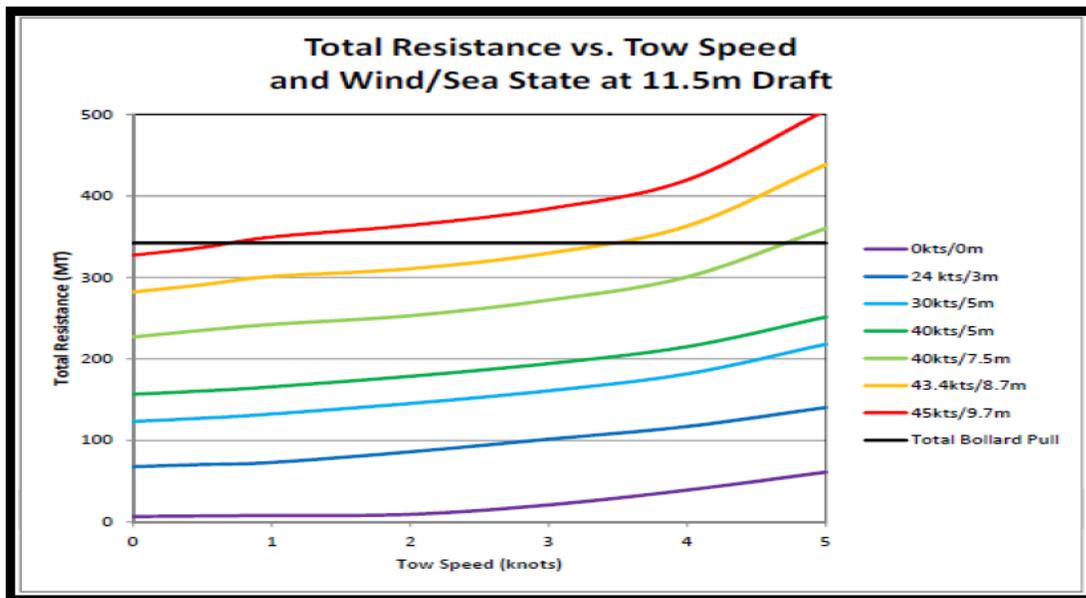
Figure 53: Tow resistances for KULLUK as determined by Jensen Marine Architects and Marine Engineers, 1/24/13 (Provided by Shell, Jensen Report 130003-245-1, rev. A)

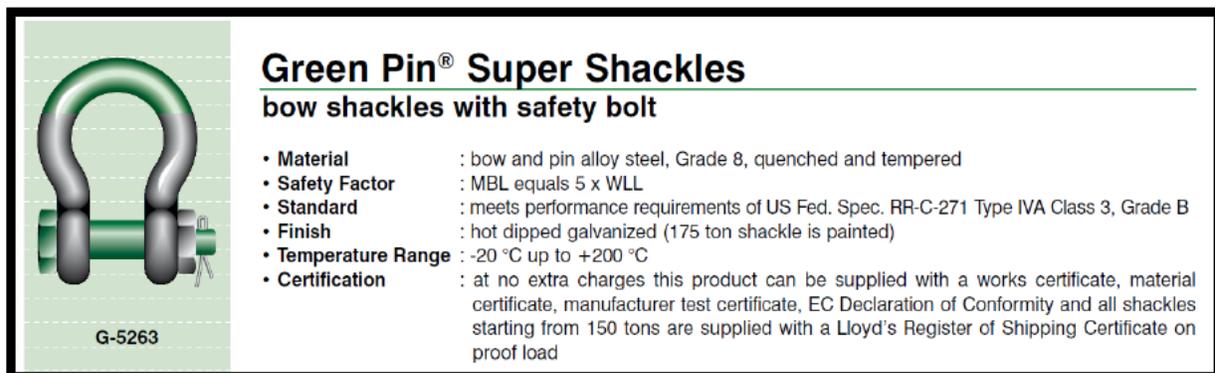
38. The apex shackle that failed at approximately 1135 on December 27 has been identified as a Van Beest Green Pin Super Shackle.⁹⁵ It was one of six that were incorporated into the tow to replace the 85 ton shackles originally intended. As all the remaining 5 shackles were from the same "YP" manufacturing batch, it is assumed that the missing shackle is of that batch as well. During the investigation, Shell provided documentation that suggests that these "YP" batch shackles were purchased from Van Beest in 2007.⁹⁶ The work and usage history of the shackles could not be definitively ascertained, other than they were incorporated as part of the KULLUK towing configuration since July of 2012. Testimony suggests that these shackles may not have seen usage prior to this time.

Figure 54: Description of Van Beest Green Pin Super Shackles from the manufacturer’s catalog. (*Van Beest product catalog available on the internet*)

41. The Proof Load (PL) of this shackle is listed by the manufacturer as 240 tons, or twice the WLL. The U.S. Navy Towing Manual defines the Proof Load of shackles as “the load at which no permanent deformation is observed after the load is released.” Shackles are often tested to their Proof Load prior to distribution by the manufacturer, and Van Beest conducts such tests for all Super Shackles batches prior to sale.

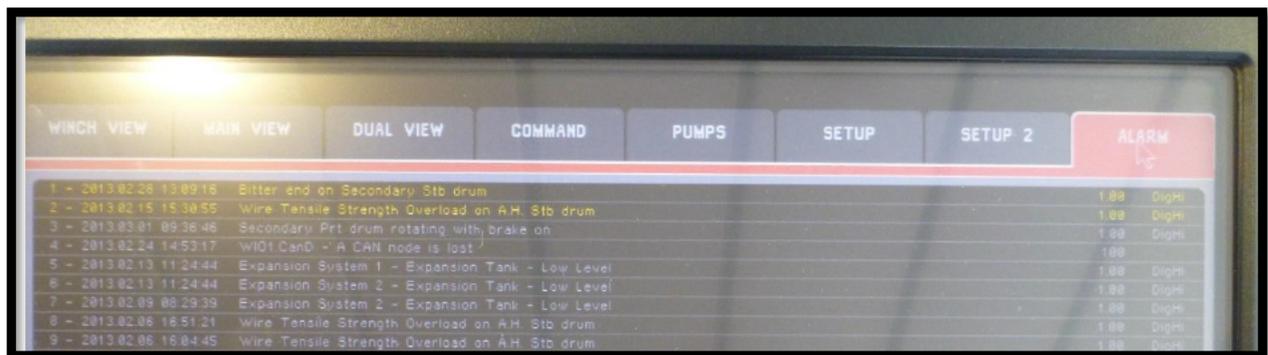
69. The AIVIQ’s towing winch system contained an advanced computerized monitoring and control system manufactured by Rolls-Royce called the Towcon RT. This system contained a means to monitor strain/tension of the towline (in Tons), tow line length, hydraulic pressure, among others, and would alarm should any of the pre-set limits be exceeded. With respect to tension monitoring, the user could easily set any strain/ tension limit by which an alarm would be activated. No user set tension settings were established, and the only high tension alarm active was a manufacturer set alarm that would activate upon reaching 50% of the tensile strength of the main tow drum. The tensile strength was set prior to the voyage at 600 tons, indicating that the alarm would activate at 300 tons of tension. See Figure 58.

Figure 59: Towcon alarm screen indicating alarms received on the bridge monitor, requiring acknowledgement of the bridge officers. Alarms indicated are for a later time period than investigation scope. (USCG Photo)

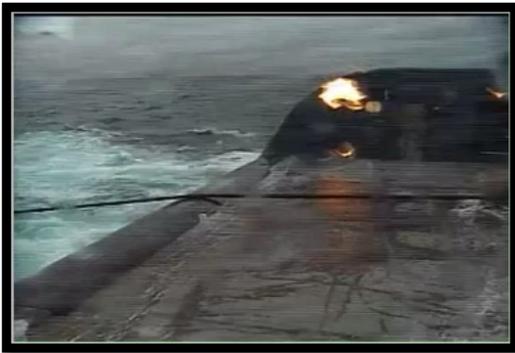
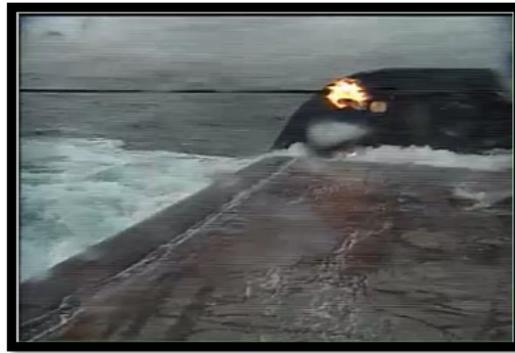
Figure 61: Starboard aft CCTV stills showing fluctuations in towline tension. Still on left shows lower tension at 10:12:42. Still on right shows high tension at 10:12:48. *(AIVIQ CCTV Provided by ECO)*

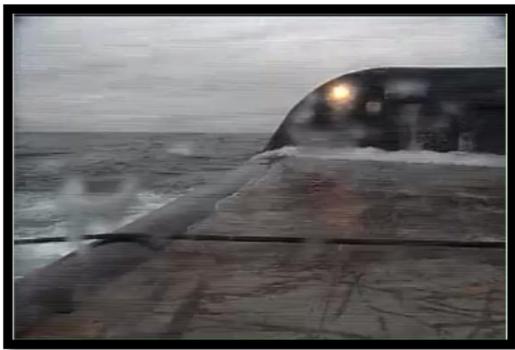
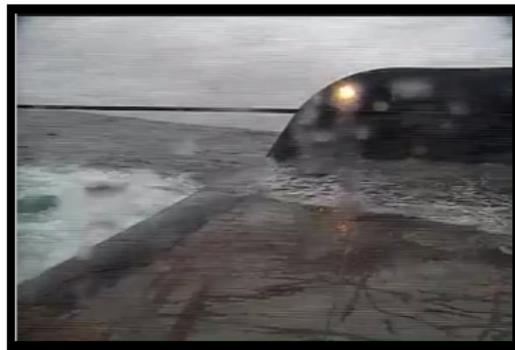
Figure 62: Starboard aft CCTV stills showing fluctuations in towline tension. Still on left shows lower tension at 11:17:14. Still on right shows high tension at 11:17:18. *(AIVIQ CCTV Provided by ECO)*

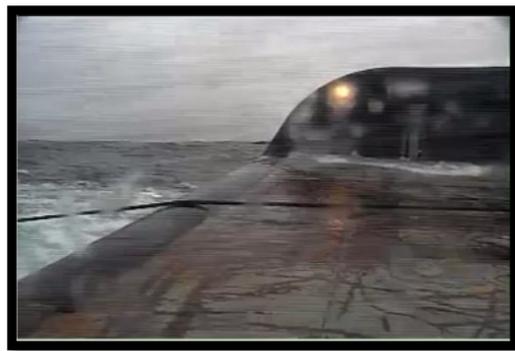
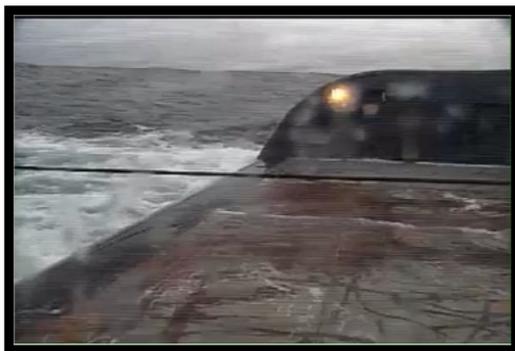
Figure 63: Starboard aft CCTV stills showing fluctuations in towline tension. Still on left shows lower tension at 11:31:49. Still on right shows high tension at 11:31:58. *(AIVIQ CCTV Provided by ECO)*

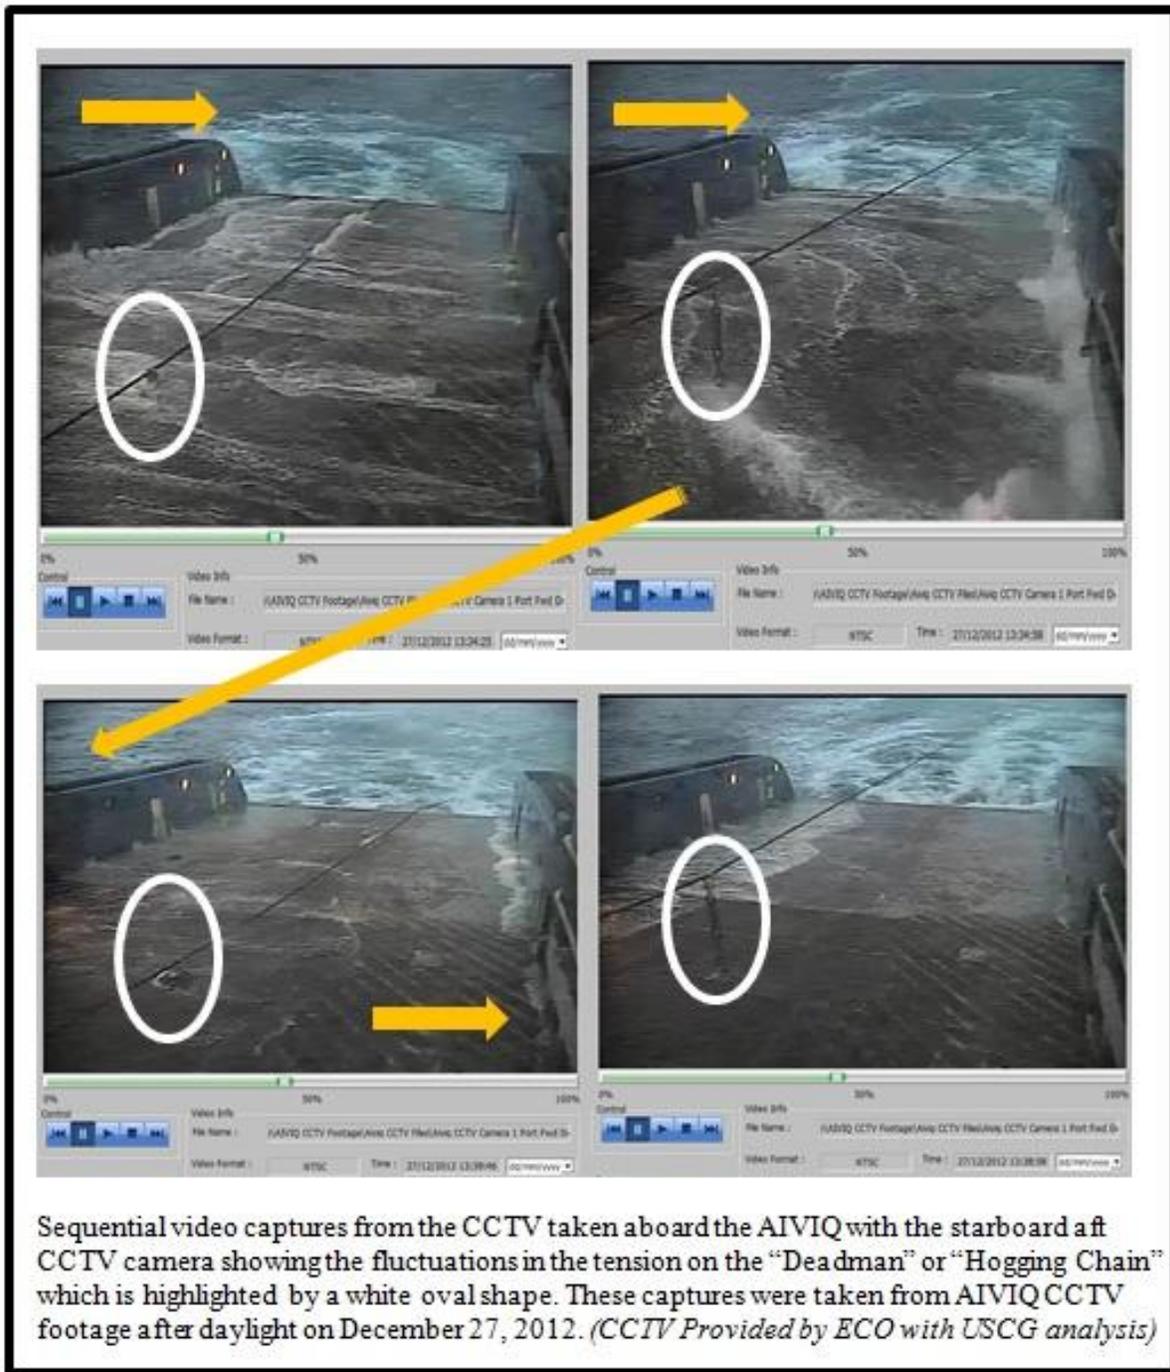
Figure 66 – Movement of the Deadman or Hogging Chain aboard the AIVIQ on the morning of December 27, 2012.
