UNITED STATES COAST GUARD

**REPORT OF INVESTIGATION INTO THE
CIRCUMSTANCES SURROUNDING THE MULTIPLE
RELATED MARINE CASUALTIES AND
GROUNDING OF THE**

MODU KULLUK

ON DECEMBER 31, 2012

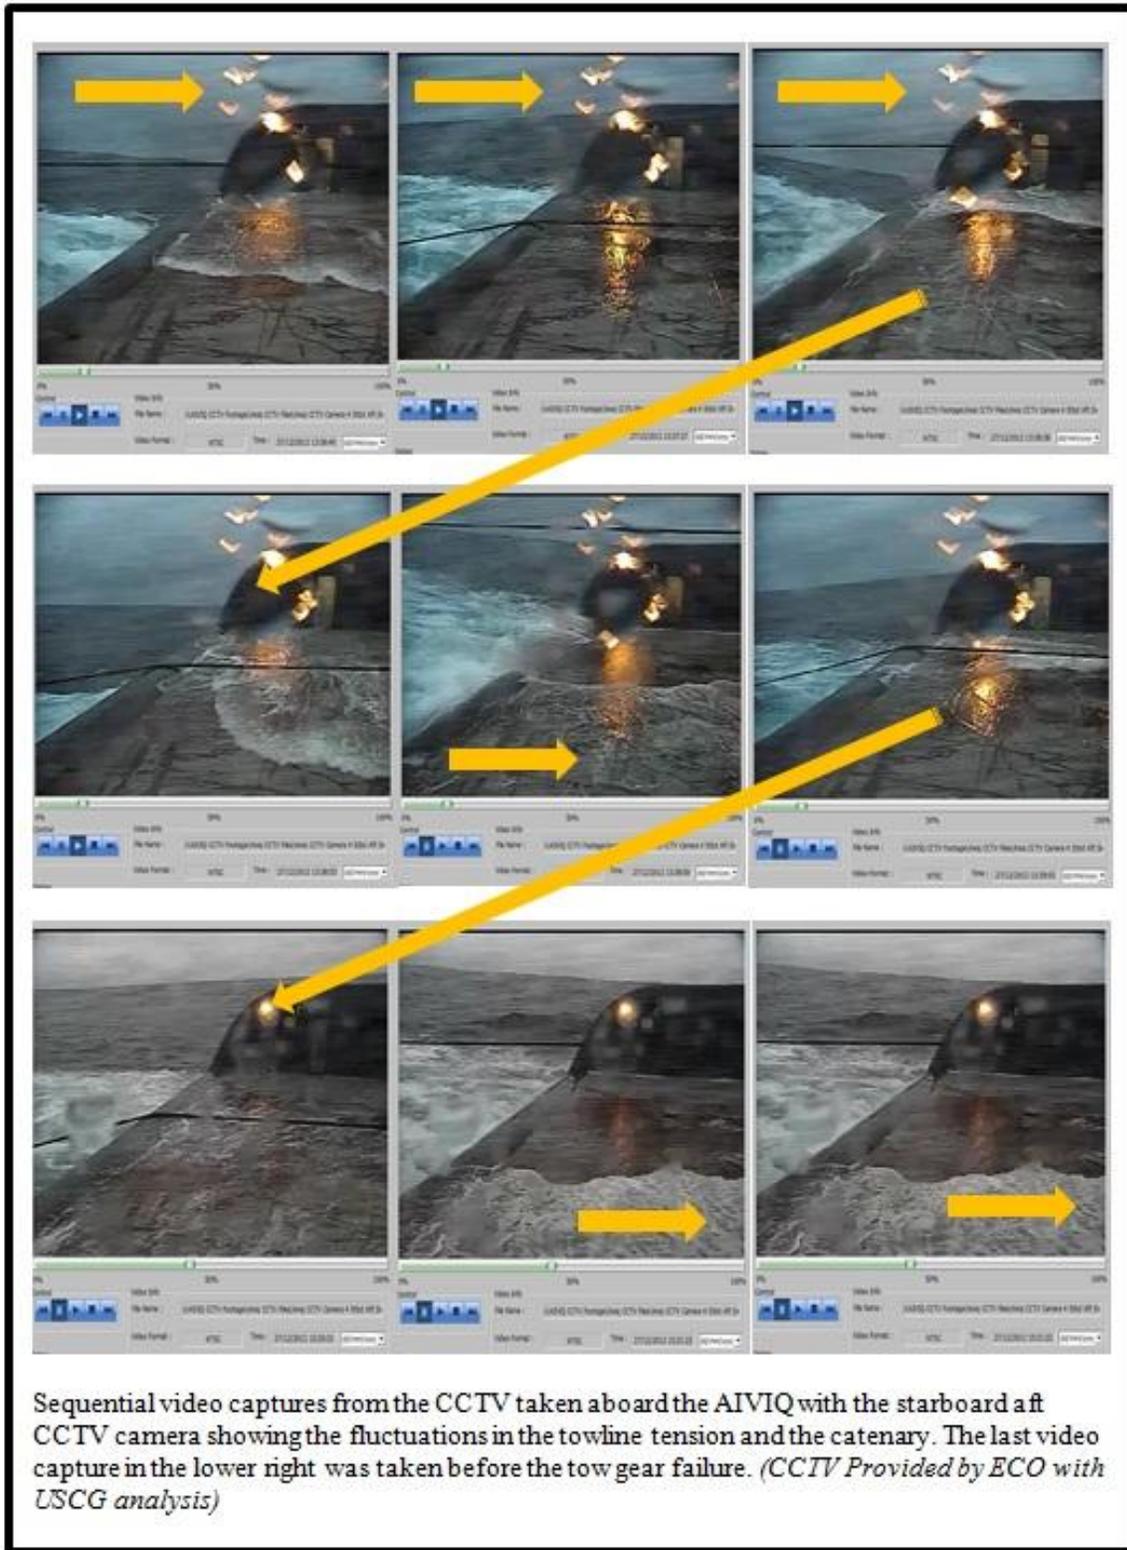
Figure 67 – Movement of AIVIQ towline and tension on the line on the morning of December 27, 2012.

78. As configured, the shackle that failed incurred the full load of the towline between the KULLUK and AIVIQ. The bridle shackles on either side of the towing plate generally shared the load. From the findings, the tow winch strain monitoring system logged 38 separate occasions during the morning of December 27 of towline loading over 300 tons. Additionally, video evidence from the 3rd Mate [REDACTED] on watch shows load fluctuations from 28 to 228 tons within the period of a few seconds, providing further proof of extreme fluctuations in the towline tension while towing the KULLUK. This event would not be logged in the towing system, so it is unknown on how many occasions the readings were high but went unrecorded as an alarm as they did not meet the 300 ton alarm threshold.

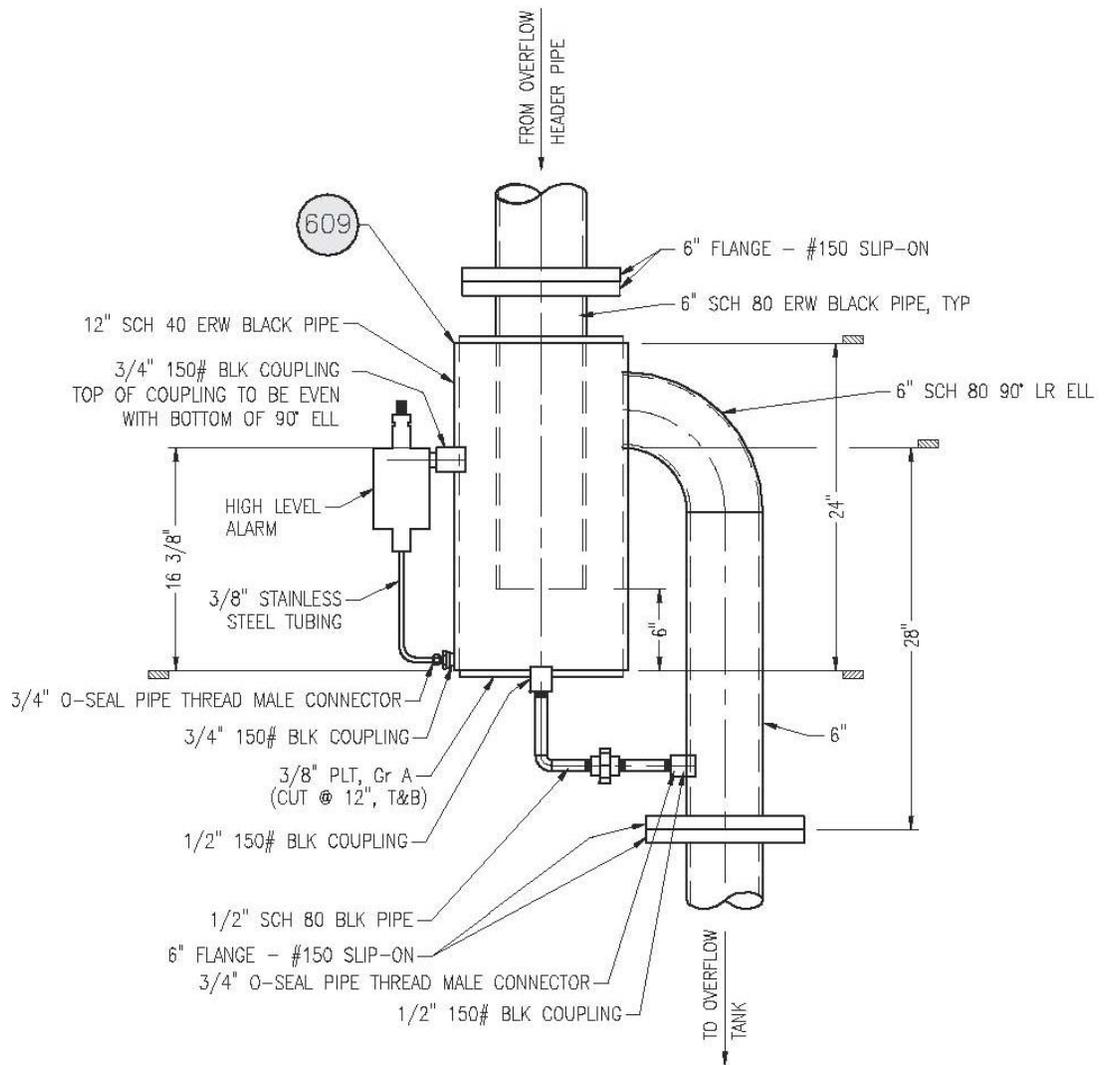
- ii. Reference (q) shows an overflow alarm sensor arrangement (see Figure 1). The 8-inch vent/overflow headers are each reduced to 6-inch pipe prior to reaching the overflow alarm sensor arrangement. Per references (e) and (f), the crew experienced many problems with the fuel oil vent/overflow alarm system prior to the casualty.

- 08/25/2012: Reference (f) - Overflow alarm activated, found drain lines clogged on port side. Removed and cleaned.
 - 09/04/2012: Reference (e) - Cleaned P/S Overflow Collection Pipe Drains.
 - 11/21/2012: Reference (e) - Drained port overflow alarm system.
 - 12/26/2012: Reference (f) - Secured fuel overflow breaker ELP-201 Bkr 17.
- iii. In reference (c), the Chief Engineer acknowledged that the water on deck shown in a photograph during the interview was well above the height of the vent/overflow tank vents.

Figure 1 - Fuel Oil Overflow Alarm Sensor Arrangement (Source: reference (q))

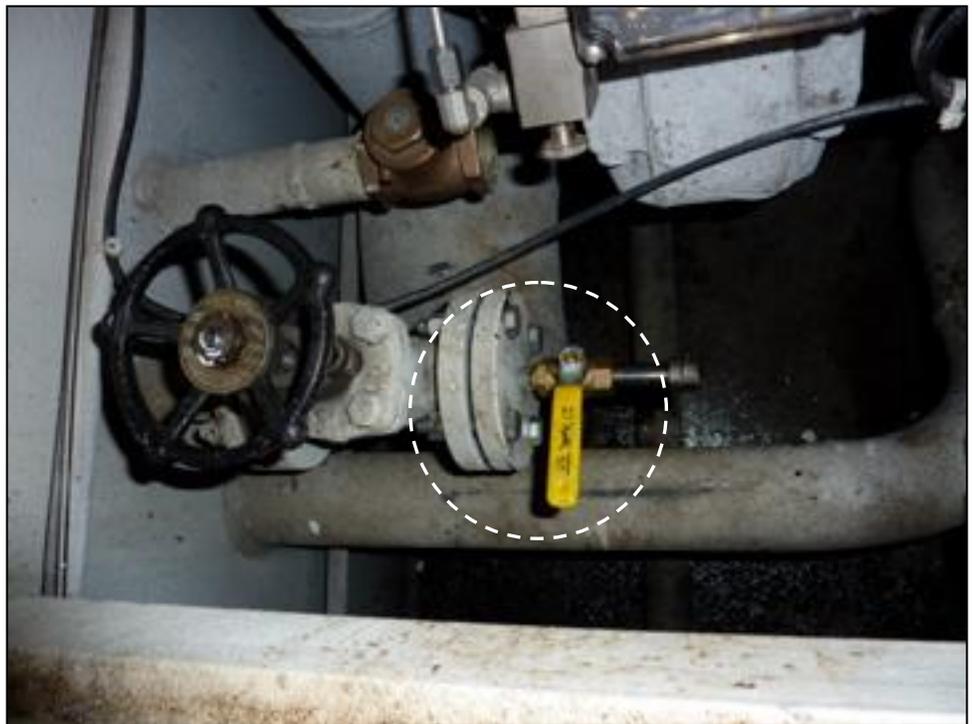
- ii. From reference (w), however, it appears that the settling tank drains, as installed, have a gate valve, a small ball valve, and a pipe plug (see Photo 1). As installed, there appears to be no drip pan provided as required by Part 4-6-4/13.3.4(a) of reference (v). The small ball valve installed on each of the settling tank drains, with no means for collecting drainage, appears to be inadequate for draining a large amount of water, sediment or oily discharge.

Photo 1 - Starboard Settling Tank Drain

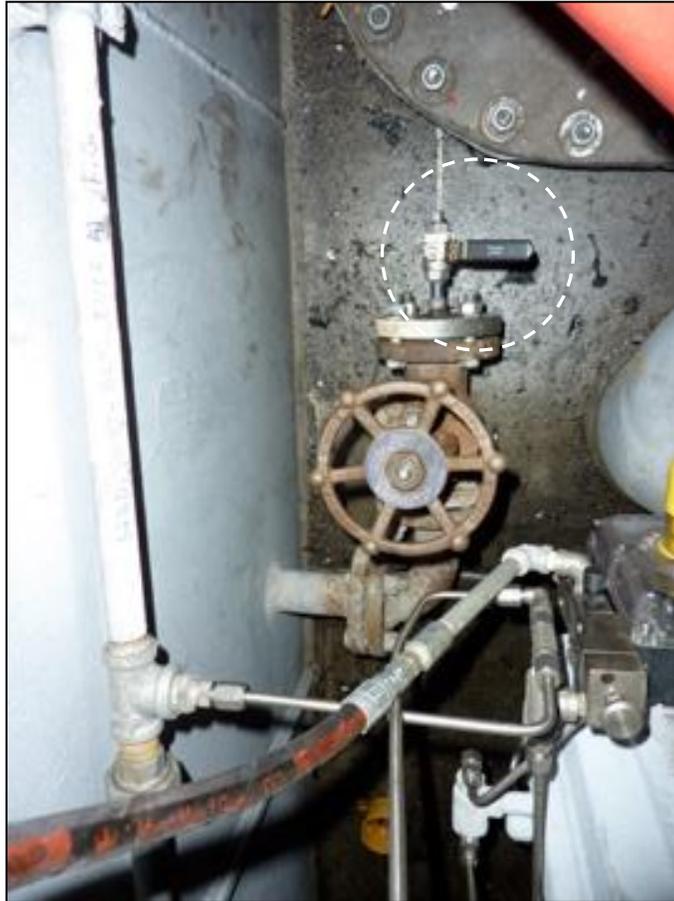
- iii. From reference (w), it appears the day tank drains have a gate valve, a small ball valve, and a pipe plug (see Photo 2). There appears to be no drip pan provided as required by Part 4-6-4/13.3.4(a) of reference (v). The small ball valve installed limits the ability to effectively decant water or sediment from the bottom of the day tanks.

Photo 2 - No. 1 Day Tank Stbd Drain

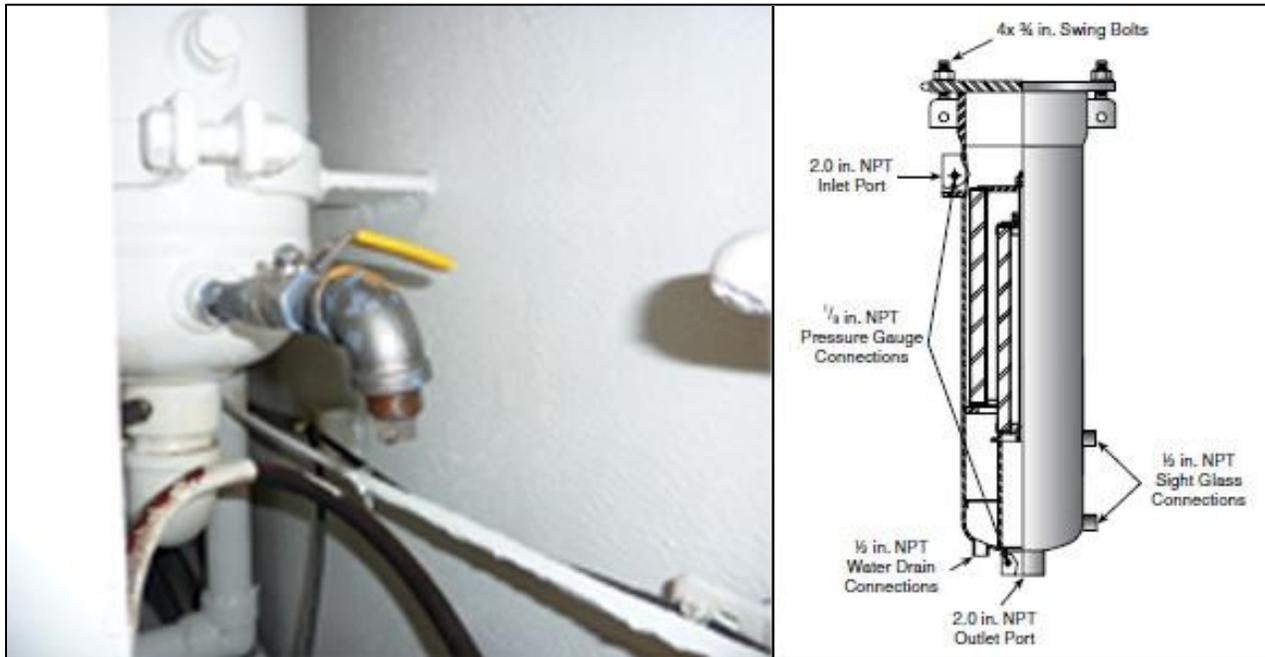
- (e) USCG inspection of the RVFS-1 filter drains identified they were incorrectly installed in the bottom sight glass port of the filters instead of the drain port provided (see Photo 3 and reference (ee)). Reference (ff) indicates this will result in water always being present in the bottom of the filter (i.e., between the lower sight glass port and the drain port).

Photo 3 - Main Engine Primary RVFS-1 Filter Drain

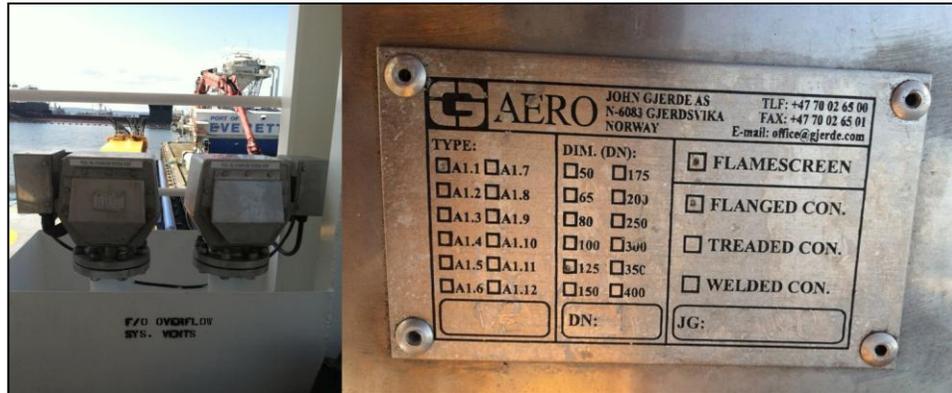
- (d) The Chief Engineer's description of the fuel oil vent design is inconsistent with the installed arrangement. In reference (c), the Chief Engineer identifies that wafers and springs within the vents prevent the influx of water when the vents are submerged. According to reference (mm), however, the installed vents

have only one moving part, a plastic circular float. Photo 4, provided in reference (nn), shows a typical fuel oil system vent installed aboard AIVIQ.

Photo 4 - Fuel Oil Overflow Vent (Typical)
