ATSB TRANSPORT SAFETY INVESTIGATION REPORT
Marine Occurrence Investigation No. 243
Final

Independent investigation into the grounding of the
Panamanian registered bulk carrier

Pasha Bulker

on Nobbys Beach, Newcastle, New South Wales
8 June 2007

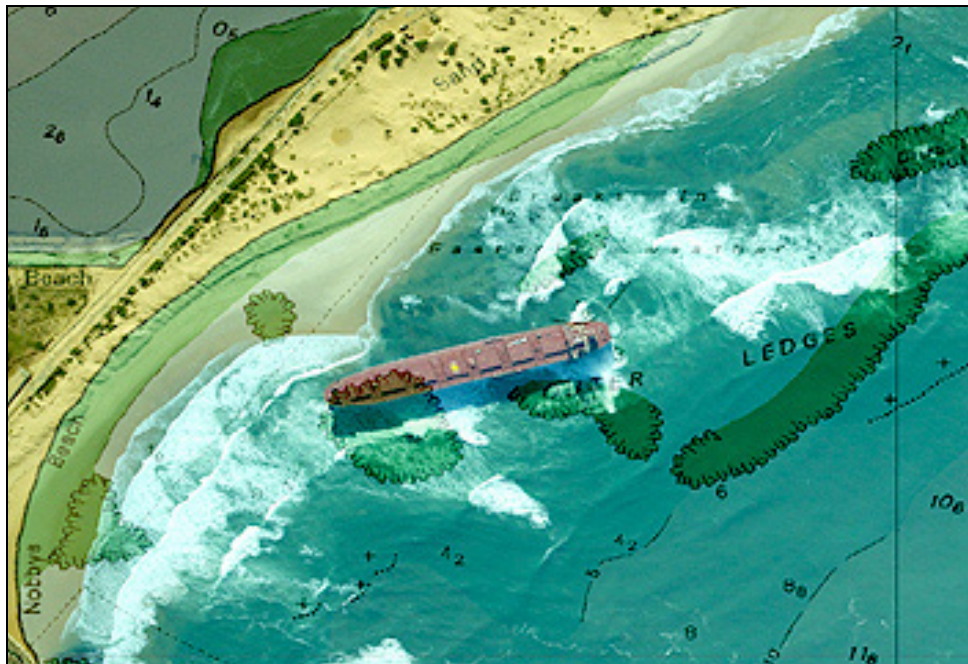
Figure 11: A visualisation of *Pasha Bulker's* position on Nobbys Beach

After the grounding, *Pasha Bulker* was pushed further onto Nobbys Beach by the heavy seas with the severe weather reaching its peak during the early hours of 9 June at about the same time as the high tide. The ship was heavily aground on the rock ledges on the beach (Figure 11).

Pasha Bulker was seriously damaged when it grounded and its condition continued to deteriorate while it remained on the beach. The main damage to the hull extended aft from number two cargo hold to the stern. The bottom plating was generally set up and heavily indented with many tears, splits and fractures. The largest was a gash about nine metres long and up to 25 cm wide under the number three cargo hold. Oil tanks in the double bottom were not breached and no oil was lost overboard. The rudder was badly damaged as was the propeller, with all of its blades bent.

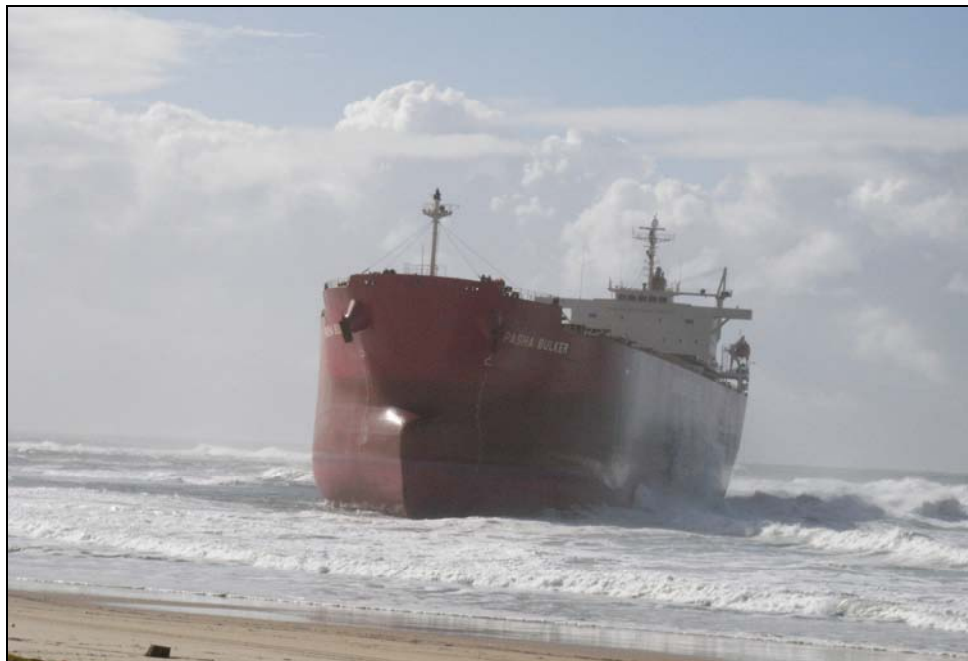
Figure 12: *Pasha Bulker* aground on Nobbys Beach

The Australian Maritime Safety Authority (AMSA), in co-operation with NPC, local and state authorities, prepared to respond to any pollution from the ship. Pollution response personnel and equipment remained on standby while the ship remained aground on Nobbys Beach (Figure 12).

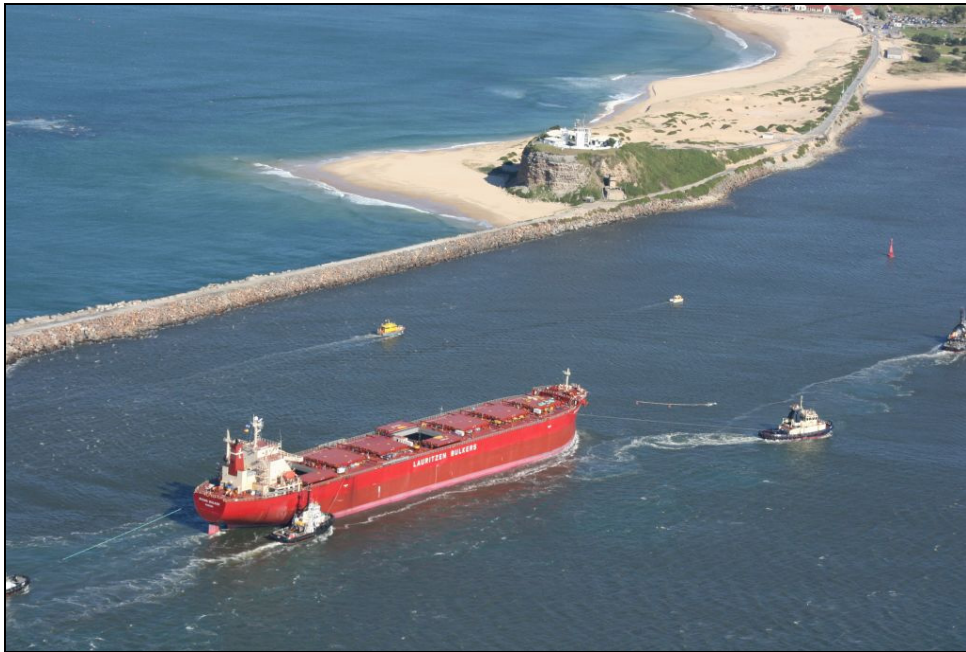
Figure 13: *Pasha Bulker* being towed into Newcastle

At 2138 on 2 July, *Pasha Bulker* was refloat. The ship, freed from the beach after 24 days, was then towed about 11 miles off Newcastle. Svitzer used divers to make a thorough assessment of the damage and the ship's condition. On 4 July, the ship was towed into Newcastle port (Figure 13) to carry out necessary temporary repairs before Svitzer could re-deliver the salvaged ship to its owners.

On 26 July, *Pasha Bulker* was towed out of Newcastle after the temporary repairs. Outside the port, a salvage tug took the ship in tow for its ocean passage to Vietnam, where permanent repairs were carried out.

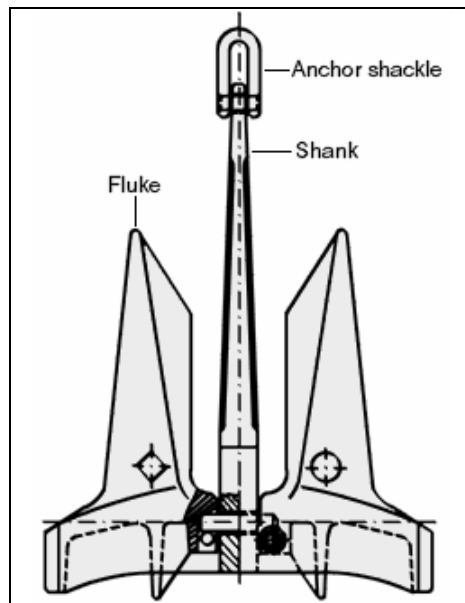
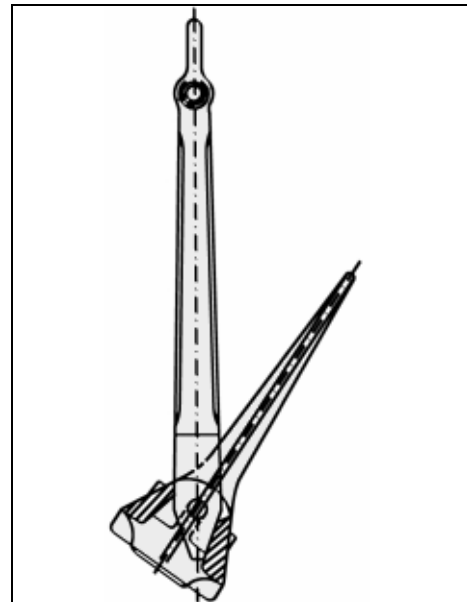
An increasing number of ships, including *Pasha Bulker*, *Betis* and *Sea Confidence*, are fitted with Admiralty Class (AC) 14 type cast steel HHP anchors (Figures 19 & 20) appropriate for their size. The type of chain cable fitted to the anchors of these ships is known as 'grade 3'. It is made from 'extra special quality steel', the strongest of the three materials commonly used for anchor chains.

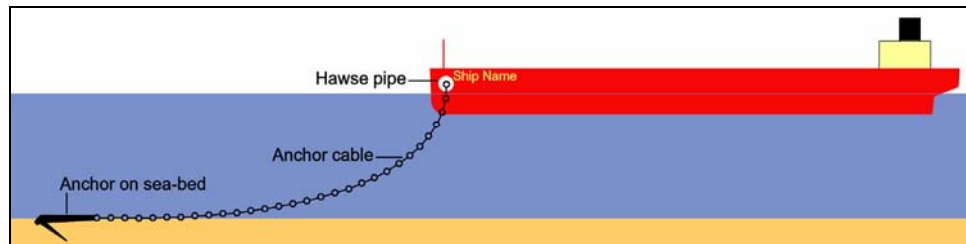
Figure 21: An illustration of a ship at anchor

An anchor provides maximum holding power when its flukes are fully embedded in the sea-bed. This occurs when the anchor shank lies on the seabed and the anchor cable pulls horizontally at the anchor shackle (Figure 21). When the pull increases, the cable lying on the seabed is lifted off, creating an angle above the horizontal. As

the angle increases, the holding power reduces. A rule of thumb is that a pull at 5° above the horizontal reduces the holding power by 25 per cent and a pull at 15° reduces the power by 50 per cent²³.

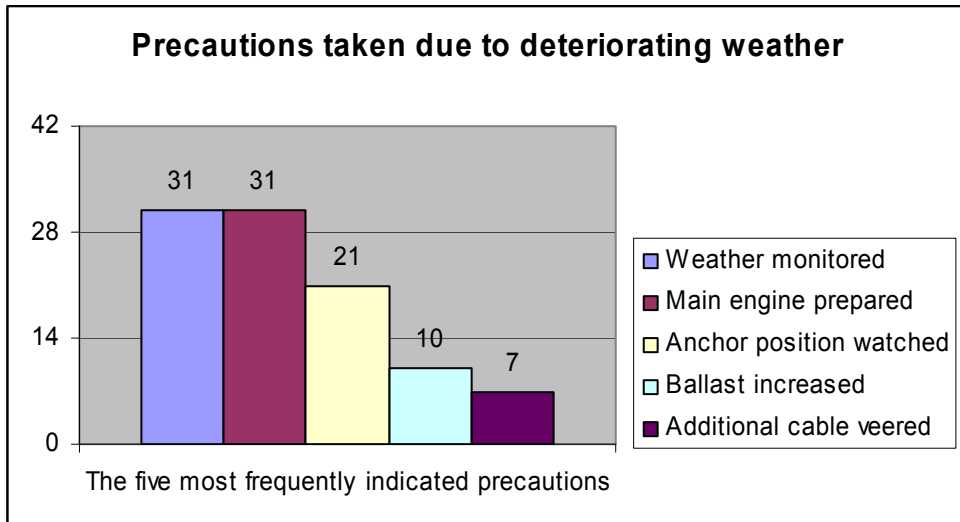
Question 4: When the weather worsened on 6-7 June, did you take any precautions?

Response: Multiple responses could be provided to this question. A total of 120 responses were received and categorised into eight groups of precautions. The order of importance of the precautions was not provided and the five most frequently indicated ones are shown.

Note: *Pasha Bulker*'s master indicated all these precautions except for 'ballast increased'.

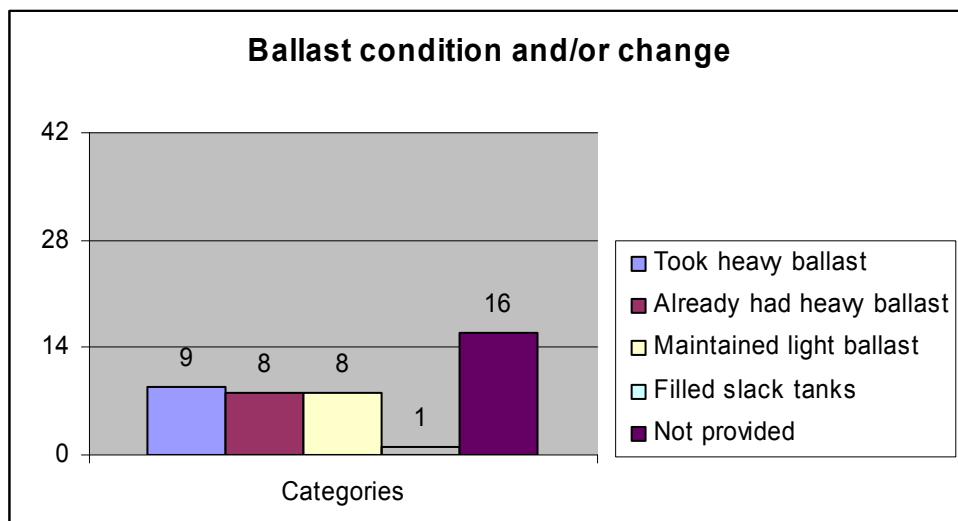
Question 5: Did you change your ballast condition and [if so] to what?

Response: In general, masters did not respond to the question as intended. Some provided this information in response to other survey questions. The chart below shows the information that was provided.

Note: *Pasha Bulker*'s master maintained the ship in light ballast condition.

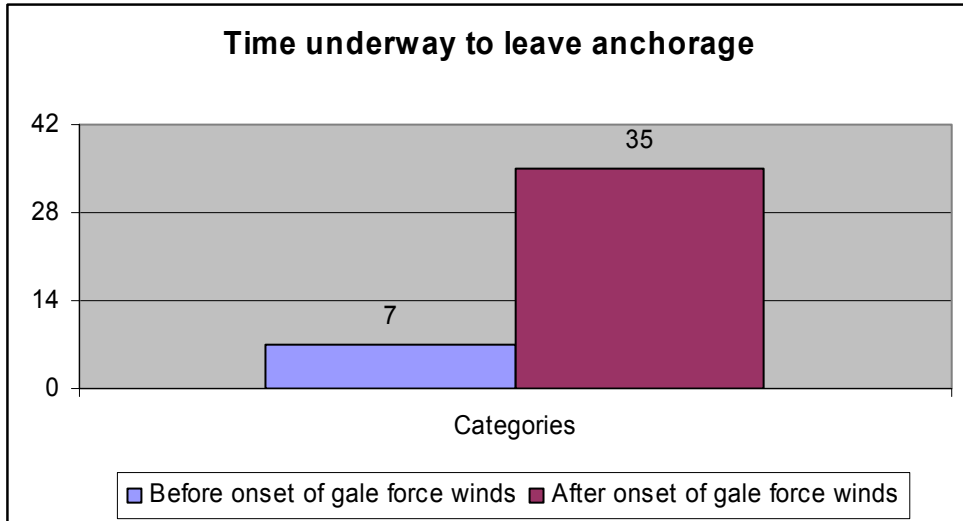
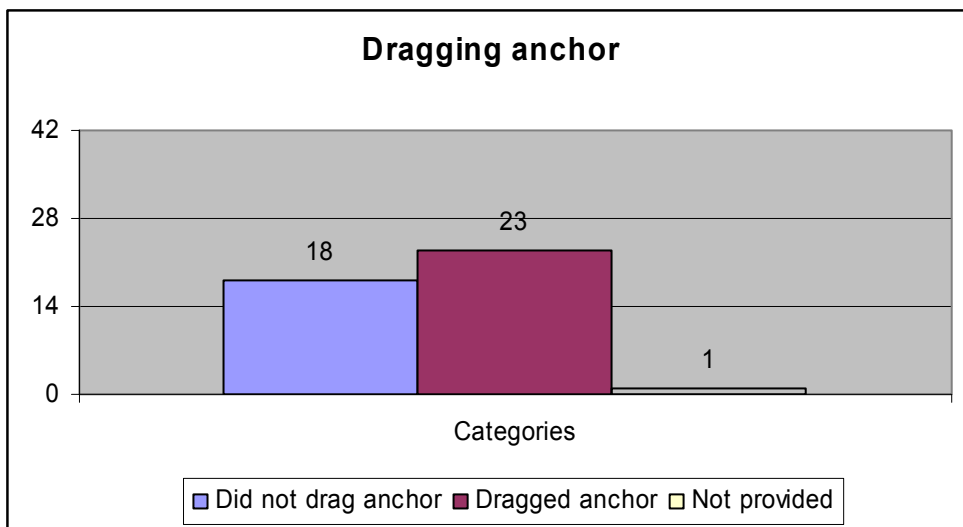
Question 6: When did you leave Newcastle anchorage and did your ship’s anchor drag before you started heaving it up?

Response: Masters provided the time their ships got underway and if their anchors dragged before being weighed. Where possible, VDR audio data was used to confirm responses and resolve any ambiguities. The wind speed increased to a consistent gale force by 0100 on 8 June. This time has been used as the determinant for before or after the wind increased to gale force.

Note: *Pasha Bulker* got underway at 0748 on 8 June after its anchor had dragged. At the time, there were 11 ships in the anchorage which were not underway.
