National Transportation Safety Board

Marine Accident Brief

Engine Room Fire on Board Towing Vessel *Dennis Hendrix*

Accident no.	DCA15LM002
Vessel name	<i>Dennis Hendrix</i>
Accident type	Engine room fire
Location	Lower Mississippi River, about 10 miles* northwest of Baton Rouge, Louisiana; 30°34.1' N, 91°16.3' W
Date	October 31, 2014
Time	0742 central daylight time (coordinated universal time – 5 hours)
Injuries	None
Property damage	\$3,800,000
Environmental damage	None
Weather	Daylight with clear visibility, light and variable winds, air temperature 47°F
Waterway information	Lower Mississippi River

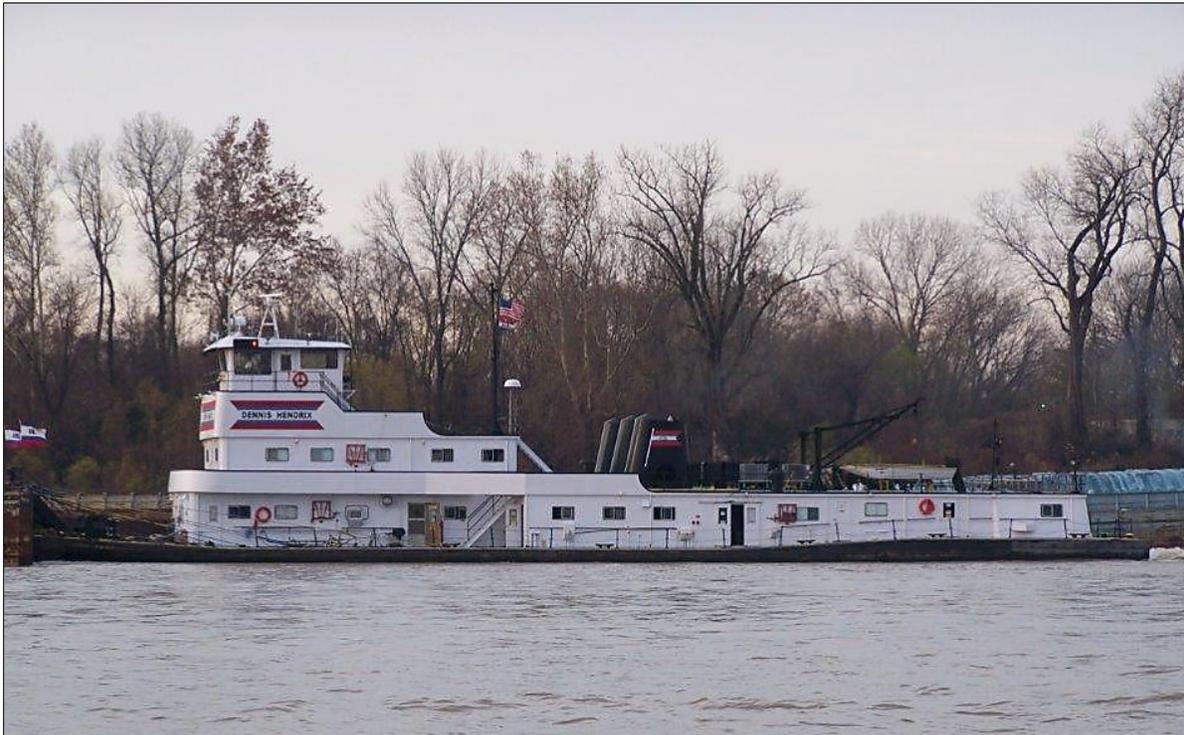
The *Dennis Hendrix* on the Mississippi River. (Photo by American Commercial Lines)

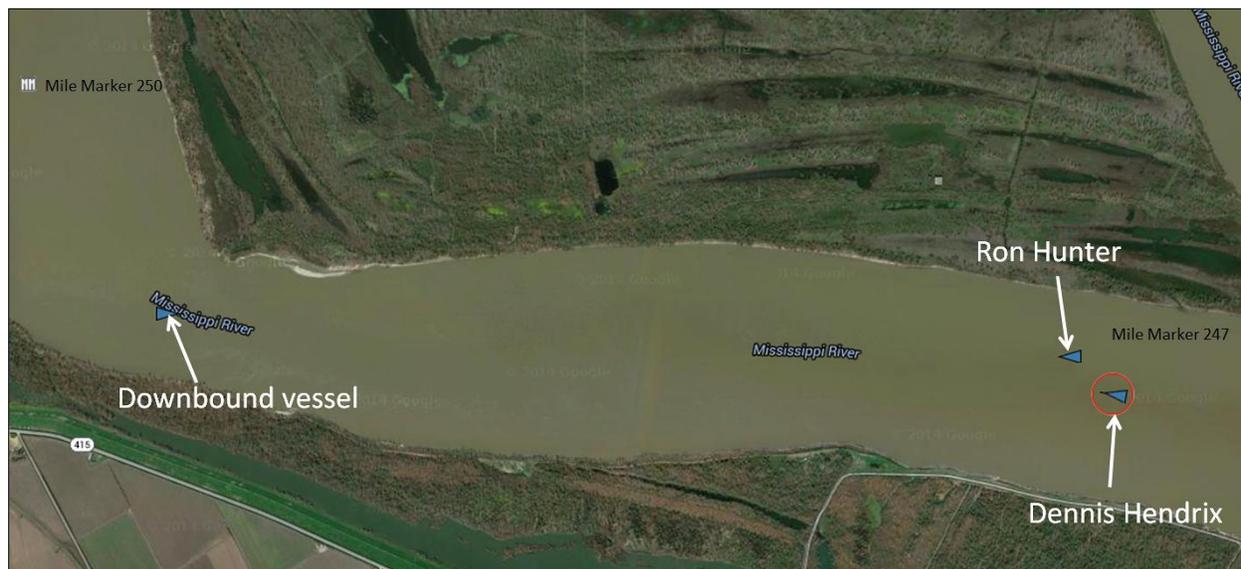
The locations of the *Dennis Hendrix*, the *Ron Hunter*, and the downbound vessel about 0742, when the fire broke out. (Image compiled from Portvision and Google Earth)

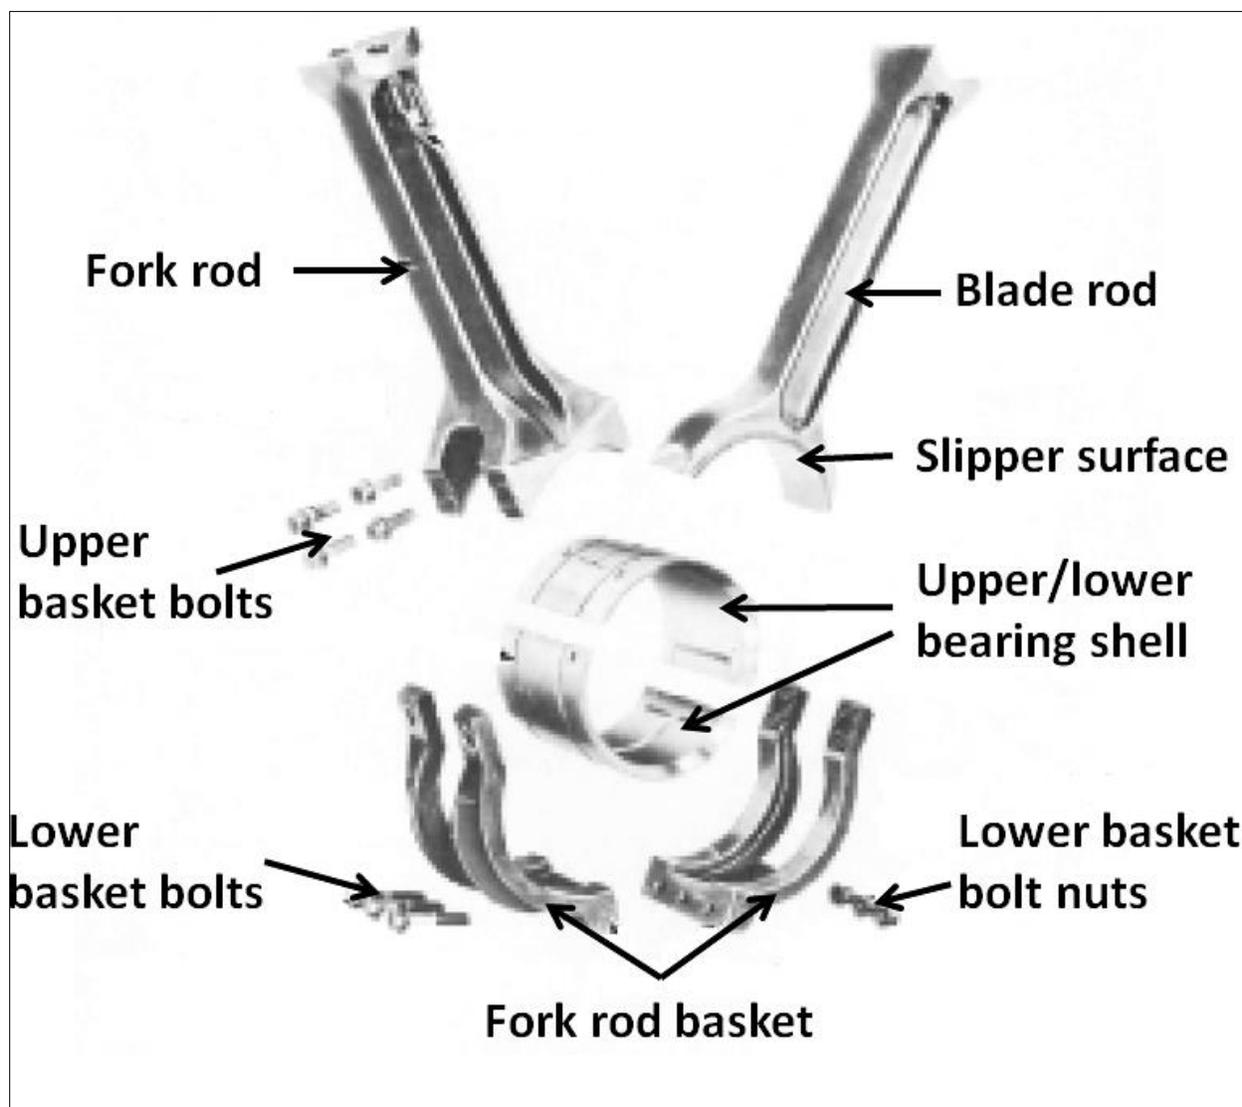
The damaged no. 5 piston and the connecting rod assembly were removed from the starboard engine and sent to a mechanical and metallurgical consultant for examination. The specific items examined were from starboard engine cylinder no. 5 and adjacent cylinder no. 13. A report submitted by Busch and Associates Inc. to ACL concluded that the no. 5 piston and connecting rod assembly failed due to loose bolts on the lower basket, leading to fatigue failure of the blade and rod and upper connecting rod bearing.

Connecting rods, bearing shells, and basket. (Graphic from Electro Motive Diesel 645E7B Turbocharged Marine Engine Maintenance, March 1981)
