PB94-916301
NTSB/RAR-94/01

RAILROAD-MARINE ACCIDENT REPORT

DERAILMENT OF AMTRAK TRAIN NO. 2
ON THE CSXT BIG BAYOU CANOT BRIDGE
NEAR MOBILE, ALABAMA
SEPTEMBER 22, 1993

Adopted: September 19, 1994
Notation 6167B

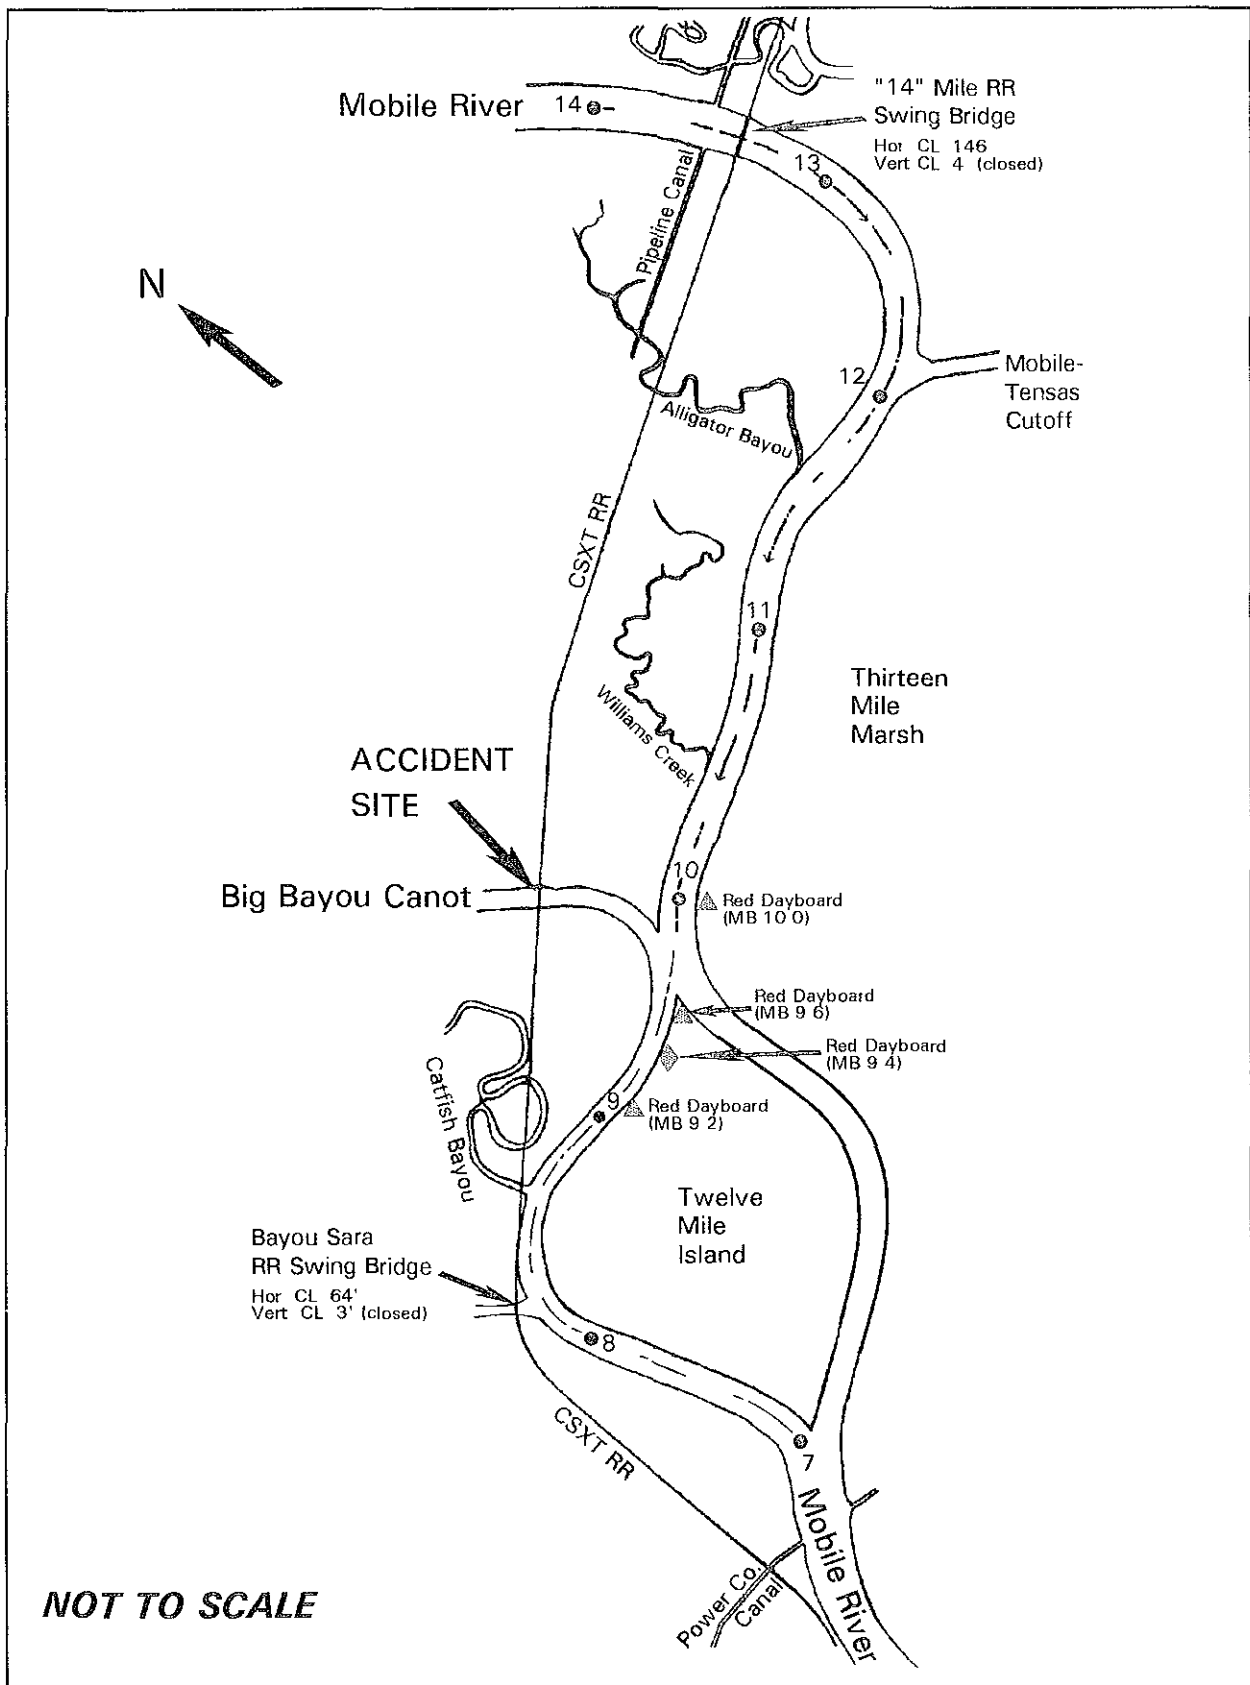
Figure 2.--Mobile River chart.

He stated that visibility was good³ and recalled learning from marine radio conversations shortly before he departed that conditions were foggy north of his position. He could see the THOMAS B. McCABE's stern lights until that vessel rounded a bend in the Mobile River at Bayou Sara (about mile 8.2). The MAUVILLA's position at the time, according to the pilot, was near the south end of Twelve Mile Island (mile 7), and he recalled visibility beginning to become "hazy" there (see figure 2).
