SAFETY INVESTIGATION REPORT

REPORT NO.: 12/2012

MV Purki **Serious injury of ordinary seaman and subsequent death of the second mate In the port of Alger, Algeria 29-30 September 2011**

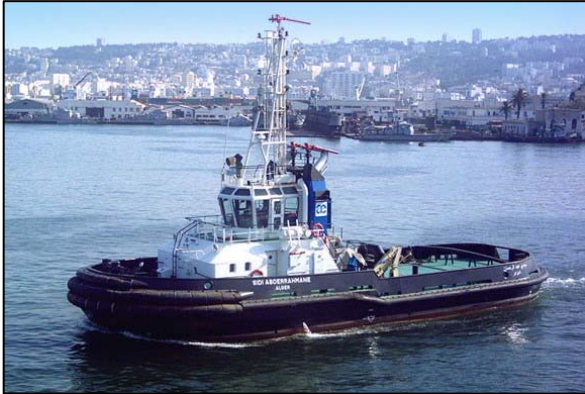
Figure 1: Tug *Sidi Abderrahmane*

The pilot boarded the vessel again at 2230 and at 2238 the tug *Sidi Abderrahmane* (Figure 1) was made fast forward by ship's line through the centre panama lead. The line was secured to the starboard mooring bitts (Figure 2). All shore lines were let go at 2245.
