Bundesstelle für Seeunfalluntersuchung
Federal Bureau of Maritime Casualty Investigation
Federal Higher Authority subordinated to the Ministry
of Transport and Digital Infrastructure

Investigation Report 15/19

Serious Marine Casualty

**Fire in the area of the deck cargo
on board the container ship
YANTIAN EXPRESS
in the Atlantic Ocean
on 3 January 2019**

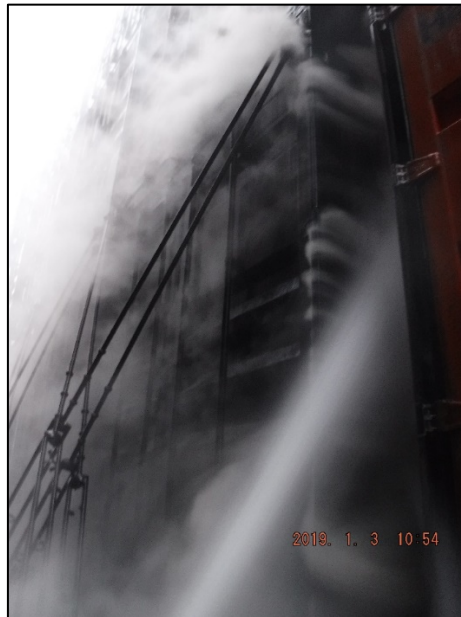
Figure 8: Firefighting at bay 12; row 03 in the middle of the image

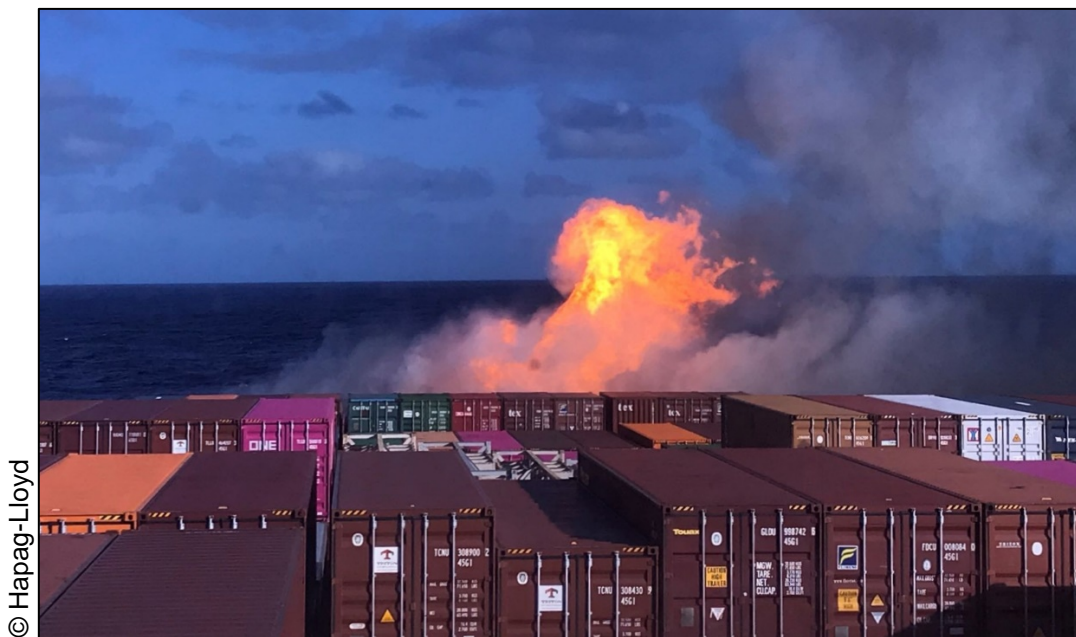
Figure 9: View of the bow of the YANTIAN EXPRESS¹⁰

The following containers were on fire at 1950: 120182, 120186, 120386, 120382, 120582, 120584, 120782, 120784. Flames were also visible at the front of the underlined containers. Furthermore, a blowout [sic] from an unidentifiable container on the bow occurred in the evening.

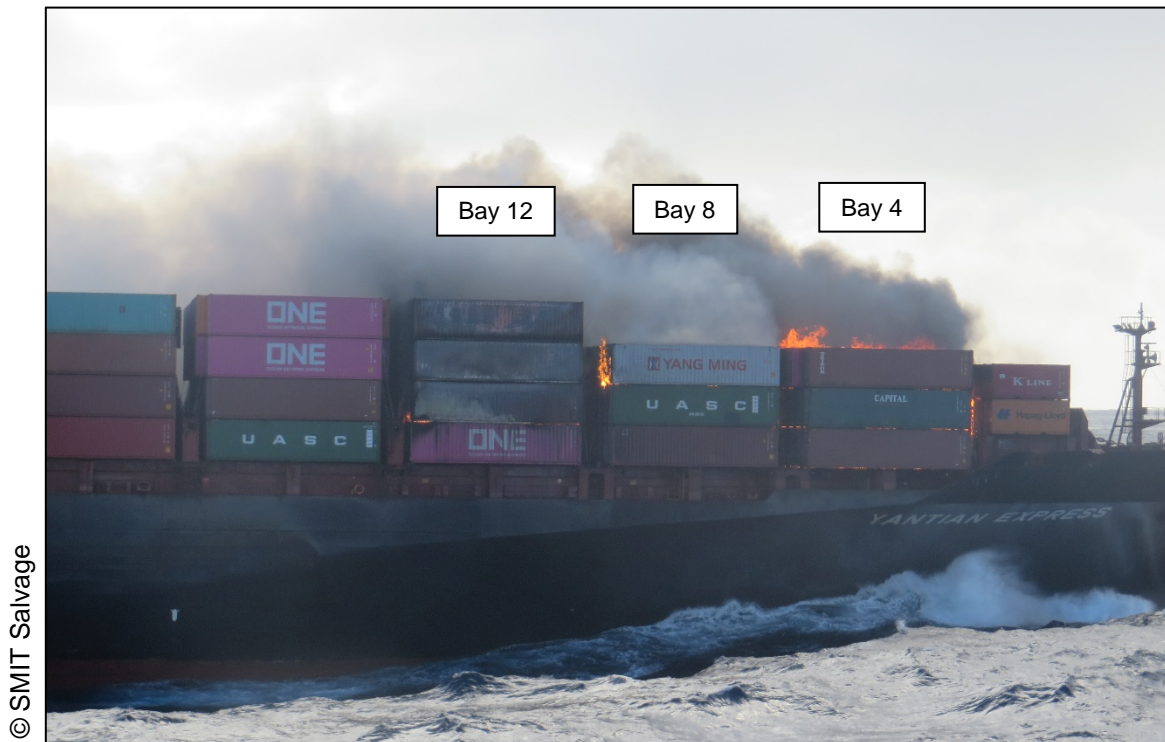
Figure 12: Fore ship of the YANTIAN EXPRESS on 5 January 2019

The crew of the YANTIAN EXPRESS had investigated the situation in the area of the fire earlier on. Two containers were burning in the fourth tier of bay 12. Containers were also burning in the first and second tiers. It was possible to attribute the black smoke that had previously been clearly visible from the bridge to a container in bay 8. It was also established that the temperature of bay 16's hatch covers stood at 16 °C on the port side. No smoke was seen coming out the containers in bay 16. Moreover, no smoke was seen when the cargo hold entrance was opened at the aft edge of cargo hold 2. No smoke was seen during the inspection inside the cargo hold, either. However, it was established that the water was halfway up the containers in the eighth tier, which corresponds to a water level of about 9 m. The classification society's emergency response team, which had been advised of this fact, then warned of possible stability problems. Consequently, the SMIT NICOBAR switched from direct firefighting to cooling down the area around cargo hold 2 afterwards. In addition, firefighting was continued in bay 8.

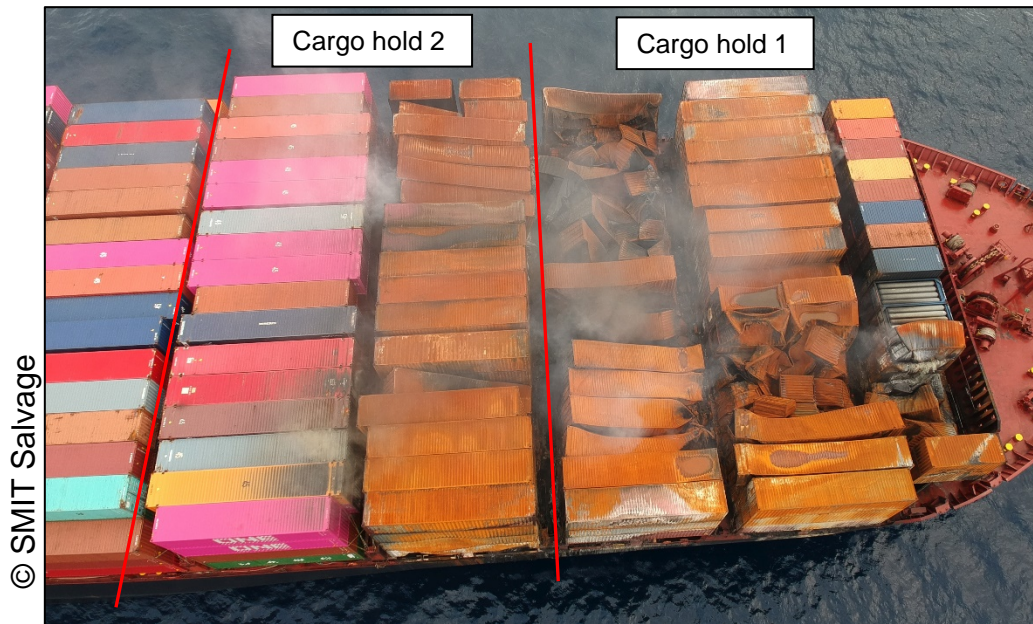
Figure 16: Fore ship of the YANTIAN EXPRESS on 12 January 2019

With regard to the cargo, the shipping company announced that four containers in cargo hold 1 and one container on the deck (161584) supposedly contained 'Titanium Sponge Granules + 10 mesh'²¹. The name in the manifest was 'Granules/Crushed Stone'. Although titanium sponge is not classified as a dangerous good, the data sheet indicates that it has a tendency to explode if it is heated or comes into contact with water. This information was important because a large amount of water had been and was being used to cool down the dangerous goods containers in bay 1. After the announcement, all cooling and firefighting measures around cargo hold 1 were initially stopped.

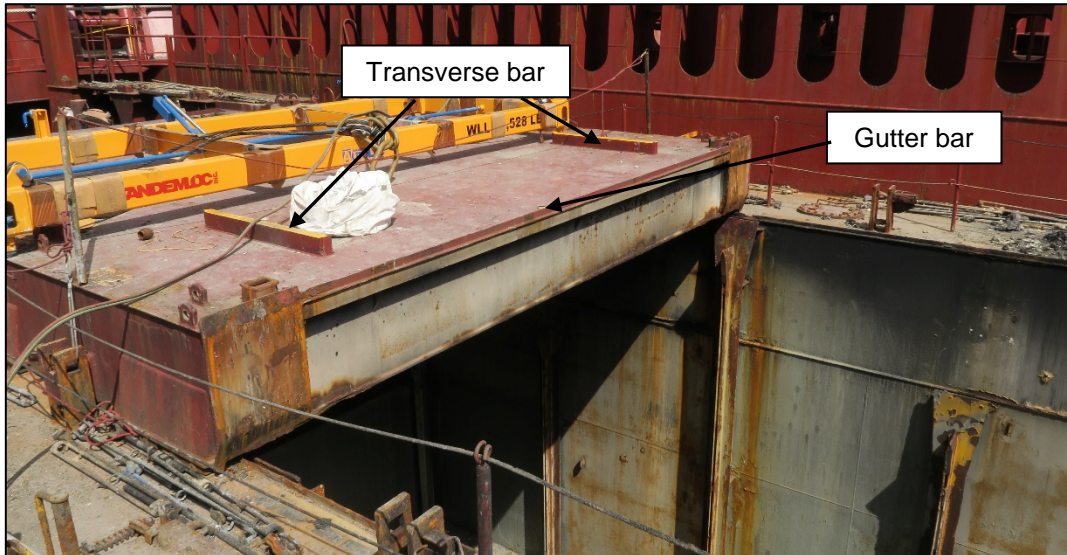
Figure 19: Cargo hold 1, bay 1, gutter bar and transverse bar

The hatch covers on the YANTIAN EXPRESS only form a partially watertight closure at the top of the cargo hold. This approved design is known as a non-weather-tight type hatch cover. Due to the design, a larger gap remains open between the individual lids.²⁸ The gap on this ship is ≤ 5 cm. A metal strip (gutter bar) welded to the edge of the cover on the side of the gap is intended to prevent rainwater or spray on the surface of the cover from entering the cargo hold as the ship moves (see Figure 19).

The chief officer also explained that the use of firefighting water beneath the containers was obstructed by the container feet located on the hatch cover and especially by the transverse bars welded onto them (see Figure 19).

The crew reported that the transverse bars on the hatch covers (Figure 19) obstructed the active cooling and extinguishing measures underneath the containers. Although the distance between cover and container is relatively large (see Figure 56), the transverse bars reduced the space available.

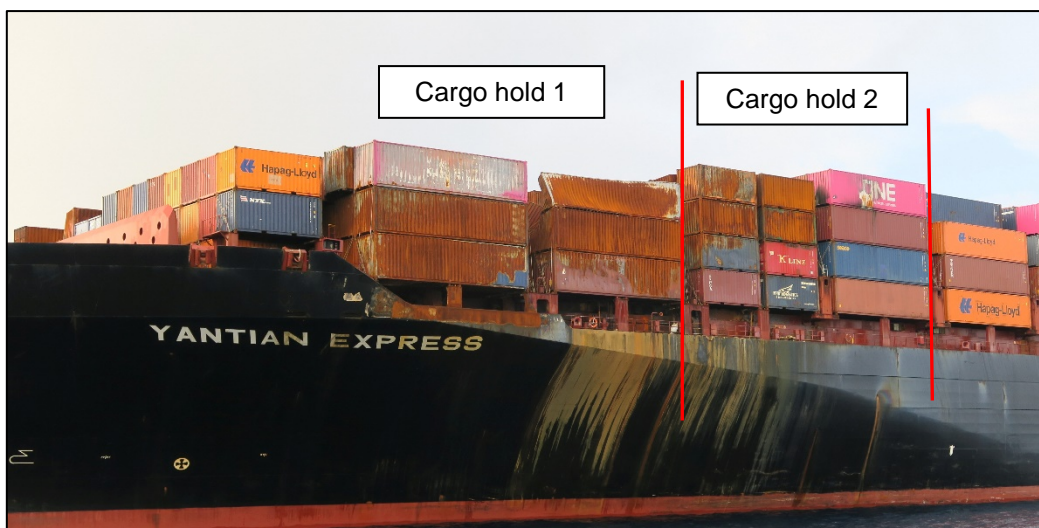
Figure 21: Fore ship on port side

During the inspection of the passageways, major damage to the ceiling of the corridor and to the equipment and cable looms located there could only be identified on the starboard side in the area of cargo hold 1.

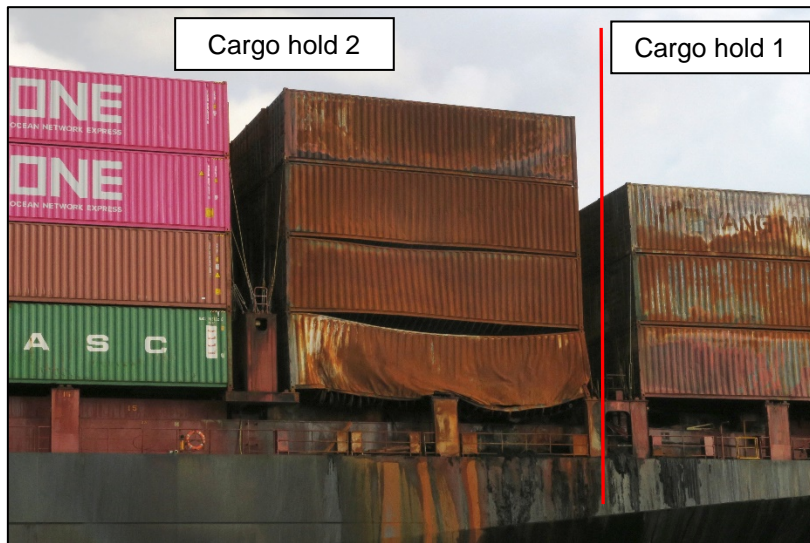
Abbildung 22: Fore ship on starboard side

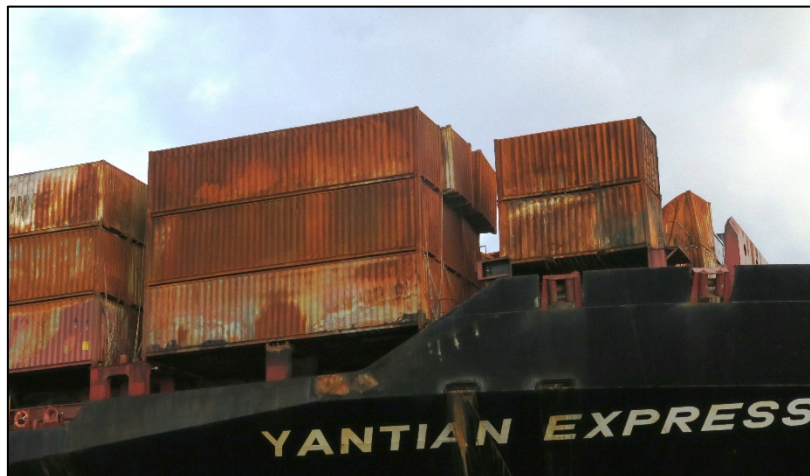
Abbildung 23: Fore ship on starboard side (cargo hold 1)

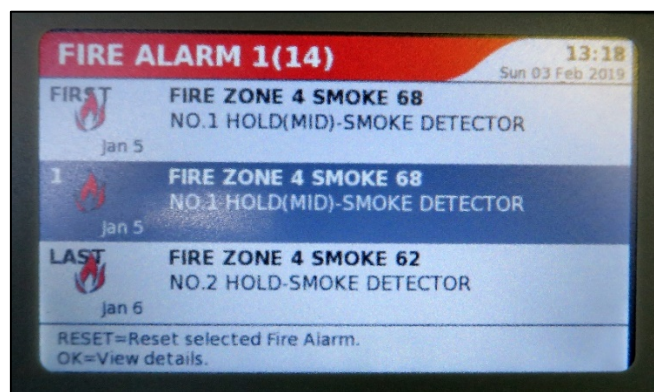
The fire alarm system on the bridge of the YANTIAN EXPRESS displayed various alarms on the integrated monitor (see Figure 24). A comprehensive evaluation was later carried out using the system's log data (see subsection 3.2.8)

Figure 24: Fire alarm system display

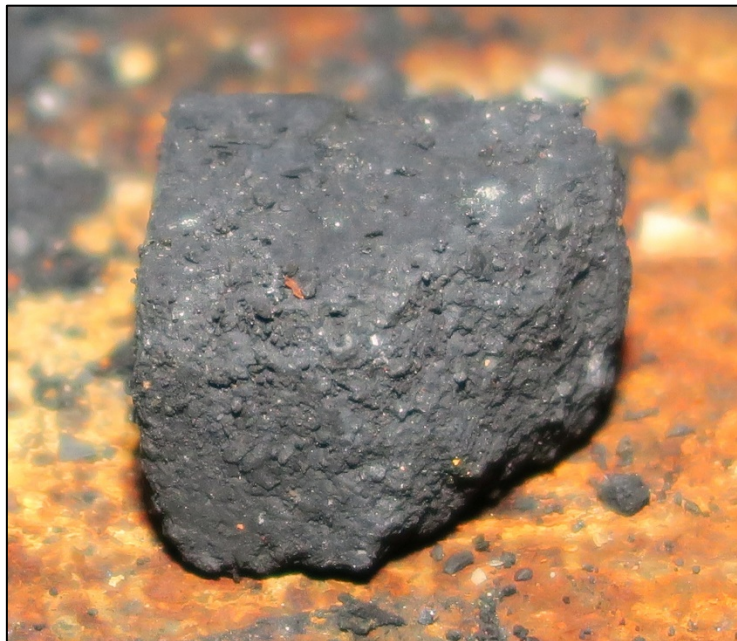
Figure 33: Close-up of a coconut charcoal cube

Coconut charcoal rather than the coconut pellets specified in the cargo documents was in container UACU5272502 at slot 120782. The difference between coconut pellets (see Figure 41) and the pyrochar shown in Figure 33 is clear. Coconut pellets are produced by grinding coconut shells and used as fuel for furnaces. In addition, coconut

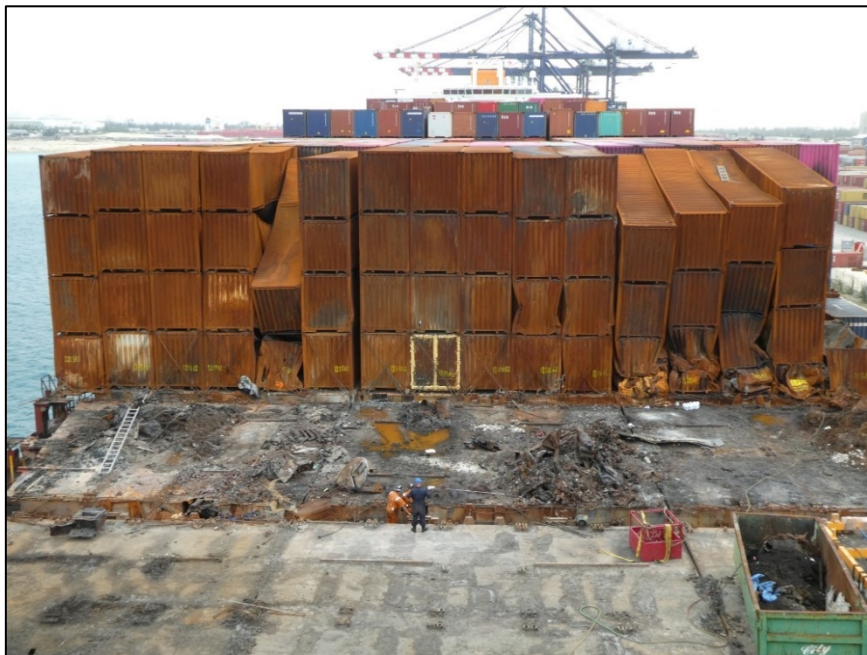
Figure 37: View from bow to stern on 26 February 2019
 A view of the forward edge of the containers in bay 12 is shown here.

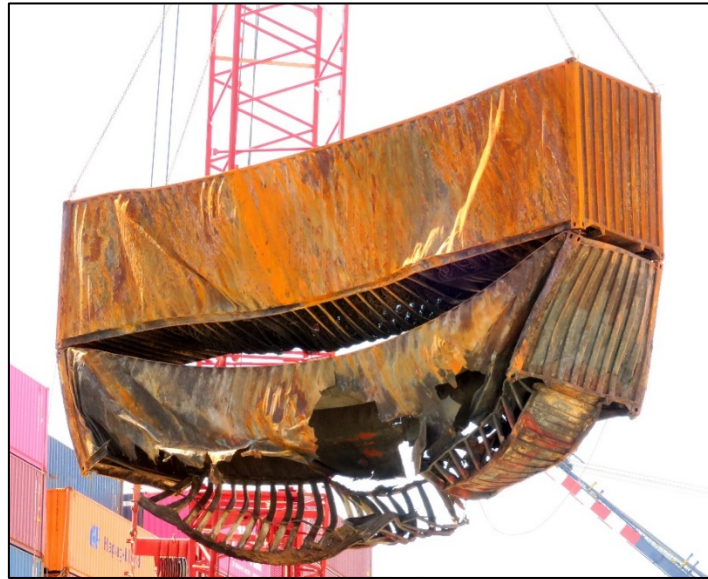
containers could only be determined in a few cases due to severe and prolonged fire burned up virtually all combustible materials. Additionally, some of the containers exhibited an extremely high degree of destruction due to the effects of fire, which in some cases caused the overall structure to collapse during unloading. The condition of the cargo inside corresponded with expectations. Cargo was no longer present in some instances because the container floors were burnt and the fire debris fell out when the containers were lifted. Otherwise, the cargo had already mixed with other cargo beforehand.

Figure 38: Containers at slots 120788 (top) and 120786

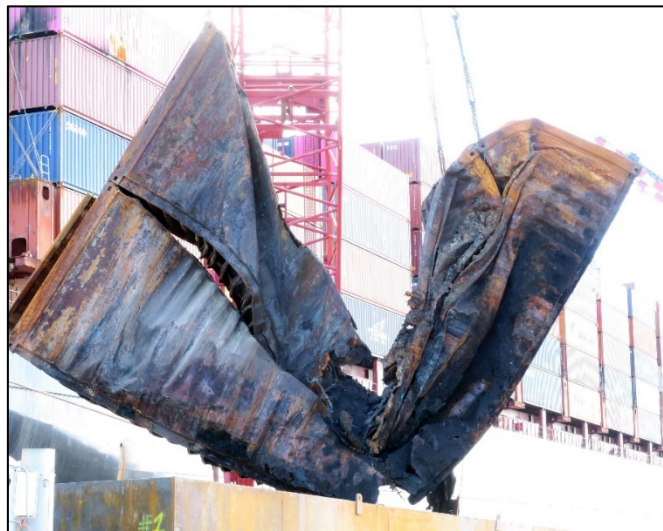
Figure 39: Containers at slots 120784 (top) and 120782

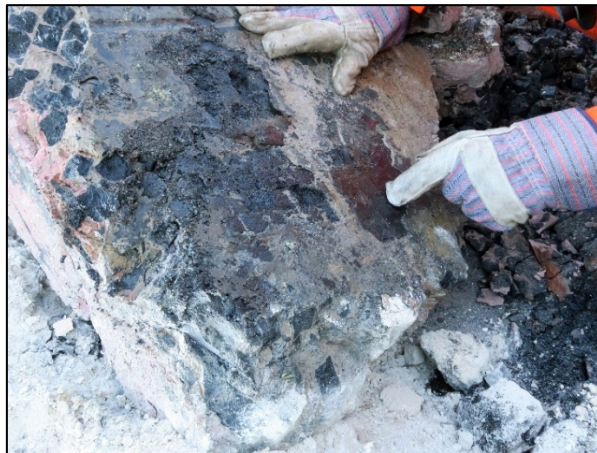
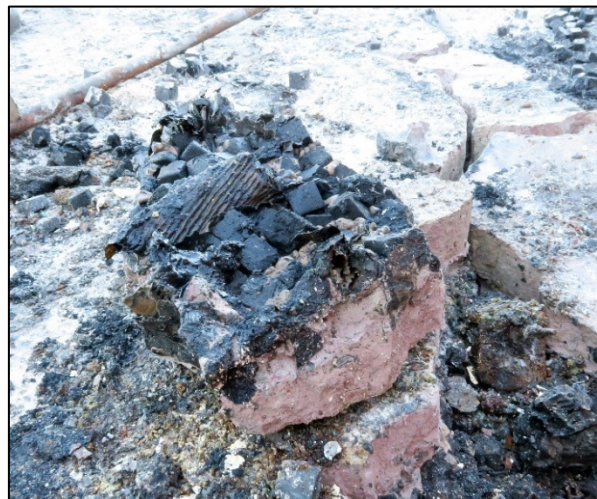
After the container had been unloaded from slot 102582, this area was examined. It was found in the process that parts of the charcoal load had also been under this container. Some of the pyrochar (in its cardboard packaging unit) was baked into the fire debris of the polypropylene shopping bags (see Figures 43 to 45).

Figure 44: Packed pyrochar at slot 120572

Figure 45: Packed pyrochar at slot 120572

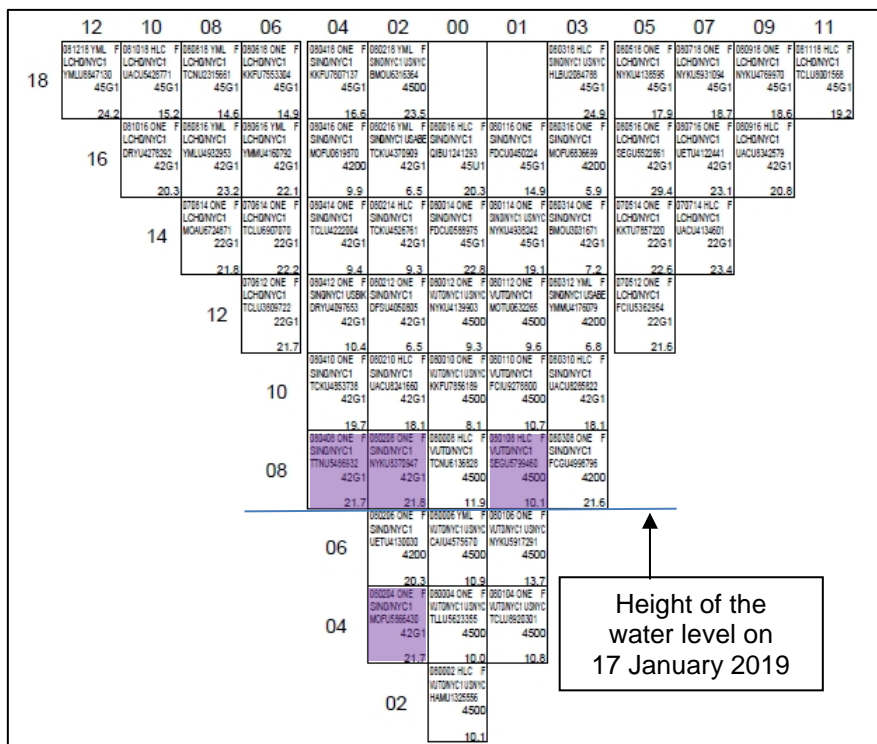
According to the shipping documents, seven 40' containers with titanium sponge were on board the YANTIAN EXPRESS. Four of them were transported in cargo hold 1, bay 8. Another container was in bay 16.

The safety data sheet provided to the BSU by the shipping company contained the following text: "Keep away from heat, sparks, open flames, heated matters and other ignition sources. Keep in a cool place and avoid sunlight. Container may explode on heating. May react drastically or explosively on contact with water. May decompose explosively when heated or involved in a fire." The prohibited firefighting agents indicated included water, CO₂ and foam extinguishing agents.

Figure 49: Cargo hold 1, bay 8, 40' container with titanium sponge

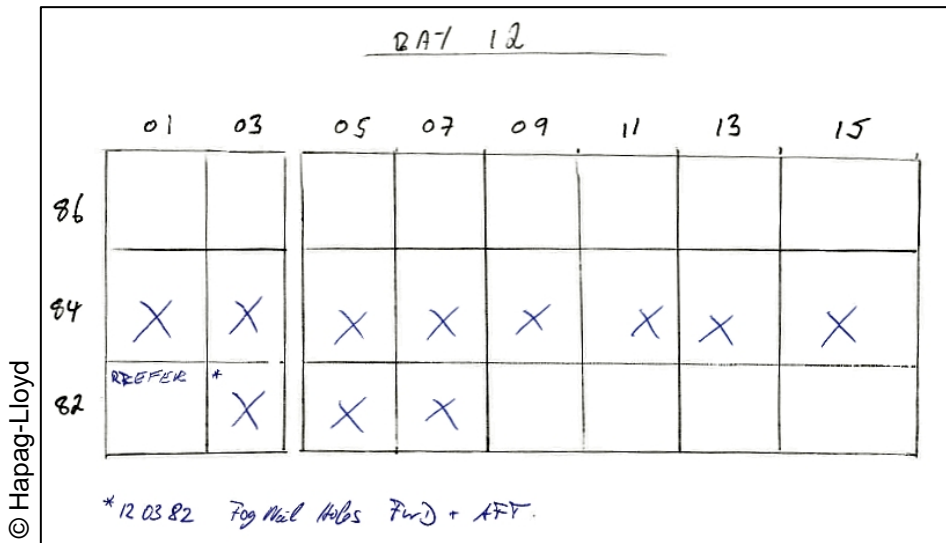
Figure 51: Holes created by the crew for the water lances

As already discussed, the crew made extensive use of the three water mist lances on board.³⁸ This had been rehearsed on a barrel during an exercise and appeared simple. The walls of the containers were much thicker, making it far more difficult. Consequently, after the firefighting had begun and the first water lances were punched into place, members of the engine room's crew drilled holes into the containers in the area of the fire in bay 12 as a precautionary measure. The portable drill on board proved less suitable for this. In the end, the mandrel belonging to the water lances was used to create a small starting hole. The hole was then expanded to the diameter of the water lance conventionally using a hammer and chisel. An overview of the holes created in the process can be found in Figure 51.

The three water mist lances were then repositioned from time to time to extinguish all the containers that had caught fire from the inside. Due to the poor accessibility of containers in the second tier, the holes there were halfway up the container.

A hole for a water lance was punched into the front and back of the container at slot 120382.

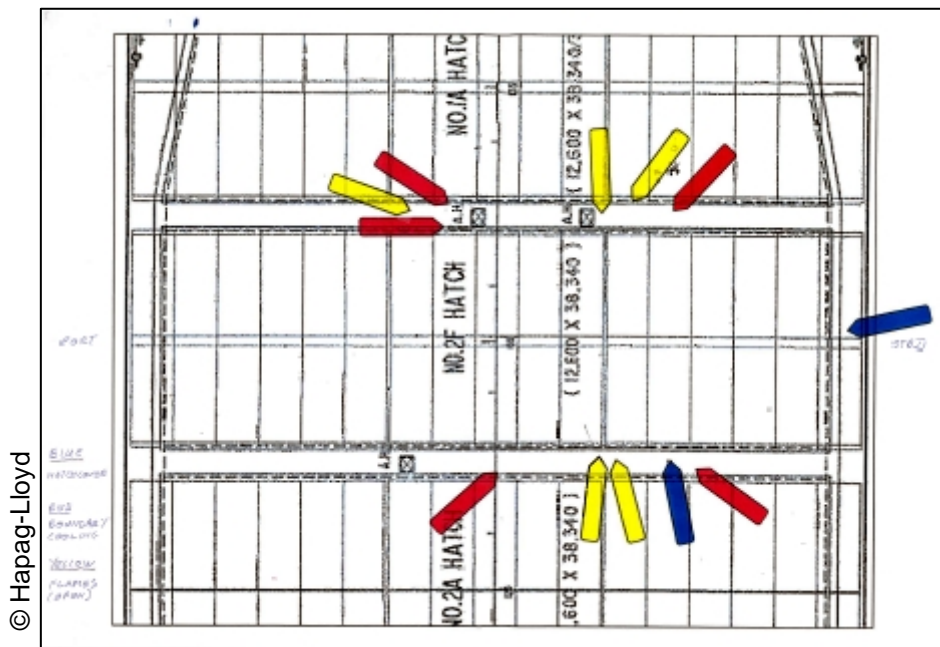
Figure 52: Firefighting by the crew at bay 12

Viewed from the top. The blue arrows indicate the use of water between hatch cover and container floor. The yellow arrows indicate the extinguishing of open flames. The red arrows indicate the cooling down of the environment.

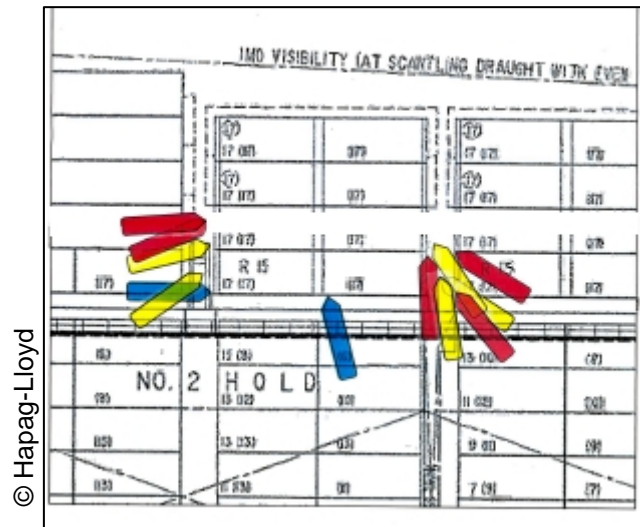
Figure 53: Firefighting by the crew at bay 12

Viewed from the side. The blue arrows indicate the use of water between hatch cover and container floor. The yellow arrows indicate the extinguishing of open flames. The red arrows indicate the cooling down of the environment.

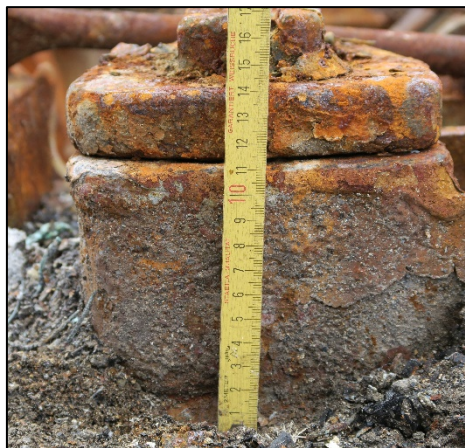
Figure 56: Height of container foot plus twist lock

This posed a particular problem in the case of those containers that could only be reached from the front or back due to their position.

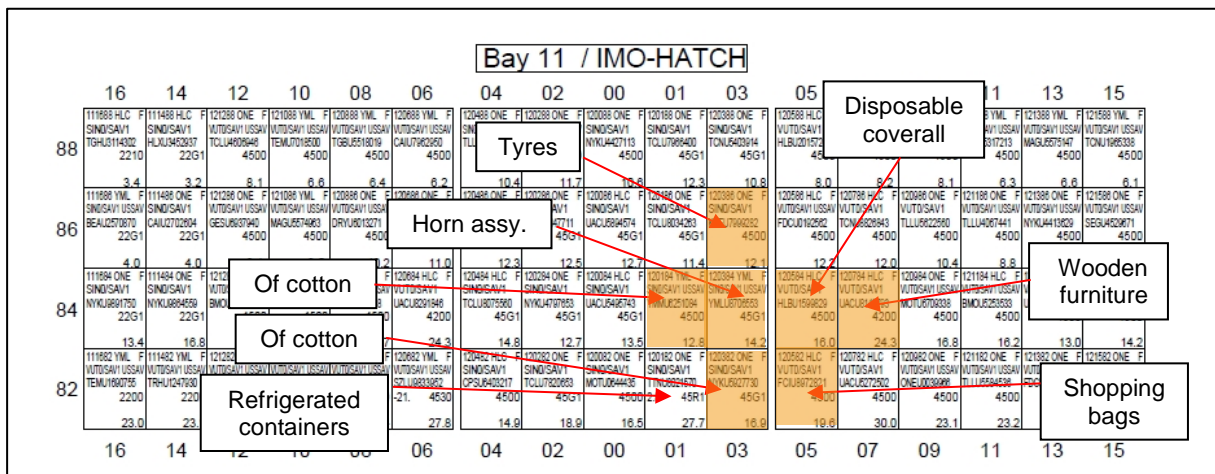
Figure 58: Bay 11 stowage plan

The cargo in the containers first affected is once more shown below (see also Figure 3 and subsection 3.2.6).

Reference samples of the in figure 58 listed cargoes were not available to determine specific fire hazards, except for the container with “horn assy”. This is because the contents had been essentially consumed by the fire and it was therefore not possible to determine what was in the containers pre fire based upon the remains alone. The investigators do assume that none of these goods posed a particular risk of spontaneous combustion under normal circumstances, however. With that said, however, the investigators cannot rule out any undeclared or misdeclared cargo in these containers.

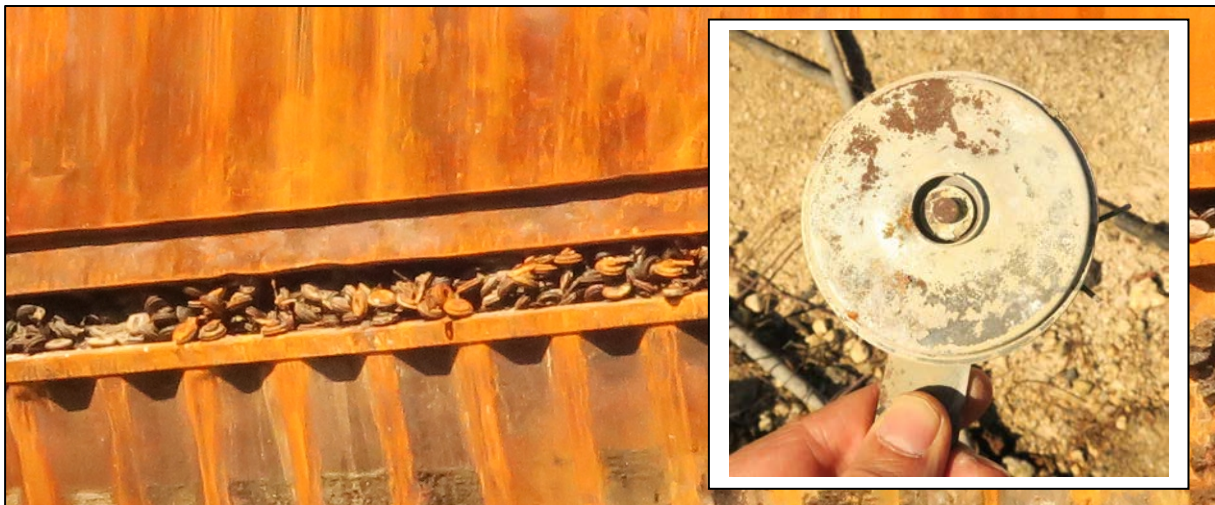
Figure 59: Horn from container at slot 120384

The cargo documents indicated that only two loads may have contained a source of ignition. One was the refrigerated container at slot 120182 and the other was the container loaded with horns (Horn Assy) at slot 120384. The investigators consider it unlikely that the refrigerated container was the cause of the fire. Firstly, the container was loaded with pineapples, which do not pose a fire hazard. Secondly, no traces of fire indicating a fire inside the unit could be found on the refrigerating unit (see also Figure 34). The container loaded with horns contained only the horns and no associated power sources. Their packaging was obviously flammable, however.
