**Marine pollution accident from the collision between
crane barge Samsung No. 1 towed by tugboats
Samsung T-5 and Samho T-3, and
oil tanker Hebei Spirit**

Prepared by
The Korean Maritime Safety Tribunal

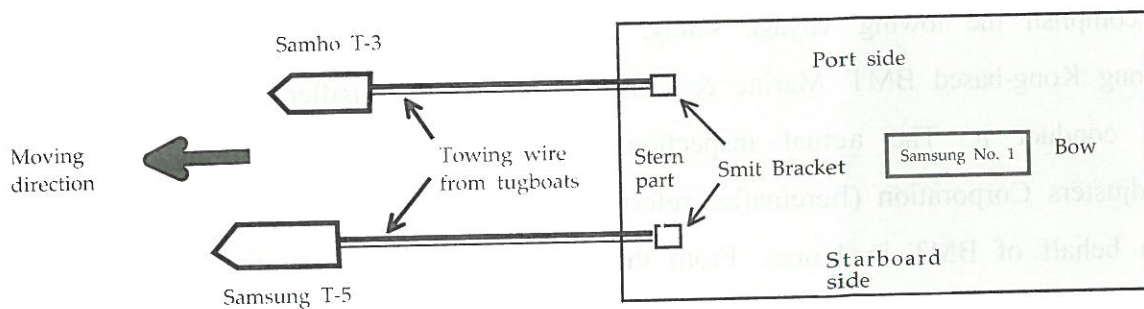
[Diagram 11] The towing wire of Samsung T-5 and Samho T-3 were connected to the smit bracket attached to the deck floor of Samsung No. 1's stern.

On Samsung No. 1, a smit bracket that connects the towing wires, was attached to the port side and starboard side each on the poop deck to secure the intermediary towing wire or pennant wire of the stretcher. But during this accident, towing wires were connected each to the Samsung T-5 starboard side (the tugboat towed the stern of Samsung No. 1, that it would be the port side if based on the moving direction) and Samho T-3 port side. ([Diagram 11])

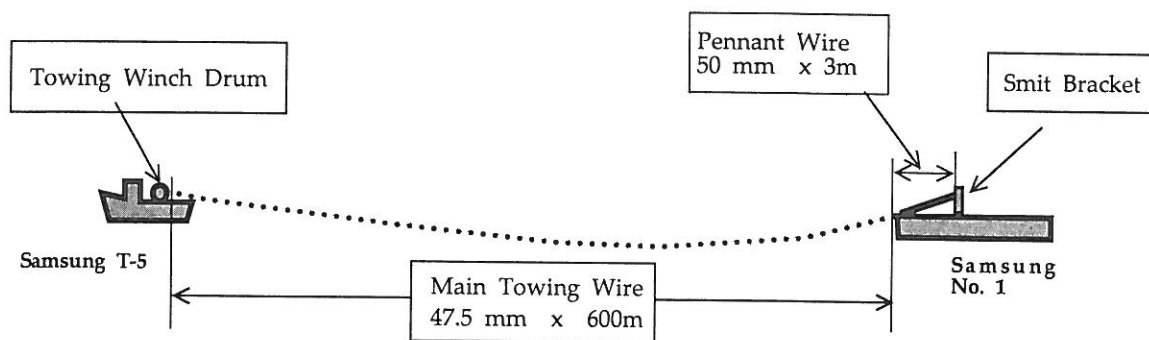
[Diagram 12] Structure of Samsung T-5 towing wire on the towing approval check list (the total length of the towing wire is 603m, but the pennant wire is placed on the deck of the barge, that the available maximum length of the towing wire is 600m, and the actual length during navigation is appropriately adjusted by the Master.)

According to the Salvage Association Towage Approval Check List for the towing fleet, the Master of Samsung T-5, the lead tug, was to adjust at will, the length of the towing wire, depending on the situation. But not only was the towing wire of Samho T-3, which had a relatively weaker bollard pull, longer in length, but the check list also unreasonably specified that a stretcher for impact absorption be connected. But Master of Samsung T-5 did not object this and jointly signed with the inspector, the towing insurance certificate. When extending the towing wire to commence full coastal navigation, he did not care at all in using steel wire ropes on both tugboats and in extending the towing wire of Samsung T-5, which had better bollard pull, by approximately 20 m. ([Diagram 12], [Diagram 13])

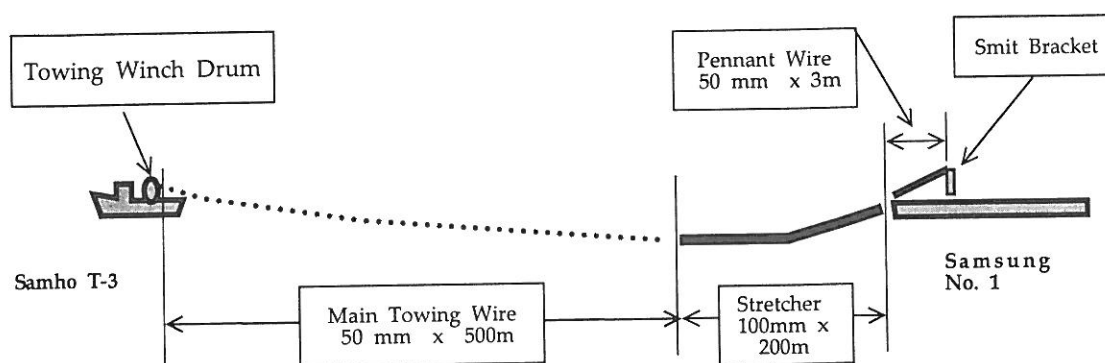
[Diagram 13] The structure of Samho T-3 towing wire on the towing approval check list (unlike the towing wire structure of Samsung T-5, the stretcher of the PP rope was added to absorb the tension impact between the main towing wire and the pennant wire. The pennant wire is placed on the deck of Samsung No. 1, that Samho T-3 towing wire's available maximum length is 700m, and the actual length during navigation is adjusted appropriately by the Master.)

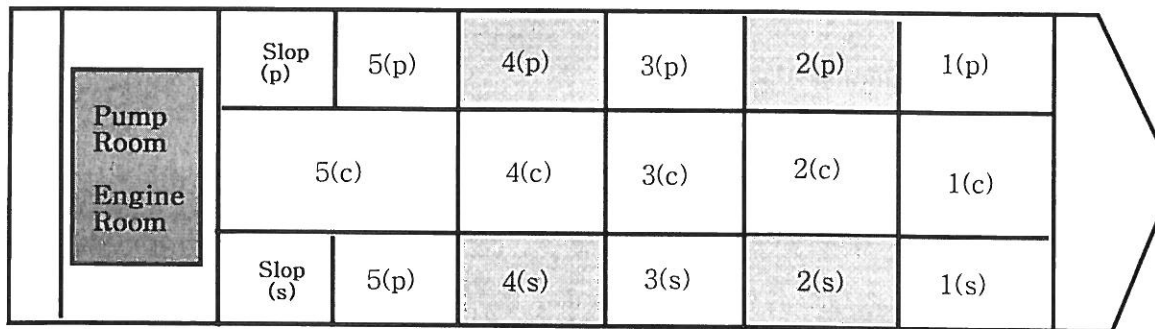
[Diagram16] The arrangement of cargo tanks and ballast tanks(marked in gray)

This ship spilled approximately 12,547 kilo-liters of crude oil stored in cargo tank (hereinafter referred to as the "cargo tank"), damaged from the collision. This proceeding must disclose the cause of mass oil leaking and the cargo management equipment required thereto is as follows.

The ship had 13 cargo oil tanks and 4 ballast water tanks. ([Diagram 16], [Table 7])

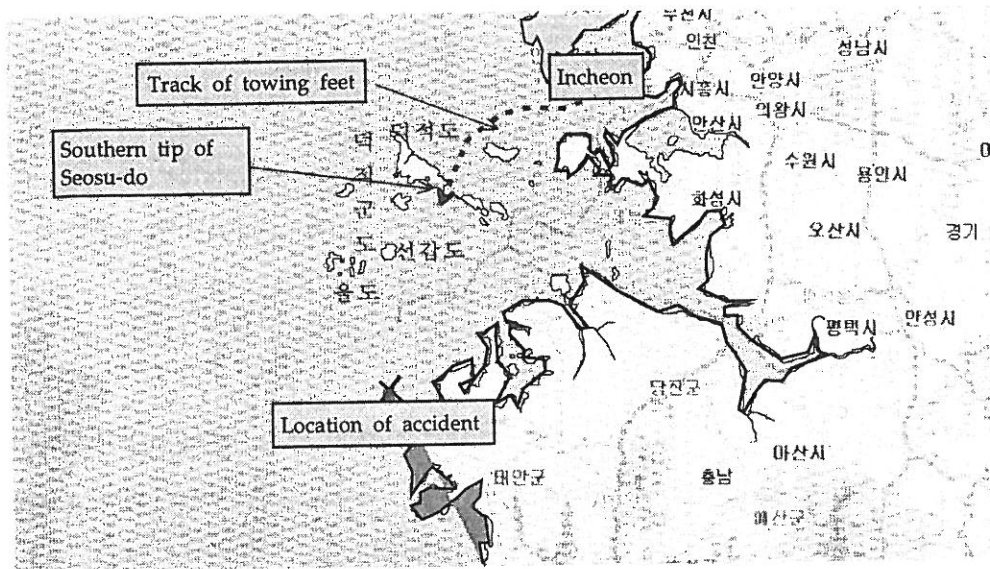
[Diagram 17] Track of towing fleet after departing from Incheon Port to the southern tip of Seosu-do

After departing from port, the Master reported to the VTS Center of Incheon Port that the ship had just sailed past Palmido Island at a speed of approximately 4 knots at around 16:00 under manual steering condition. Thereafter, it sailed South along Seosudo Island in the designated area of Incheon Port and passed the island at around 20:30. For coastal navigation, it extended the towing wires of Samsung T-5 and Samho T-3 to approximately 420 meters and 400 meters, respectively. From 16:40, it set the speed at approximately 4.2 knots and the intended course of 206° ([Diagram. 17]). At this time, the tugboats had their mast light, side light, stern light, towing light and others turned on, and Samsung No. 1 had its navigational light along with red, white, and red lights to show the fleet had restricted control ability, and other bright lights for deck work, turned on.
