Report on the investigation of  
the grounding of the general cargo vessel

***Kaami***

on Sgeir Graidach, the Little Minch, on

REPORT NO 7/2021

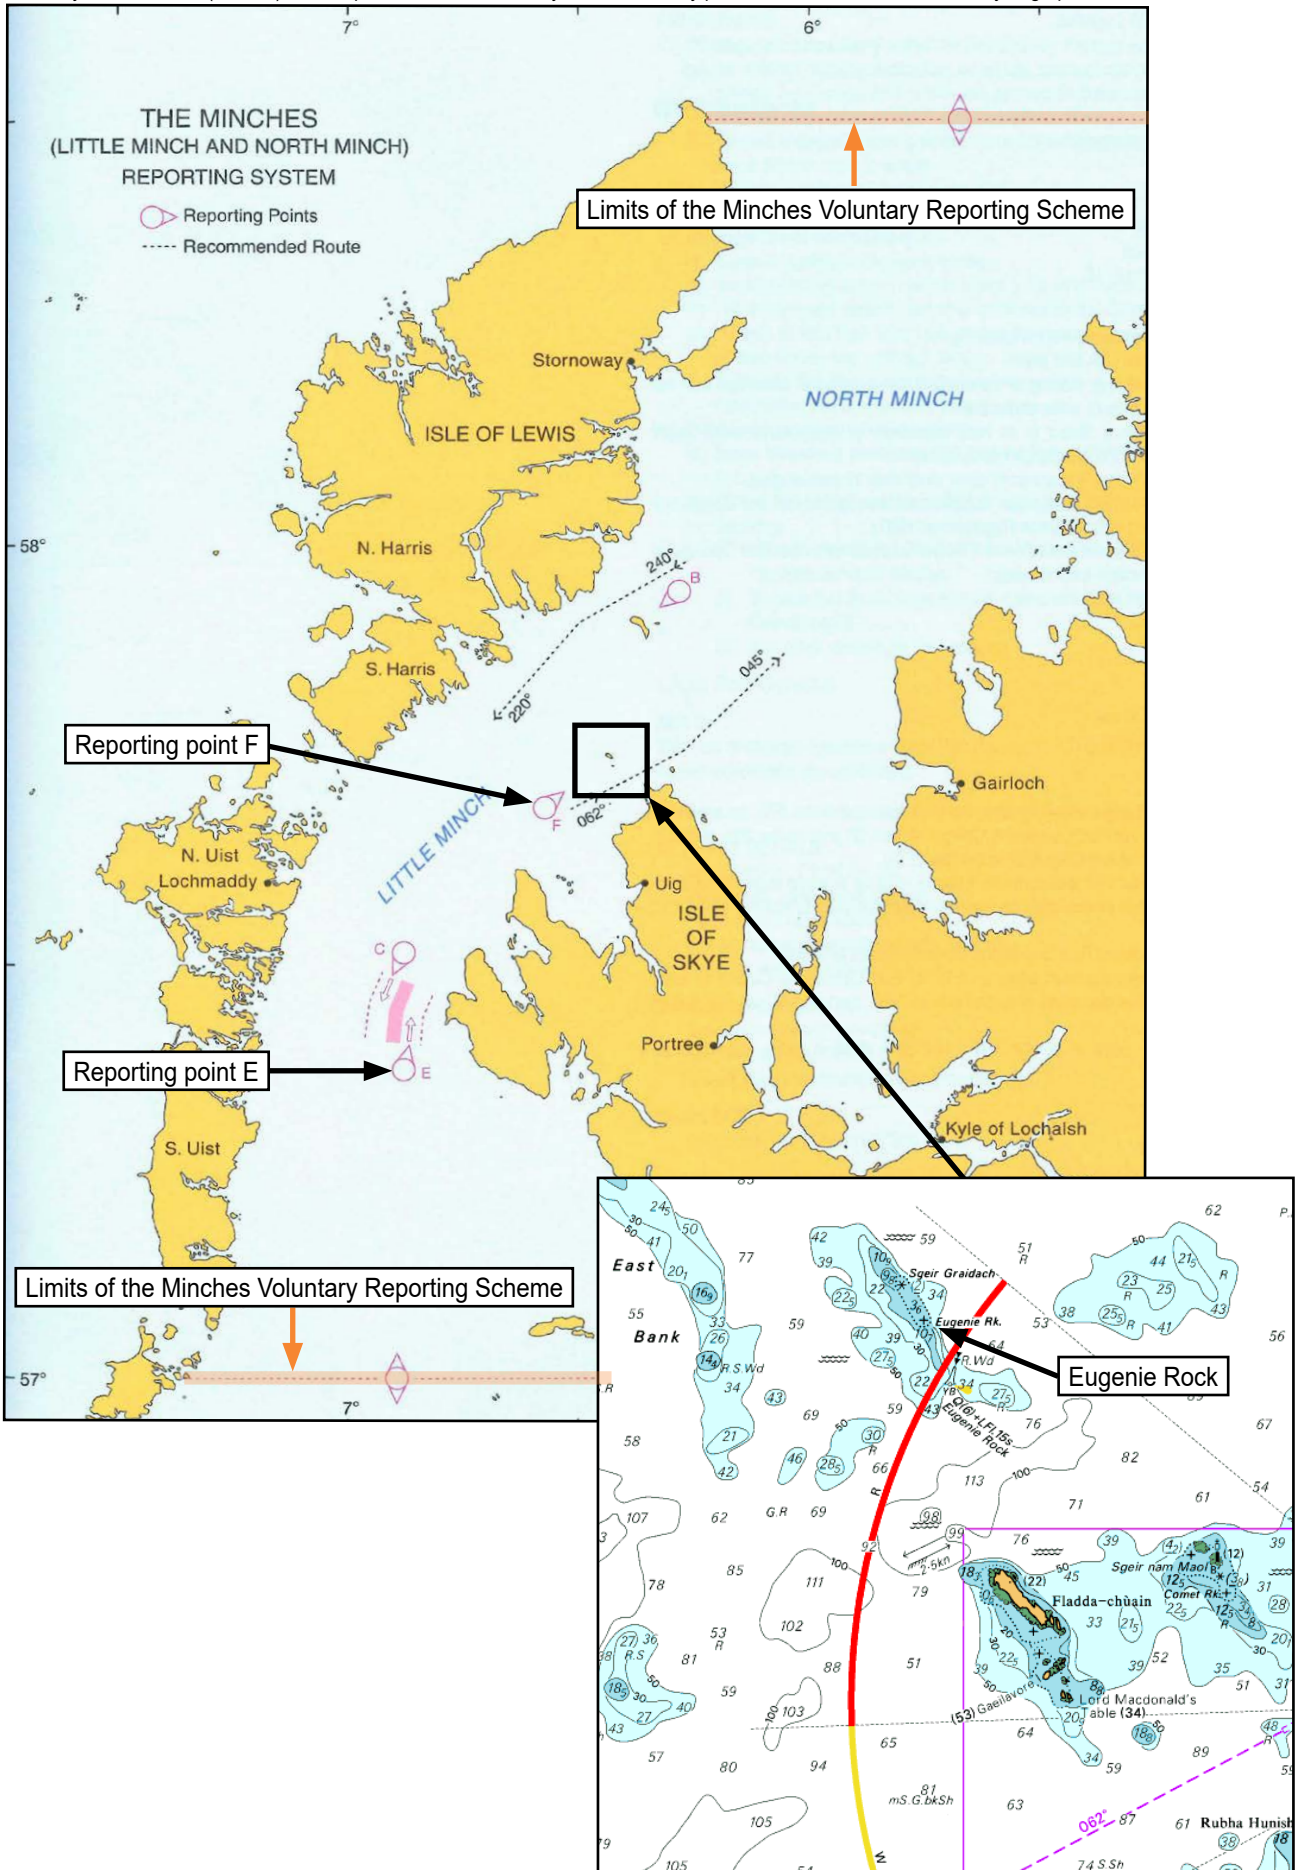
*Kaami's* voyage proceeded up the Irish Sea, through the North Channel and, at 2024 on 22 March, the vessel reported into Stornoway Coastguard Operations Centre (CGOC) on entering the Minches voluntary reporting system (**Figure 1**).

Figure 1: The Minches Voluntary Reporting Scheme

UK coastguard operations are managed by the National Maritime Operations Centre (NMOC) in Fareham, England, and a network of ten regional CGOC. Each of the CGOCs had responsibility for a zone of coastline and adjoining sea area. Zone flexing is a procedure that allowed responsibility for zones to be passed between CGOCs to ensure even workloads across the network. The geographic extent of Stornoway CGOC vessel traffic monitoring (VTM) area (Zone I) can be seen in **Figure 1**.

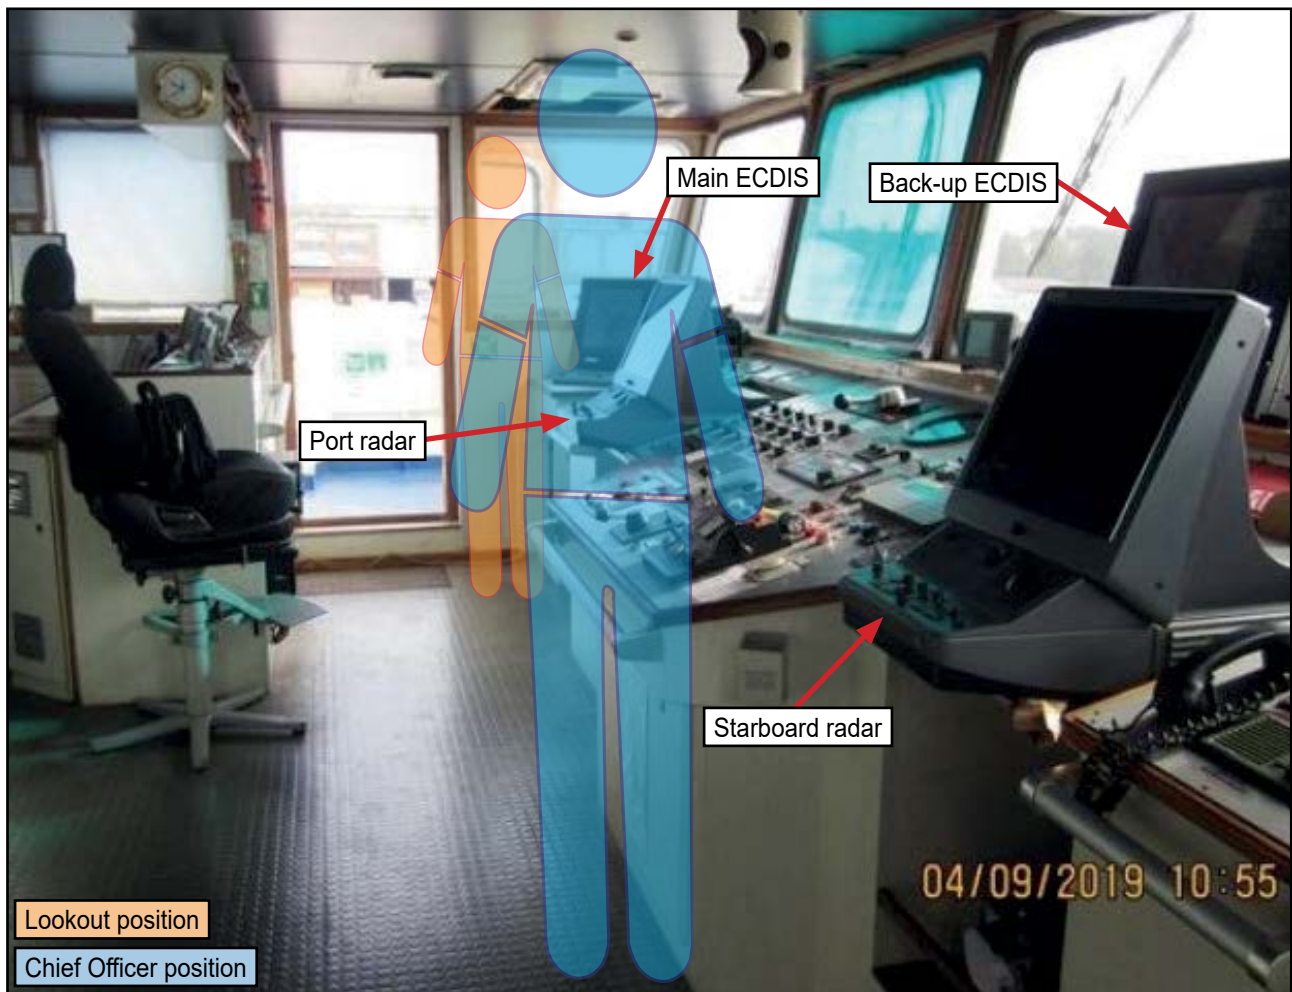
**Figure 2: Kaami's bridge**

The ECDIS system comprised of a main planning unit on the port bridge wing and a back-up unit on the centre line above the main control station (**Figure 2**). Both computers were connected via a local area network and each system was supported by an independent, uninterrupted power supply. It was possible for either terminal to be used independently from the other. For example, the navigating officer could use the centreline back-up ECDIS for passage monitoring at sea, while the main ECDIS on the port wing was used for voyage planning. The ship's gyro compass data, GPS, log, echo sounder, anemometer, and automatic identification system (AIS) were fed into the ECDIS.

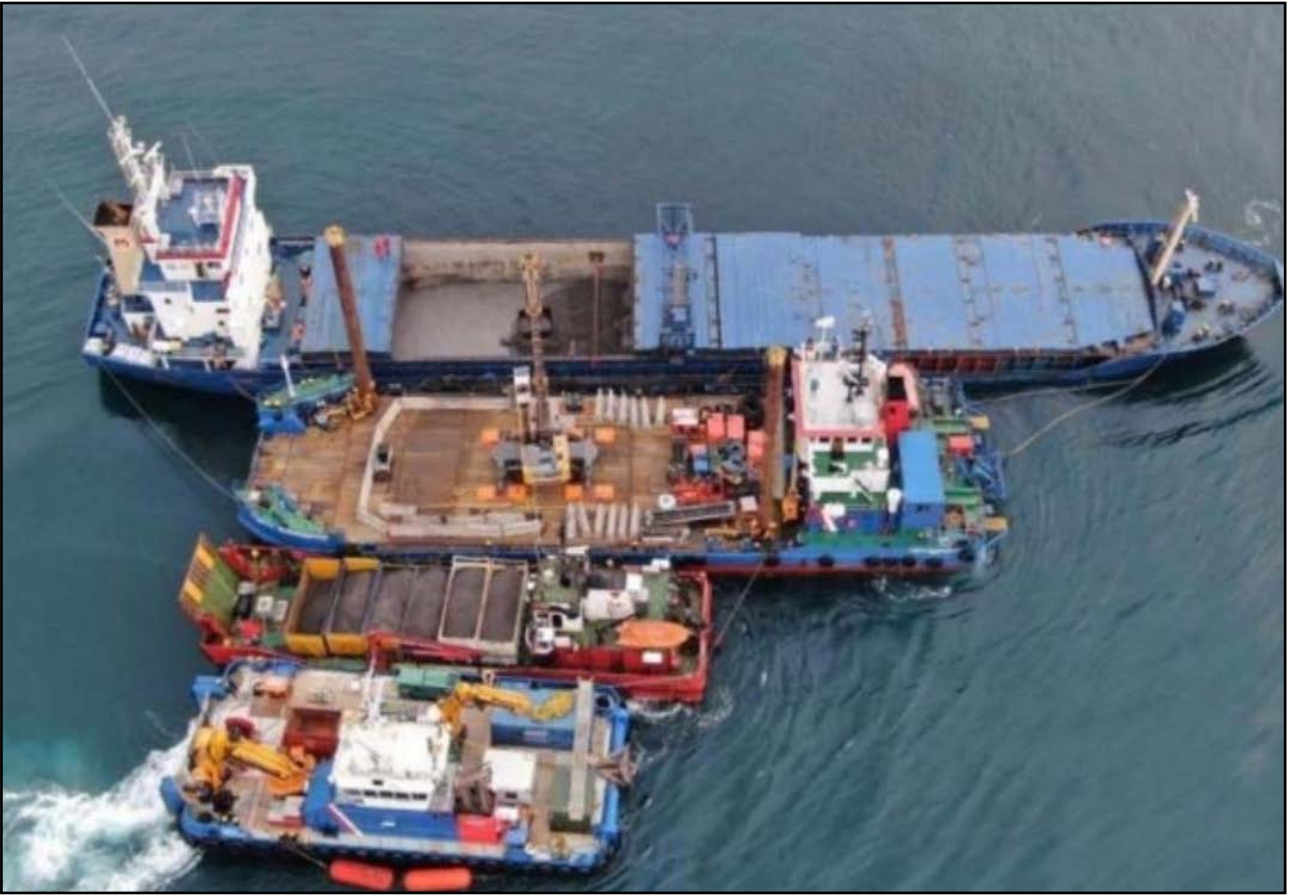
**Figure 6:** Salvage barges alongside *Kaami*

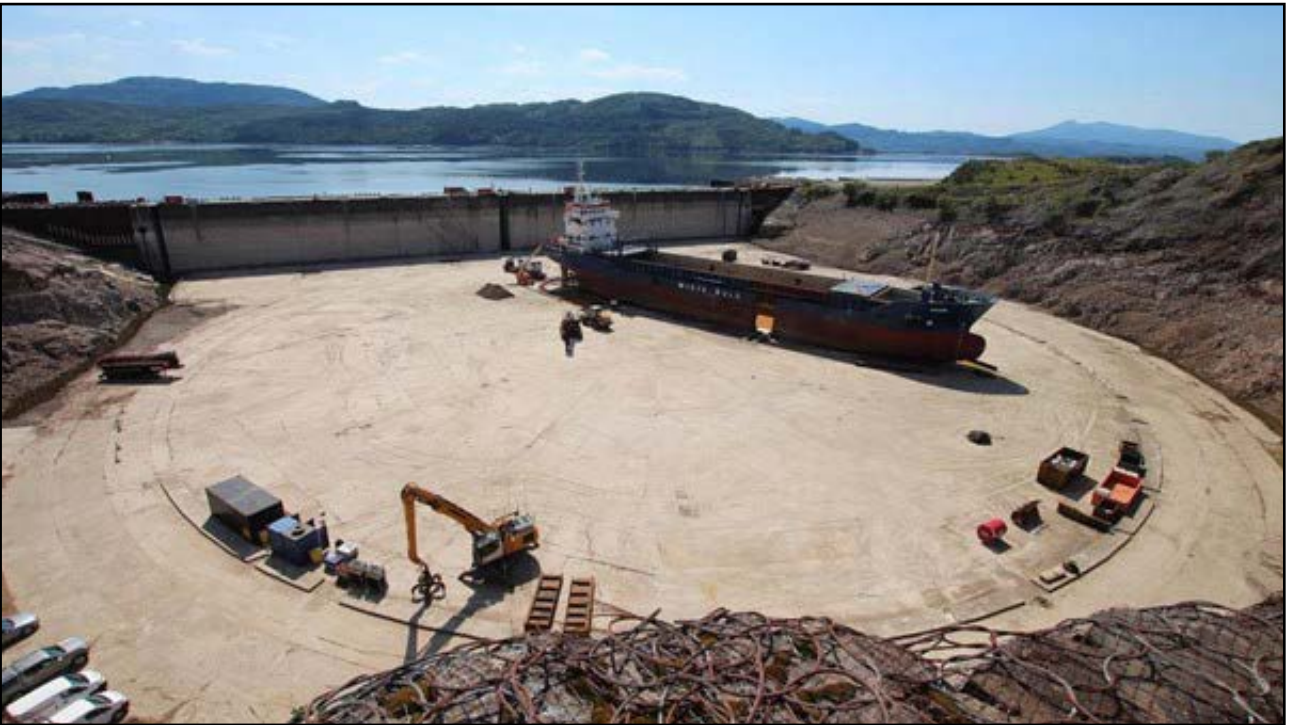
**Figure 7:** *Kaami* in the Kishorn facility

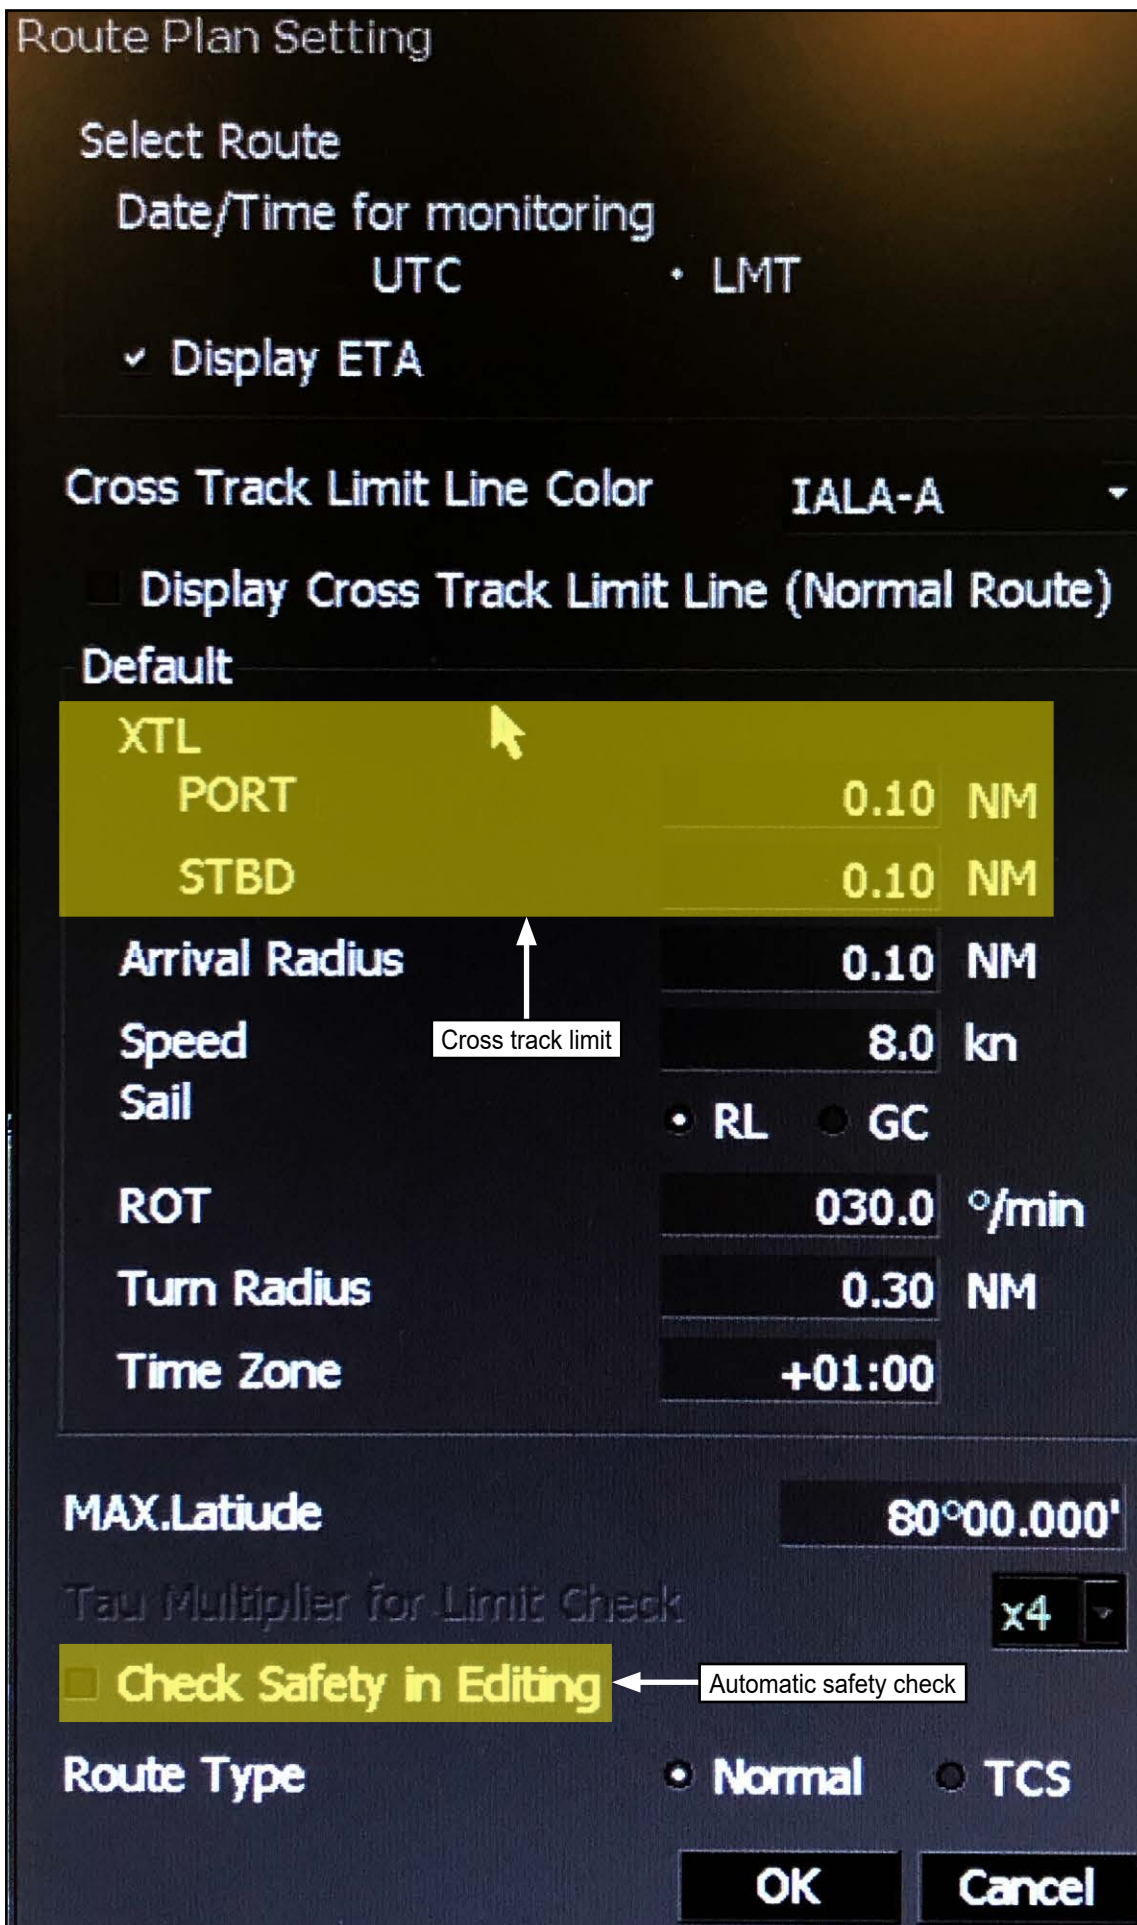
When planning a voyage on the JRC JAN 2000 the navigator had the option either to use the 'table editor' to enter the waypoints numerically using latitude and longitude or use the 'graphic editor' to drop waypoints directly on to the ENC using the click of a mouse. Parameters such as leg speed, cross track distance (XTD<sup>4</sup>) and turn radius could be adjusted in the voyage planning mode (**Figure 8**).

The safety check function for the JRC JAN 2000 ECDIS could either be automatically conducted during route editing, by selecting the option from the route planning setting menu, or at any point in the editing process within the table editor or graphic editor modes (**Figure 8**).

Figure 8: Voyage planning screen showing XTD and safety check

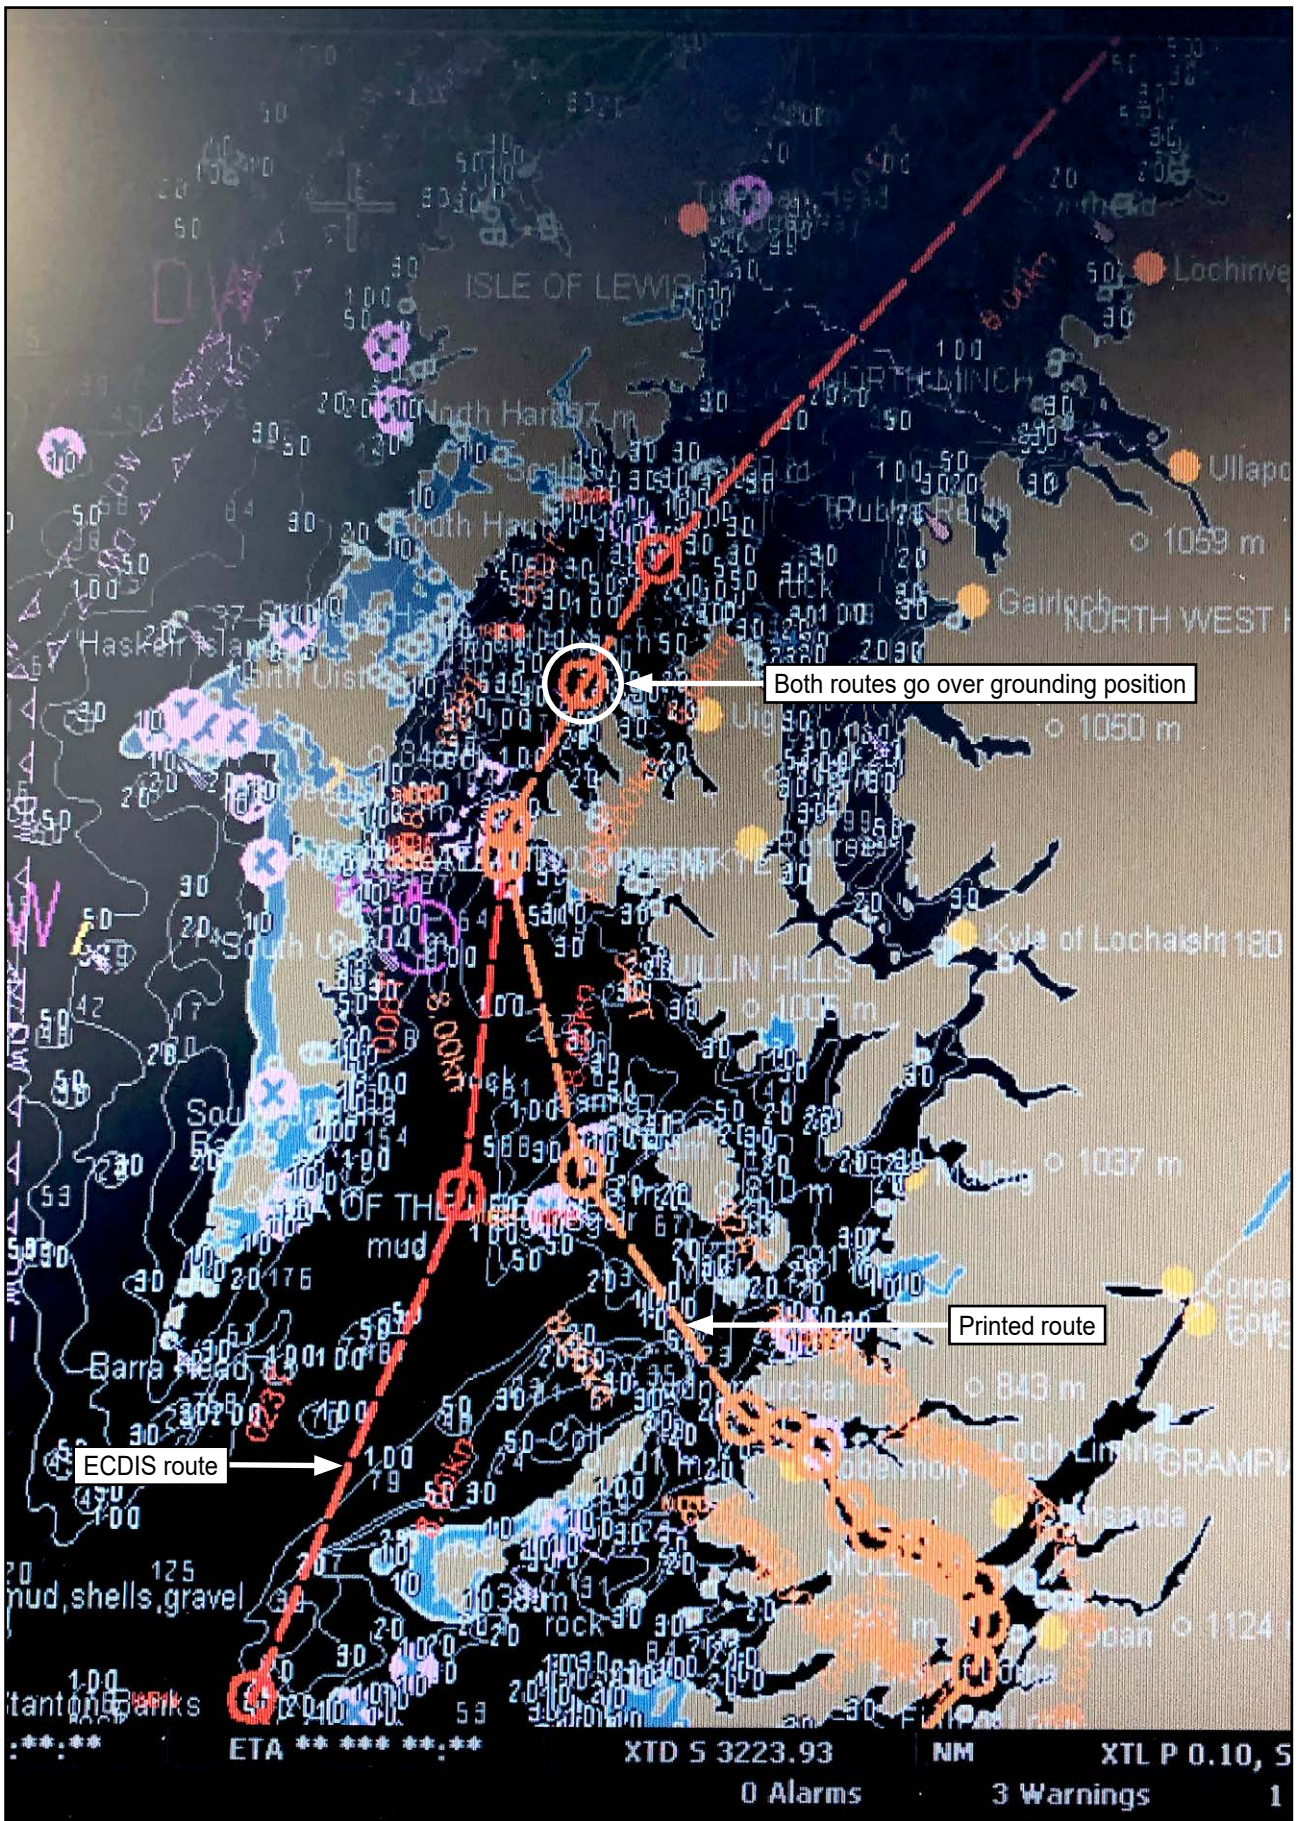
Figure 15: Different routes due to weather routing

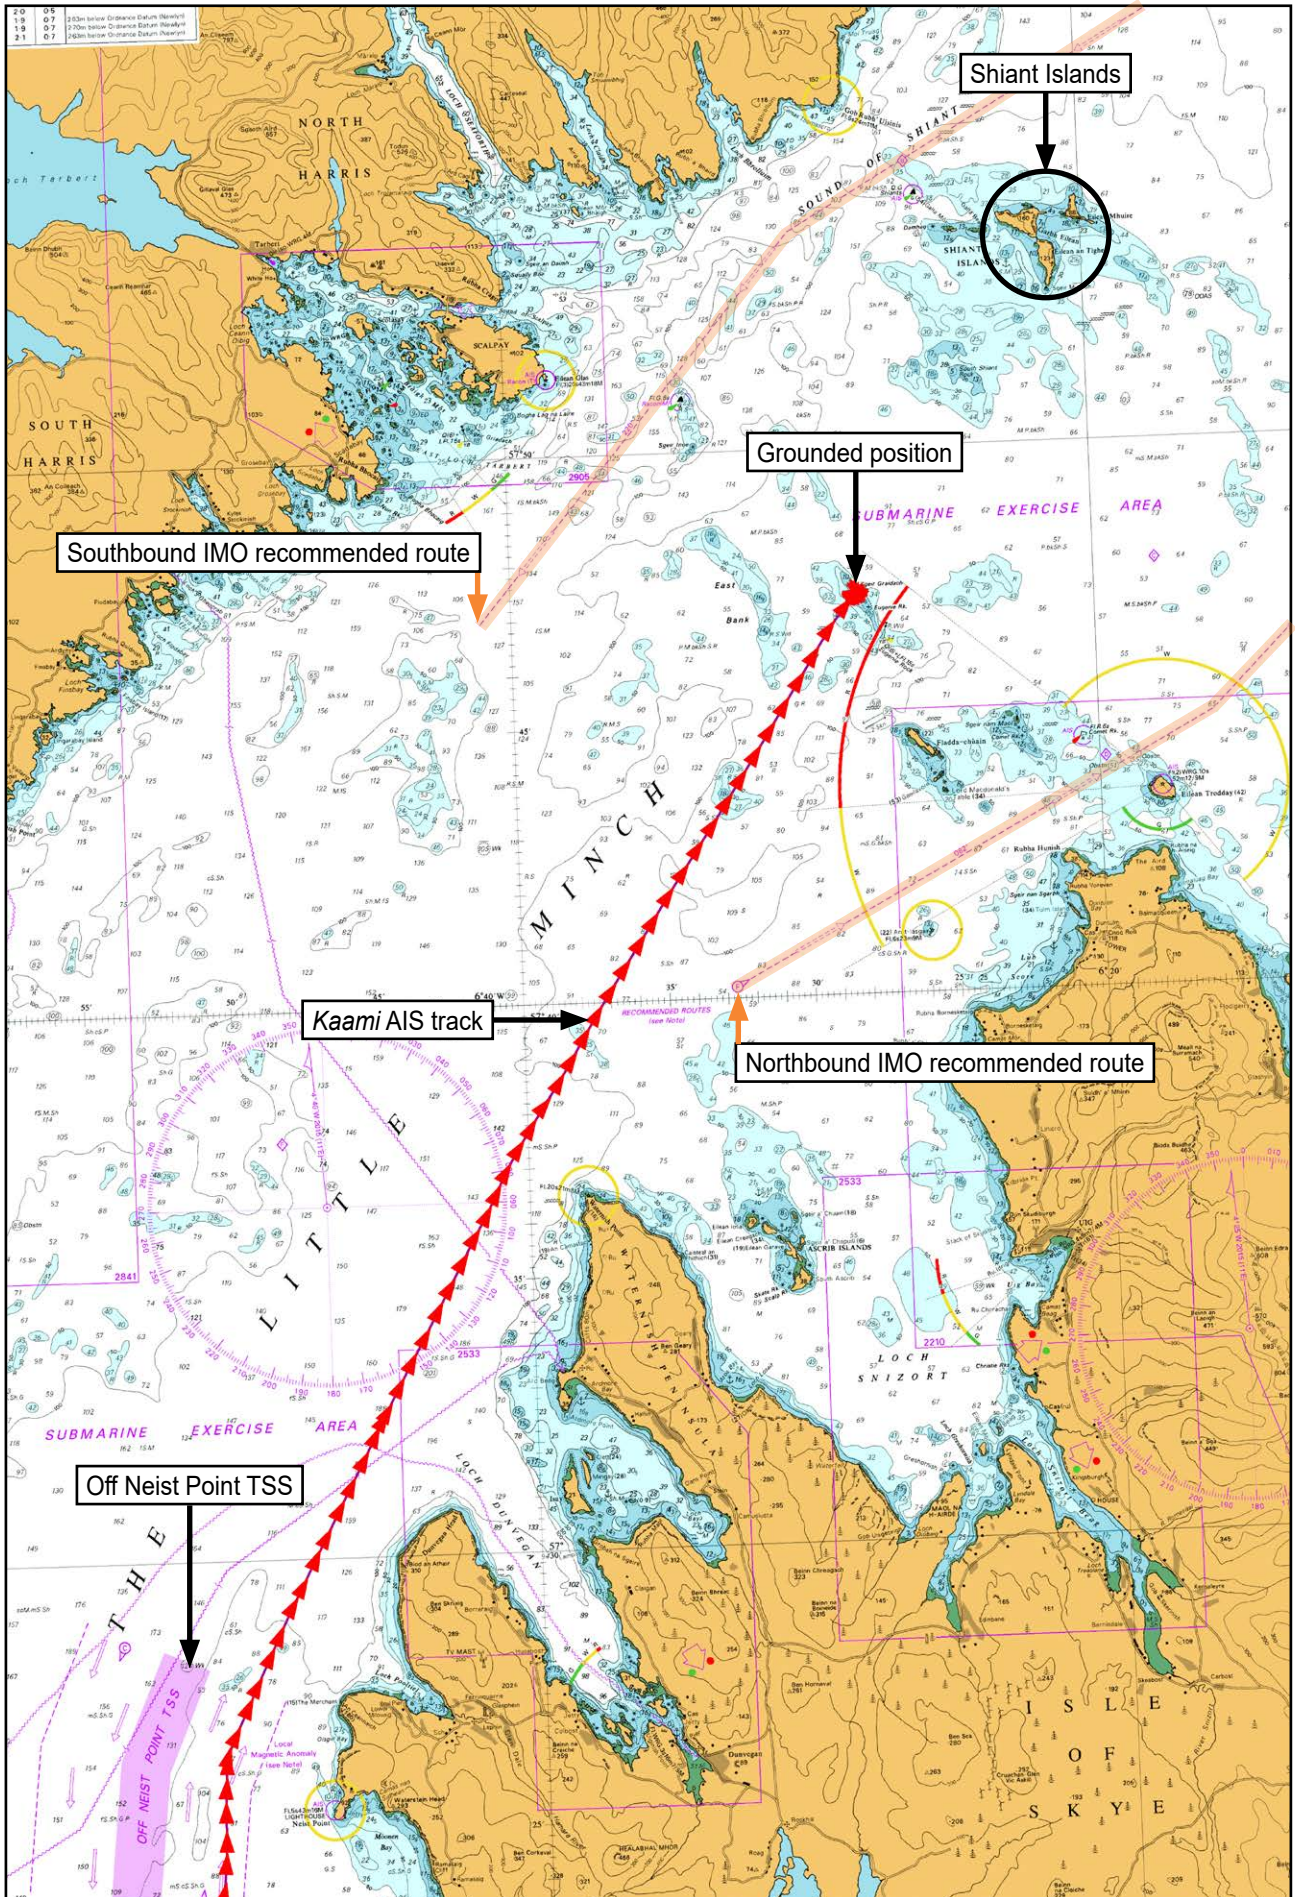
The Minches voluntary reporting scheme includes the Off Neist Point TSS (**Figure 17**) and the IMO recommended routes for south and northbound vessels. There is also a deep-water route for laden tankers >10,000gt to the west of the Hebrides avoiding the Little Minch. Details of the system are promulgated in the Admiralty List of Radio Signals Volume 6 (NP286(1)).

Figure 17: BA 1794 showing the Shiant Islands and Kaami's track
