Loss of containers overboard involving *APL England*

46 NM south-east of Sydney, New South Wales, on 24 May 2020

ATSB Transport Safety Report

351-MO-2020-002

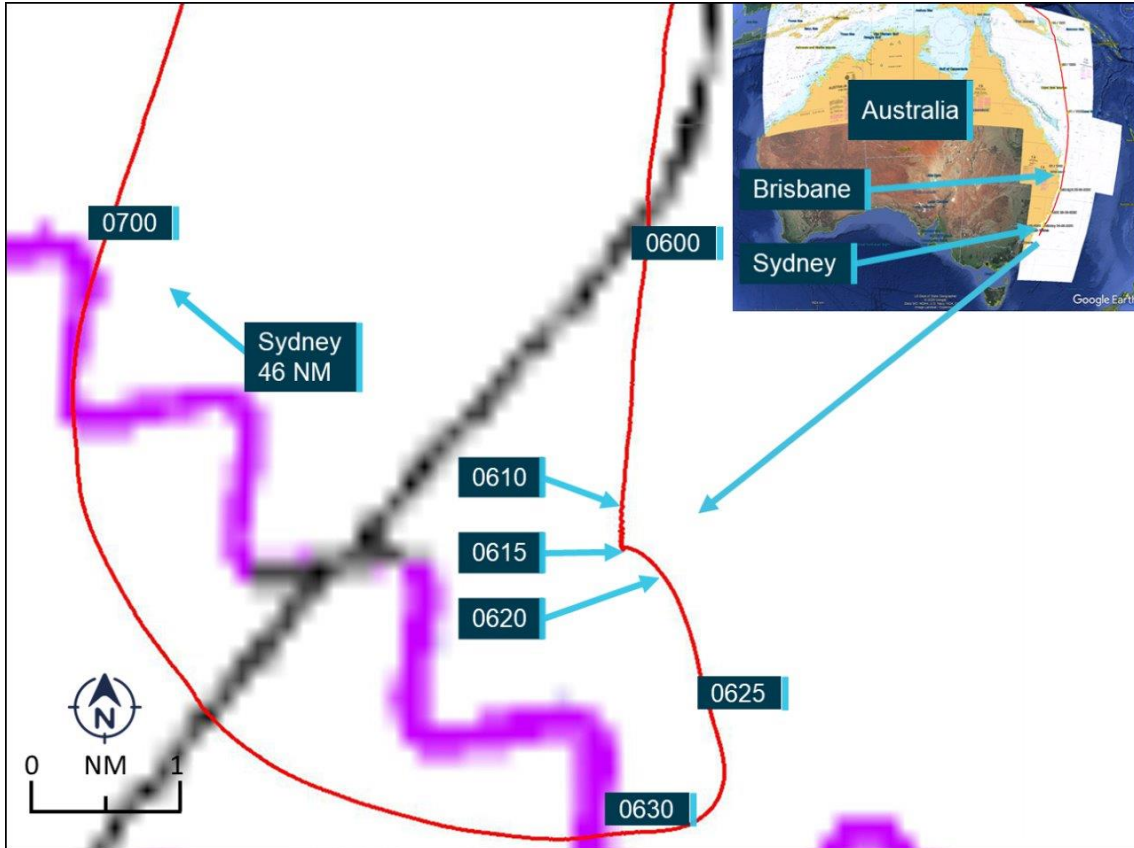
Figure 2: APL England track and incident location

Just after 0600, the ship was on hand steering and maintaining its southerly course at about 7 knots (Figure 2). Conditions remained unchanged with the ship pitching and periodically rolling more noticeably in high seas and gale force winds.

A steering system alarm sounded, followed by an engine room alarm at 0610:28 (main engine piston cooling oil low inlet pressure). The duty engineer was seated at the engine control console (near the alarm acknowledge push button) when the heavy roll and alarm occurred. The engineer had to hold on for security and answered the alarm 6 seconds after it sounded.

The ship continued to roll heavily. At 0610:53, 25 seconds after the initial alarm, the main engine shut down due to loss of engine lubricating oil pressure.
