# Collision involving the bulk carrier *Goliath* and tugs *York Cove* and *Campbell Cove*

Devonport, Tasmania on 28 January 2022

**ATSB Transport Safety Report**

MO-2022-002

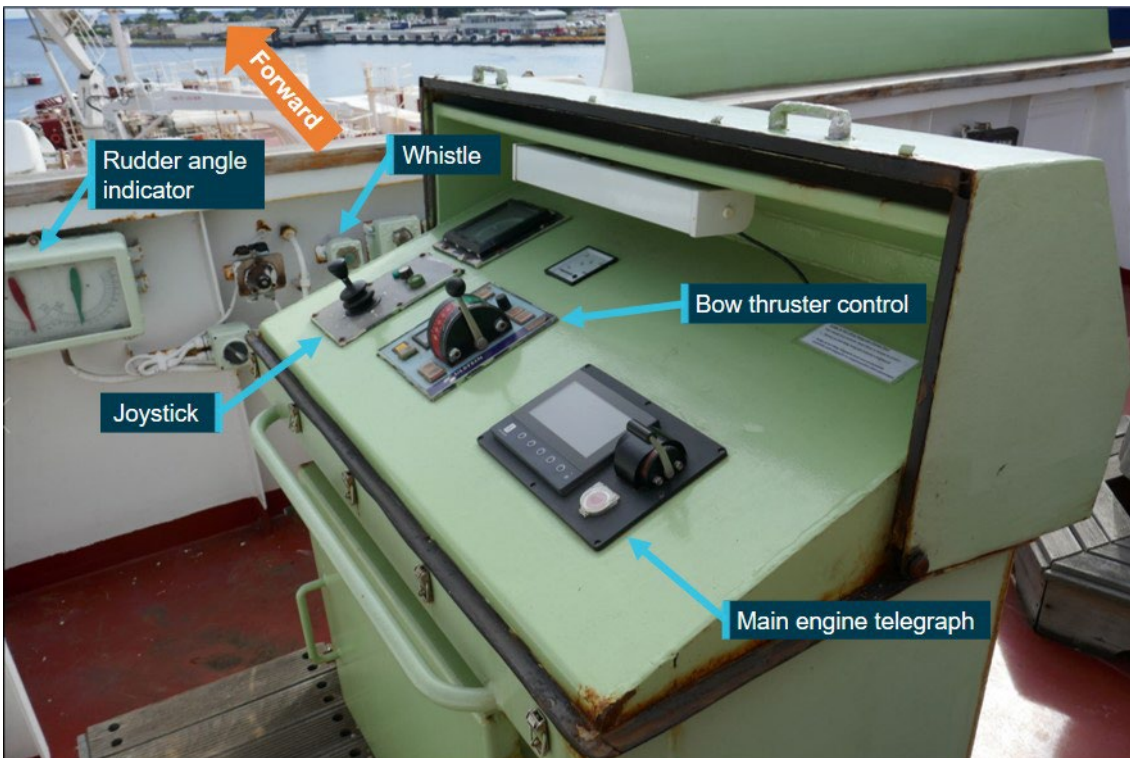
**Figure 5: *Goliath's* port bridge wing conning station (looking forward)**

Once the second mate confirmed that the wing console was ready, the master walked out and took the con at the port bridge wing conning station (Figure 5). The chief mate, who had walked to the bridge wing door and observed the second mate taking control of the propulsion and steering at the wing console, then left the bridge and went down to the mess room.

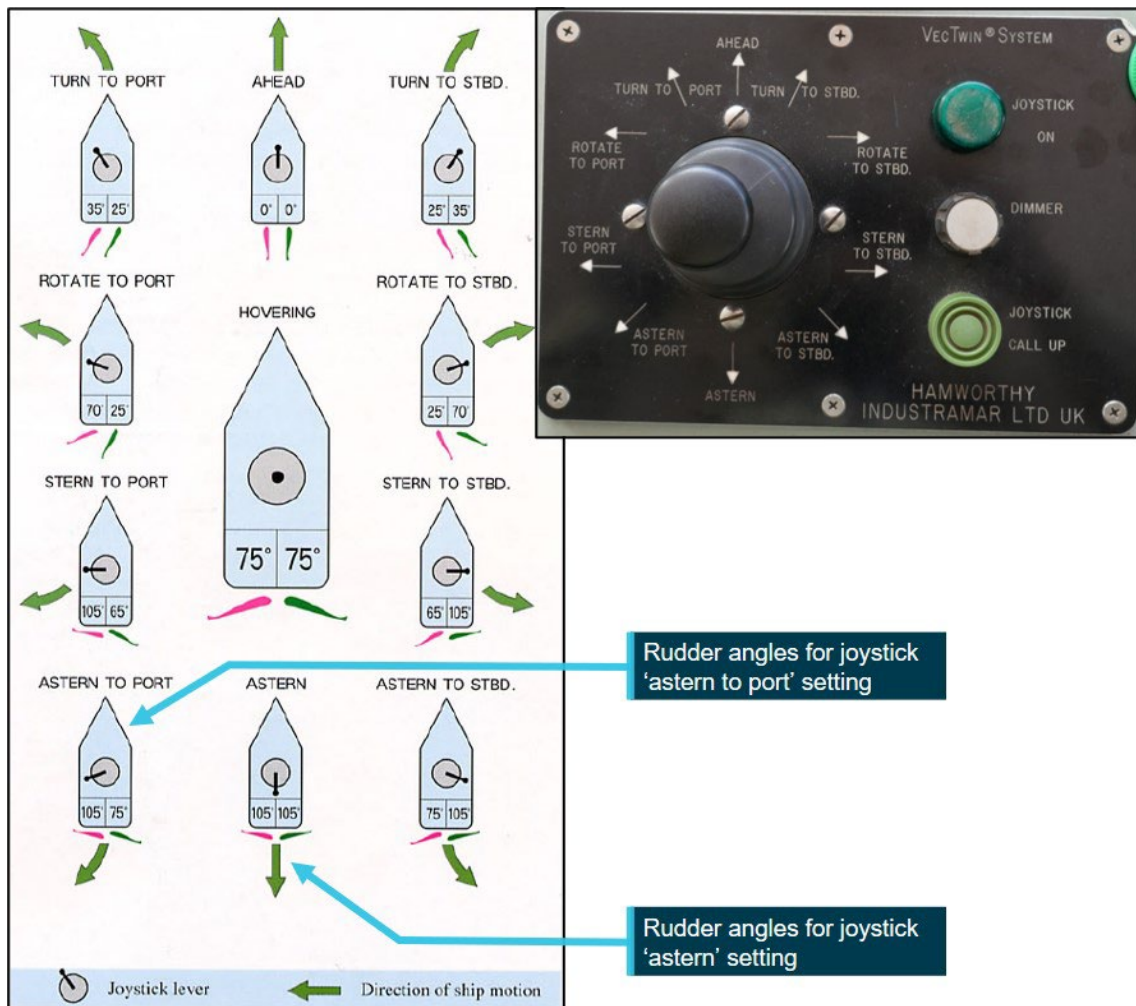
**Figure 12: VecTwin steering joystick showing settings and corresponding rudder angles**

In VecTwin (joystick) steering mode, a joystick was used to select various pre-set combinations of rudder angles which, with ahead inputs on the ship's main engine, allowed for the generation of thrust in different directions and for enhanced manoeuvrability, particularly at slow speeds. The system coordinated the 2 rudders independently with rudder angle settings ranging from 105° outboard to 25° inboard depending on the joystick setting selected (Figure 12). On board *Goliath*, VecTwin steering mode was generally only used at speeds under 2 knots, which generally limited its use to low-speed manoeuvring in port.

When using the VecTwin steering mode, ahead inputs on the main engine could be used to generate astern thrust, transverse thrust or even to 'hover', all with the propeller kept rotating in the ahead direction. For example, with the 'astern' joystick setting selected, each rudder was set to 105° outboard, with ahead inputs on the main engine generating astern thrust to slow/stop the ship or move the ship in the astern direction. This meant that the ship could be slowed, stopped, or moved astern without the need to stop the engine and engage astern propulsion, as usually required for conventional ship manoeuvring.

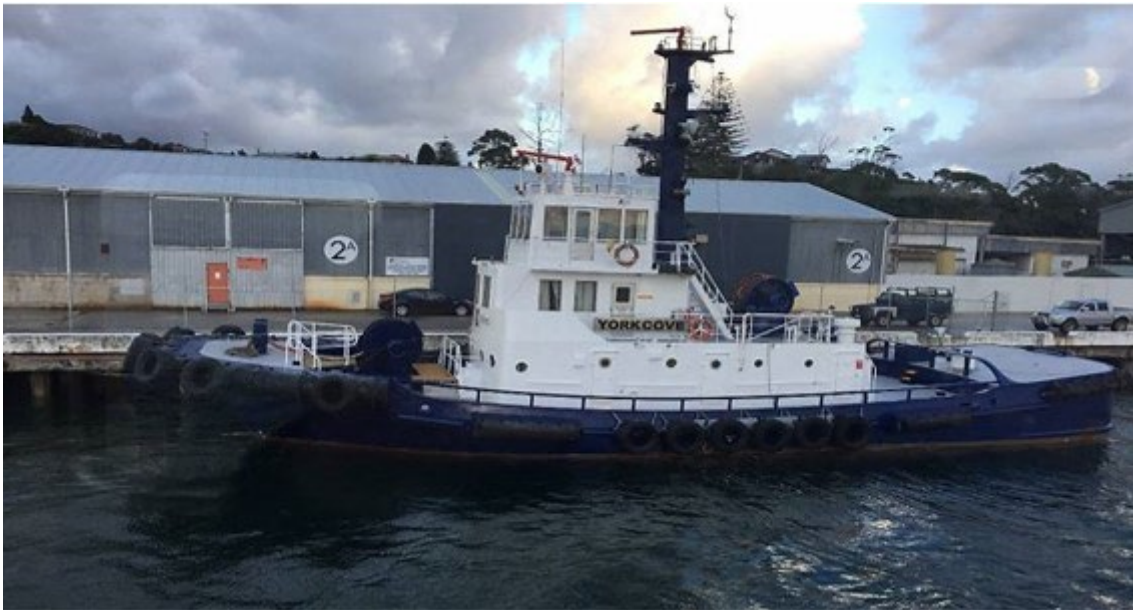
**Figure 14: *York Cove***

*York Cove* (Figure 14) was an Australian-registered tug built in 1990 by Ryochu Kairiku Unyu, Japan. The tug operated under other names in Japan and the Republic of Korea until it arrived in Australia in 1998 and was re-named *York Cove*.

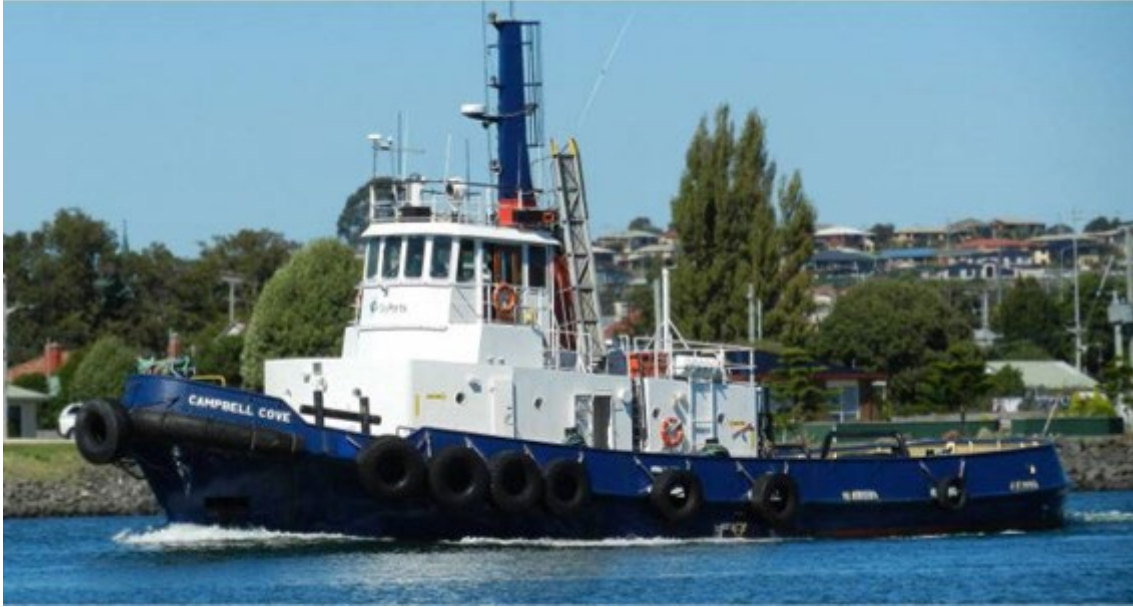
**Figure 15: Campbell Cove**

*Campbell Cove* (Figure 15) was an Australian-registered tug built in 1976 by Carrington Slipways in Newcastle, New South Wales. The tug initially operated at the port of Newcastle until about 1998 when it relocated to Devonport.
