MARINE SAFETY INVESTIGATION REPORT

Safety investigation into the collision between the
Maltese registered LNG carrier

ASEEM

SHINYO OCEAN

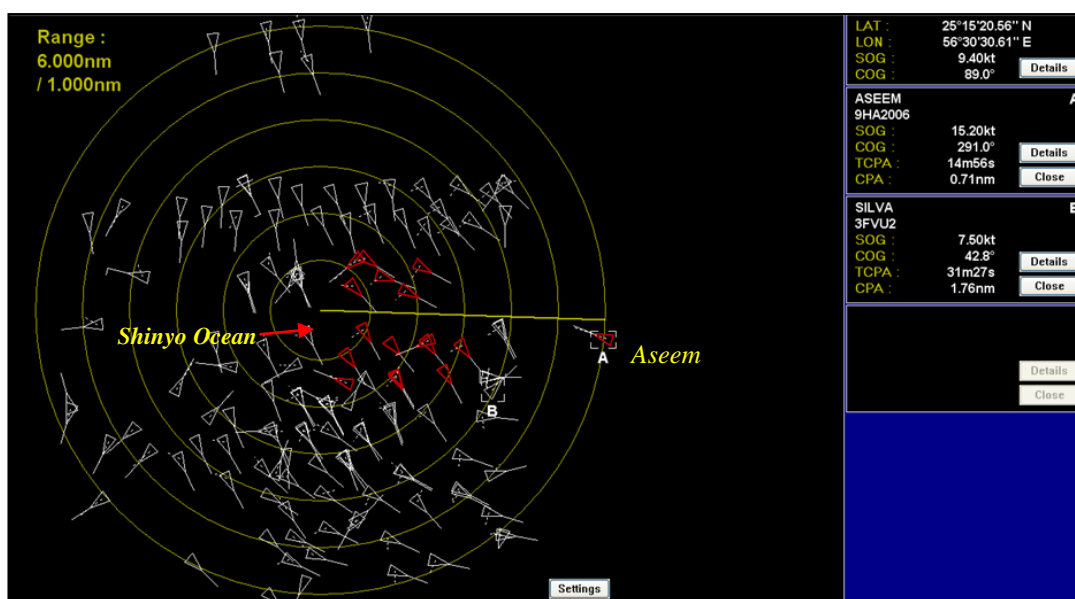
Figure 6: AIS showing the situation at 2336

Evidence suggested that, at 2336, while the vessel was proceeding through the passage channel, the master informed the officer of the watch that he planned to alter the vessel's course to port after passing the vessels which were on her port side (Figure 6).

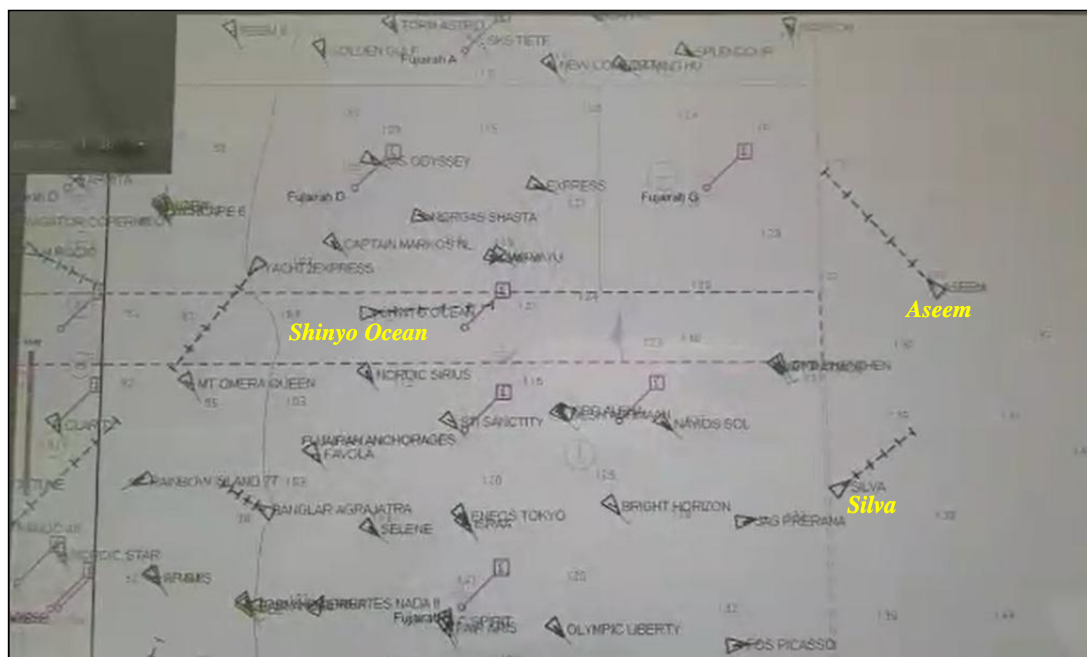
Figure 7: Extract adapted from an ECDIS playback, showing the situation at around 2342

The master then established contact with *Shinyo Ocean* over the VHF radio and informed *Shinyo Ocean* that *Aseem* would be taking a round turn to starboard in order to allow *Shinyo Ocean* to clear the channel, after which *Aseem* would enter the passage channel, with the intention to anchor within 'D' Anchorage. This message was acknowledged by the officer of the watch (OOW) aboard *Shinyo Ocean*, who also informed *Aseem* that *Shinyo Ocean*'s course would be altered to port and that she would be proceeding towards the Hormuz Strait (Figure 7). At 2343, *Aseem* commenced a round turn to starboard; while *Shinyo Ocean* started altering her course to port at 2345.

At 2346, the attention of the master of *Shinyo Ocean* was drawn towards another vessel, *Silva* (Figure 7), which had just departed from 'B' Anchorage. He inquired with his OOW about the vessel and the OOW acquired *Silva* on the radar.

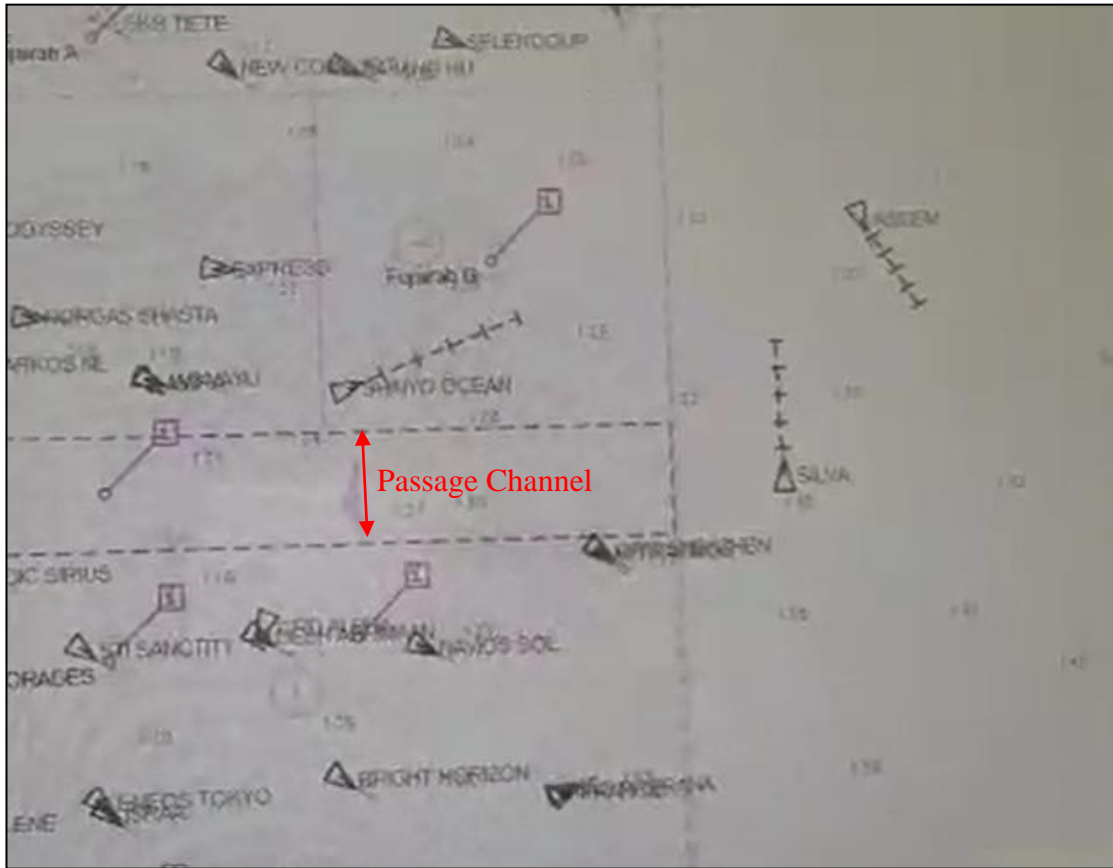
Figure 8: Extract adapted from the ECDIS playback, showing the situation at around 2350

By 2350, *Shinyo Ocean* was North of the passage channel limits and within 'G' Anchorage (Figure 8). Following the conversation between *Shinyo Ocean* and *Silva*, at 2351, the OOW of *Shinyo Ocean* suggested that the vessel's speed is reduced, as altering the vessel's course to starboard could result in a close-quarter situation with *Aseem*.

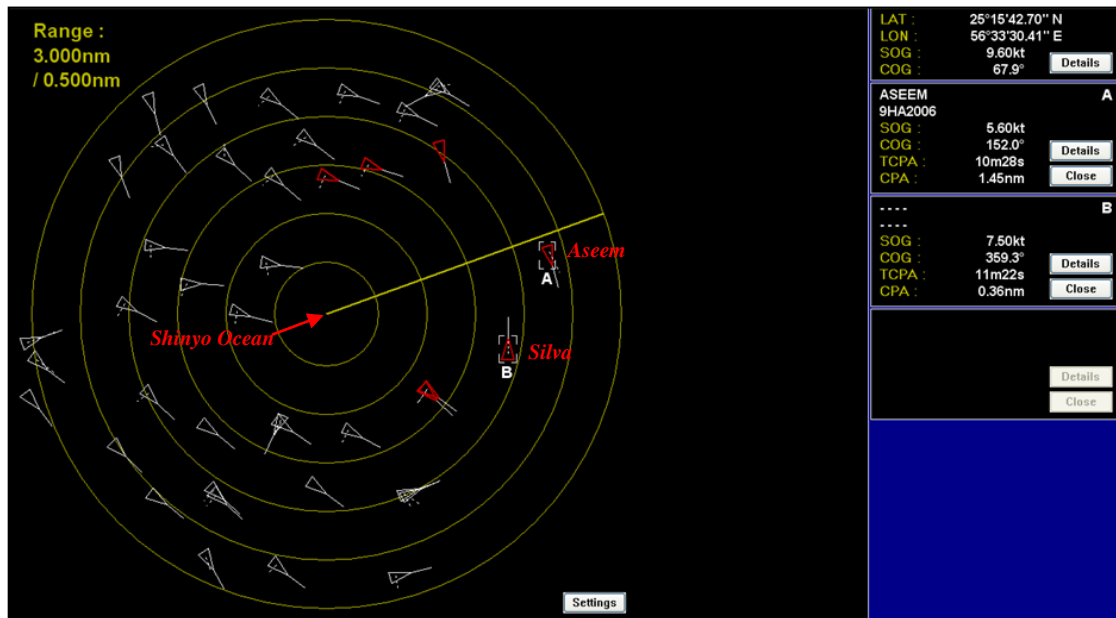
Figure 9: AIS showing the situation at 2352 (A: Aseem; B: Silva)

At around 2352, the master of *Shinyo Ocean* ordered the helm to 10° to starboard, followed by an order of 'hard to starboard'. At this time, *Shinyo Ocean* was on a heading of 070° with a speed of 9.6 knots, while her course was being altered to starboard. *Aseem*, bearing 074° at a distance of 2.36 nm from *Shinyo Ocean*, was on a heading of 164°, through her round turn to starboard, with a speed of 5.6 knots, and *Silva*, bearing 103° at a distance of 1.89 nm from *Shinyo Ocean*, was on a heading of 000° with a speed of 7.5 knots (Figure 9).

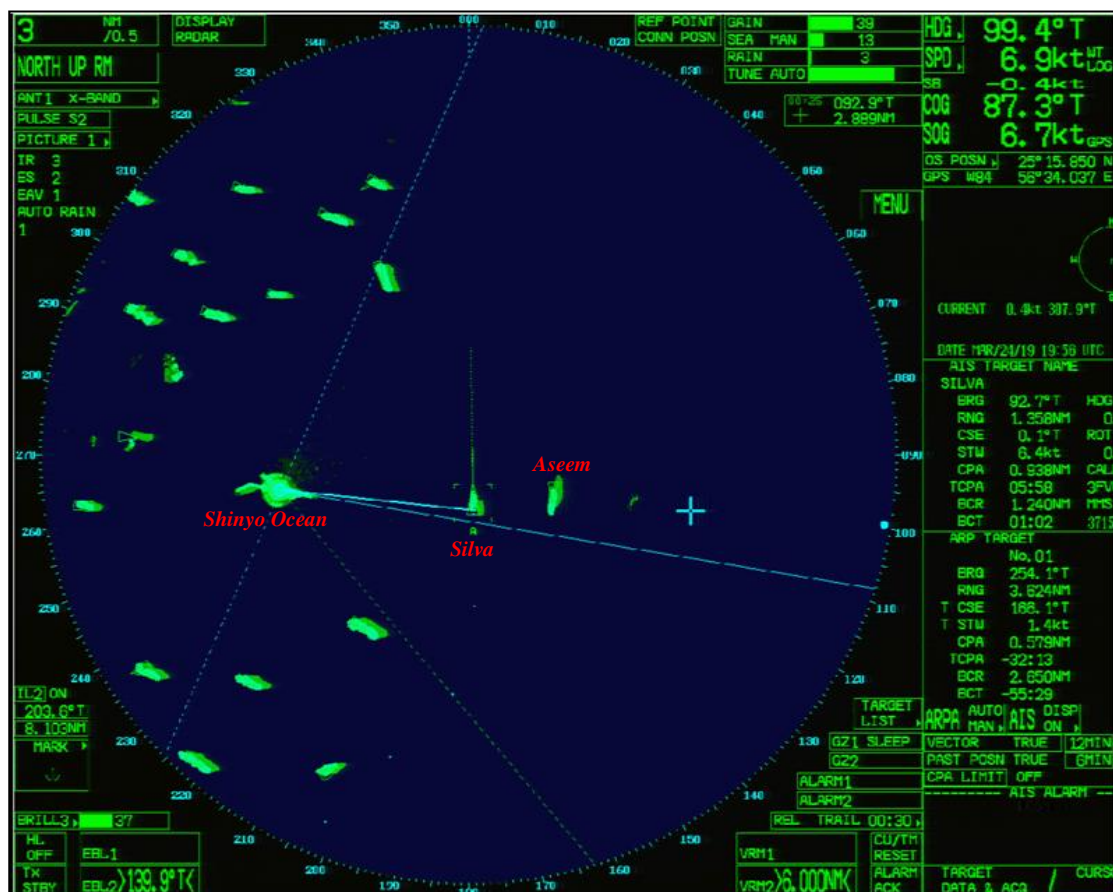
Figure 10: Radar showing the situation at 2356

At 2356, the master of *Shinyo Ocean* once again called *Aseem* over the VHF radio and informed the latter that he would continue swinging the vessel to starboard, and that *Aseem* could turn around and proceed towards the anchorage. He also informed *Aseem* that *Shinyo Ocean* would only proceed back North, once *Aseem* had altered and proceeded. The third officer of *Aseem* acknowledged this message; however, he informed the master of *Aseem* that *Shinyo Ocean* had stopped and had asked *Aseem* to proceed towards the channel. At this time, *Shinyo Ocean* as well as *Silva* were lying on the starboard beam of *Aseem* (Figures 10 and 11). The master of *Aseem* then ordered AB 1 to ease off on the starboard helm.

As *Shinyo Ocean* was proceeding through 'G' anchorage, she encountered *Silva* (which had just departed from 'B' anchorage) crossing her bow at a range of about 1.24 nm (Figure 10). At this time, *Shinyo Ocean* was observed to be within 'G' anchorage – at a distance of approximately 0.74 nm from the seaward boundary of the anchorage area, while *Silva* was approximately 0.5 nm clear of the seaward boundary of 'G' anchorage (Figure 11). *Shinyo Ocean*'s course was then widely altered to starboard and the vessel continued swinging to starboard, thus bringing her back towards the passage channel and on a collision course with *Aseem*. The situation had by now become complex and evolved in such a way which had not been anticipated neither by *Aseem* nor *Shinyo Ocean*.

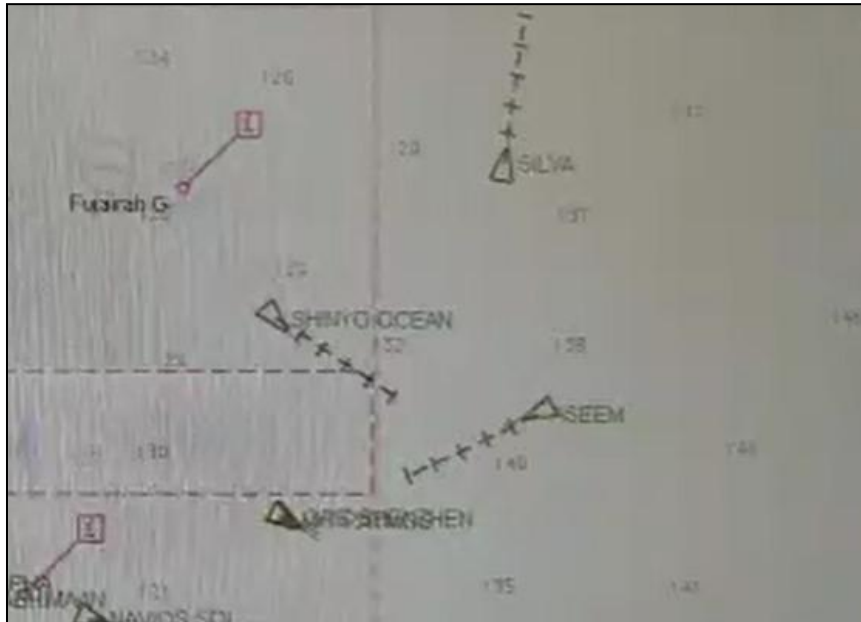
Figure 12: Extract of the ECDIS playback, showing the situation at around 0001

another vessel was at a distance of one nm right ahead of *Aseem*. He once again asked *Shinyo Ocean* on her intentions, to which the OOW of *Shinyo Ocean* responded that the course and speed of his vessel would be maintained. The CPA with *Shinyo Ocean*, at this time, was 0.35 nm. The vessel at anchor was at a distance of 0.7 nm, right ahead of *Aseem* (Figure 12).

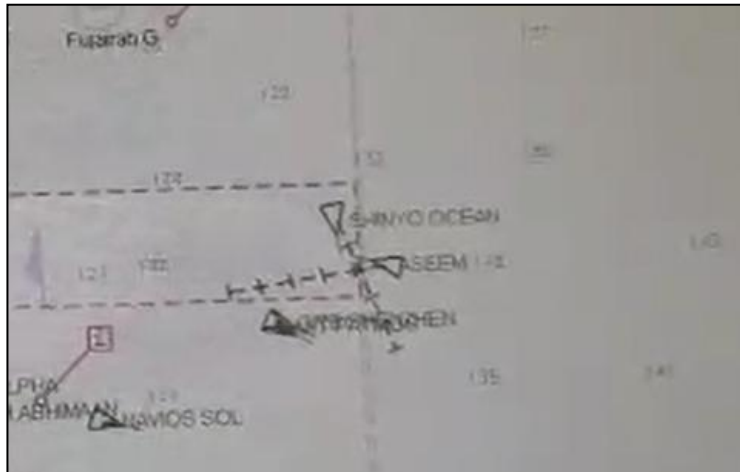
Figure 13: Extract of the ECDIS playback, showing the situation at around 0005
 (Source of the ECDIS playback: Federal Transport Authority – Land and Maritime, U.A.E.)

A couple of minutes later, the OOW of *Shinyo Ocean* once again called *Aseem* over the VHF radio and requested for *Aseem*'s wheel to be put hard over to starboard. The master of *Aseem* ordered the wheel hard over to starboard. The anchored vessel was now 0.3 nm ahead of *Aseem*. At 0004, the master of *Aseem* called *Shinyo Ocean* and confirmed that the wheel was hard over to starboard. He then asked for *Shinyo Ocean*'s wheel to be put hard over to port. At around 0005 (Figure 13), the master of *Shinyo Ocean* ordered the wheel of his vessel to be put hard over to port, while the master of *Aseem* ordered the wheel of his own vessel to be brought amidships.

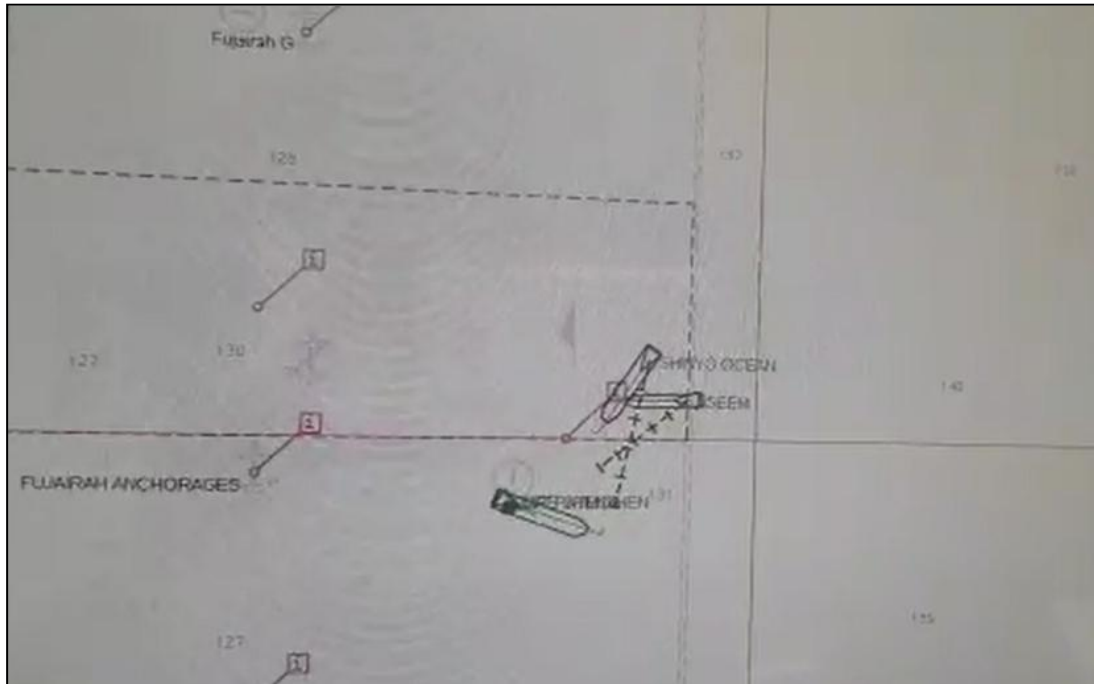
Figure 15: Extract of the ECDIS playback, showing the collision

At around 0006, *Aseem* and *Shinyo Ocean* collided in (approx.) position 25° 15.0' N 056° 34.9' E, just within the passage channel of the Fujairah Offshore Anchorage Area (Figures 14 and 15). At that time, the heading of *Aseem* was 295° and her speed was 8.3 knots, while the heading of *Shinyo Ocean* was 173° and her speed was 7.3 knots. Contact was made head on, by *Aseem*, into the port bow of *Shinyo Ocean*, about 20 metres aft of her anchor windlass.
