MISLE Incident Investigation Report For

SLNC GOODWILL / Loss of Life

On 05Aug2020 00:42:00 EDT

Diesel Generator Failure Investigation

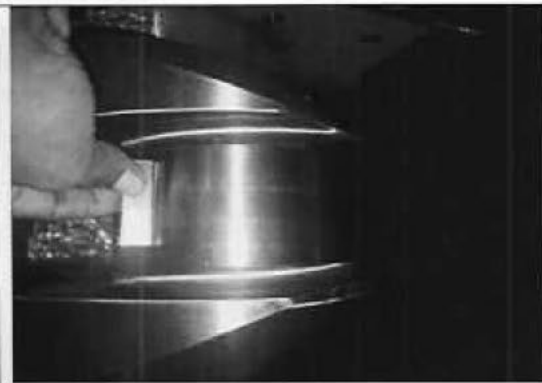
Cp wear ridge being checked with blue paste

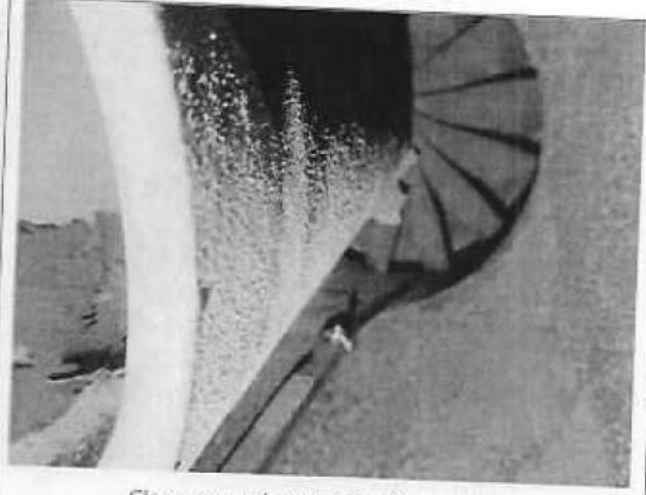
Clearance taken during dismantling

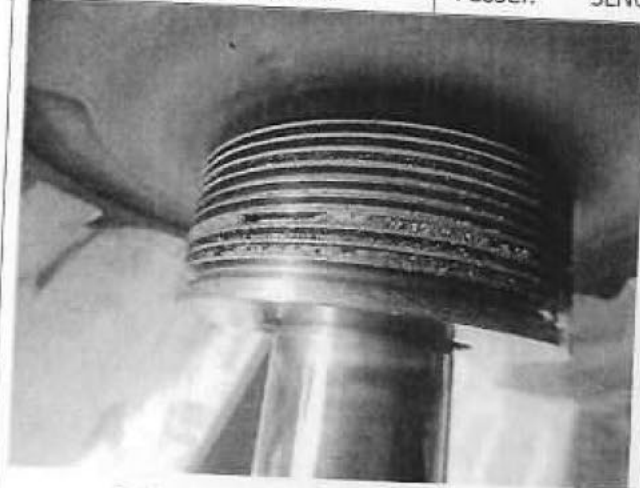
Guide bush OD satisfactory – to reused

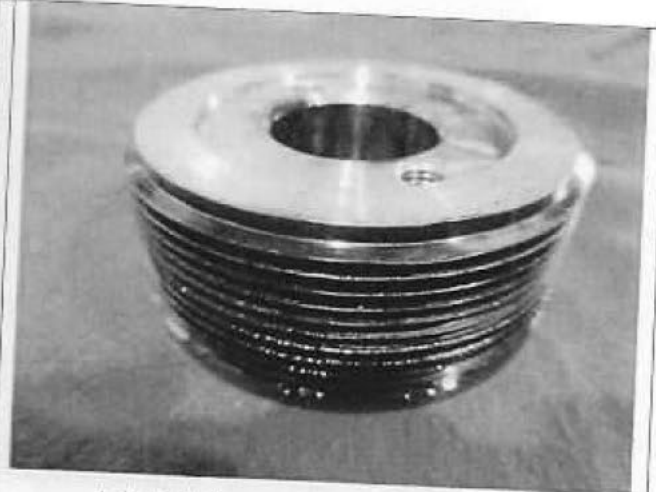
Labyrinth ring OD satisfactory – to reused

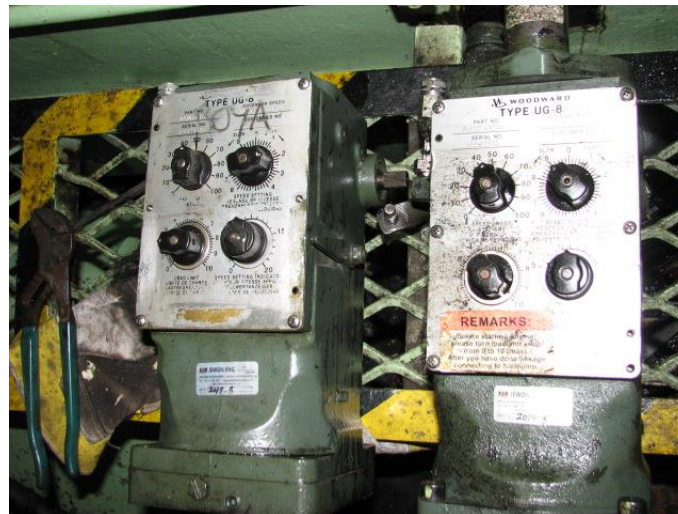
Figure 6. Governor C (right) was installed at the time of the casualty. Governor B (left) had been removed the day prior.

4.2.13. The data plate affixed to Governor C listed the same serial number and part number as the data plate affixed to Governor B. Despite this, the operating company believed the original serial number for Governor C was 16178255.
