# Collision between container ship *Maersk Shekou* and tall ship *STS Leeuwin II*

Fremantle, Western Australia, on 30 August 2024

## ATSB Transport Safety Report

MO-2024-001

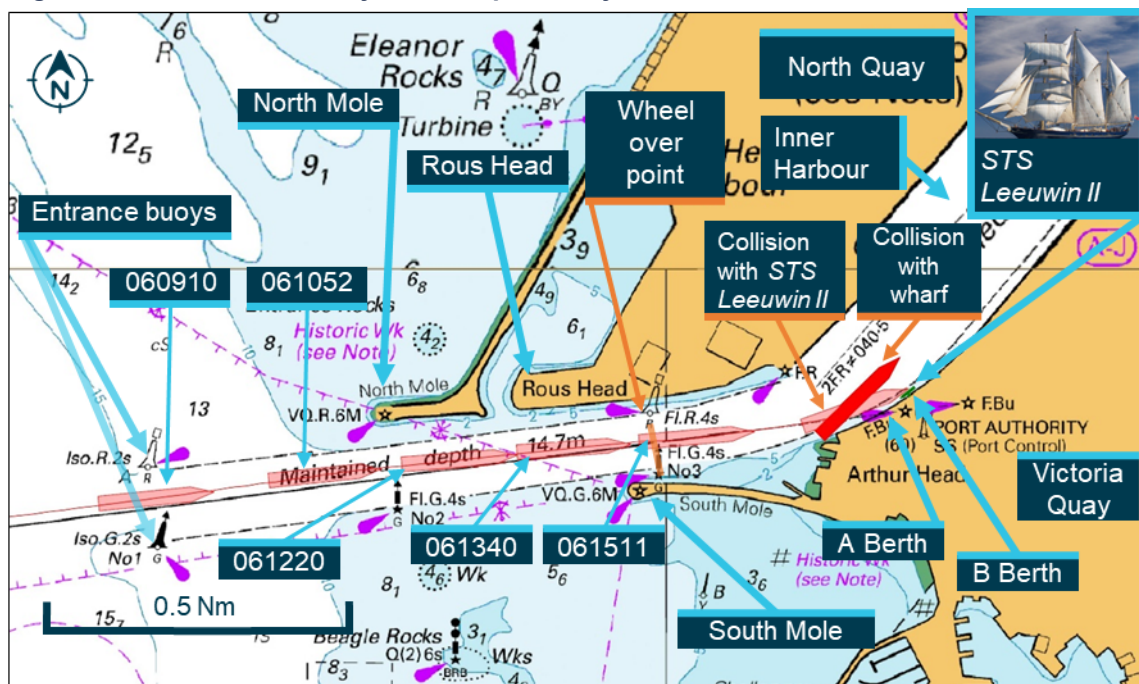
**Figure 2: *Maersk Shekou* key times of port entry**

At 0609, as the ship passed the IHEC entrance buoys, A and No 1, the *Svitzer Eagle* tug was made fast on the starboard quarter (Figure 2). Between helm and engine orders, the pilots continued to engage in various marine and social discussions. About a minute later, the *Svitzer Emma* tug was secured at the *Maersk Shekou's* port shoulder. At this stage, the ship's speed had reduced to 9.3 knots.

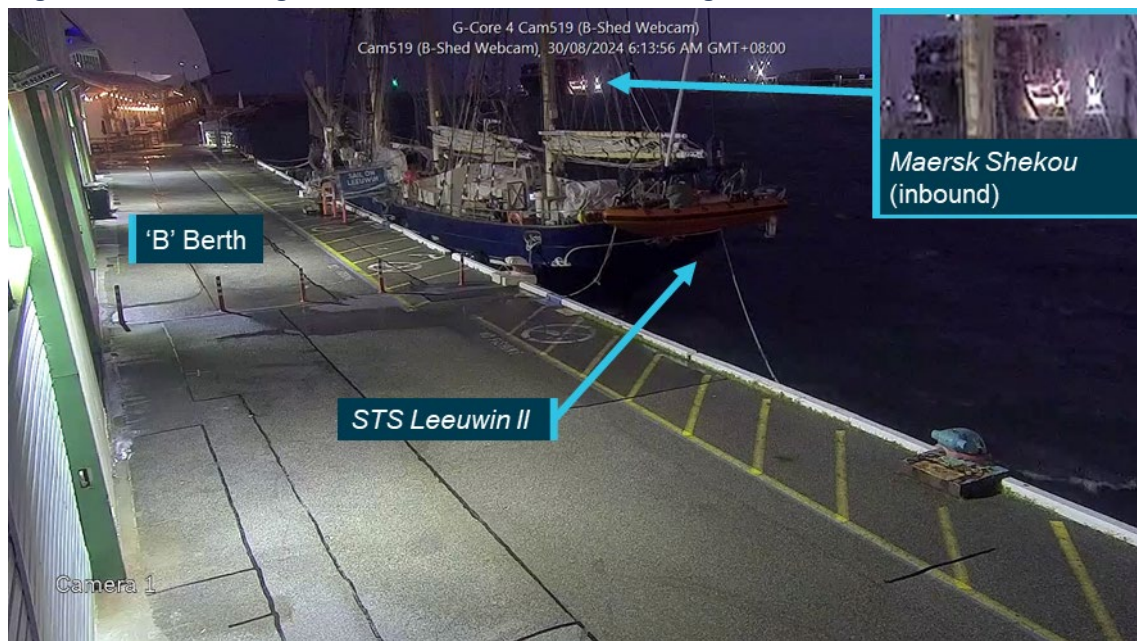
**Figure 3: CCTV footage of *STS Leeuwin II* at its mooring with *Maersk Shekou* inbound**

At 0615:47, the *Maersk Shekou*'s engine achieved its full ahead potential of 76 RPM, and the helmsman maintained the rudder in the midship position. The ship was proceeding at 7.2 knots on a steady 083.5° heading, into the path of *STS Leeuwin II*, which was less than a ship's length away, and moored port side alongside B berth at Victoria Quay (Figure 3).

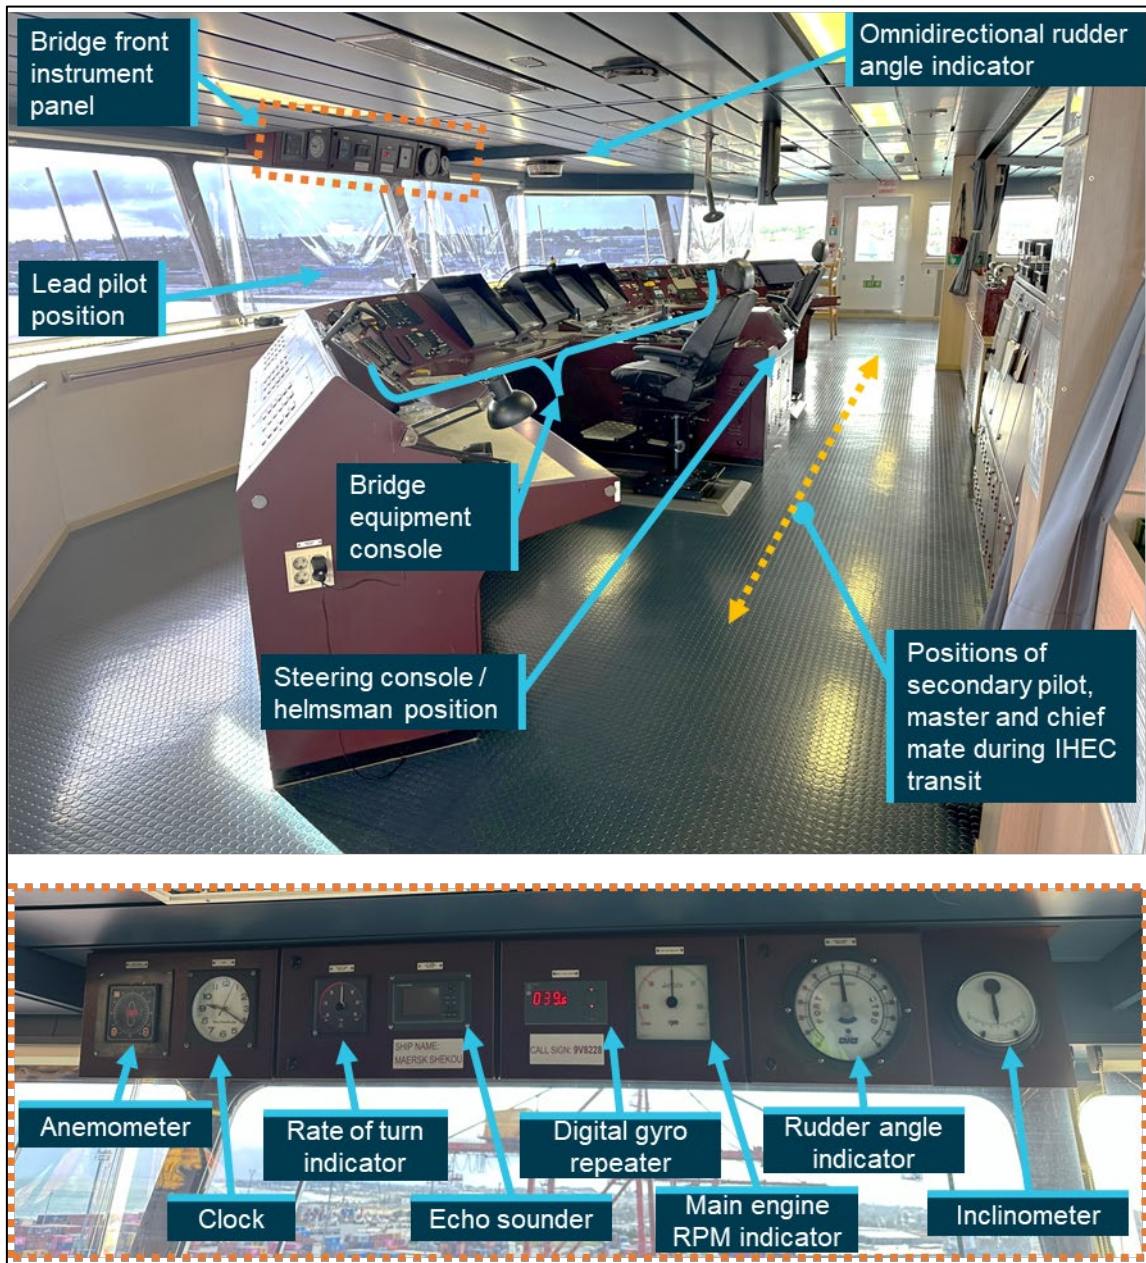
Figure 7: View of *Maersk Shekou's* wheelhouse and bridge front indicator panel (inset)

An omni-directional indicator was also fitted on the wheelhouse deckhead above the manoeuvring console. Based on their reported positioning inside the wheelhouse during the accident transit, the bridge front instrument display panel would have been visible to both pilots and the ship's bridge team members (Figure 7).

There were no equipment defects reported prior to the ship's arrival in Fremantle on 30 August 2024. On the day of the accident, the second mate recorded that the steering gear was tested at 0300 as part of the pre-arrival checks. On review of the VDR data, there was no evidence of the steering gear being operated at that time. Notwithstanding, no operational deficiencies were identified with the ship's bridge equipment or steering gear in relation to the accident.
