MARINE ACCIDENT INVESTIGATION BRANCH

Bridge Watchkeeping Safety Study

Safety Study 1/2004
July 2004

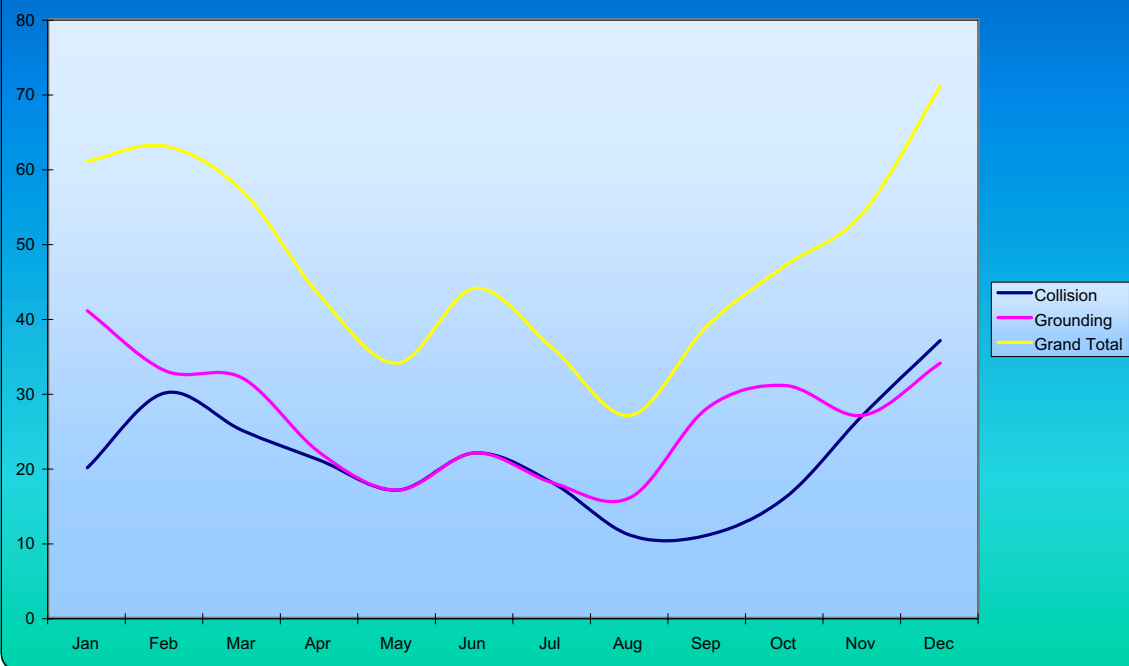
Figure 14

Number of merchant vessels >500gt involved in collisions or groundings in UK waters / month of accident

Even when opportunities to rest arise, there is no guarantee that a bridge watchkeeping officer wants to, or is able to, sleep. Personal tasks such as telephoning or writing home still have to be completed, and the noise and motion of the ship, as well as ambient levels of temperature and light, will all affect an individual's ability to sleep. The fact that many of these factors are influenced by the weather might help explain why the majority of groundings occur in the winter months, when outside temperatures are lower, the incidence of higher sea states is greater, and the nights are longer. A similar seasonal distribution of groundings was found among all vessels over 500gt within UK waters between 1994 and 2003 (**Figure 14**).

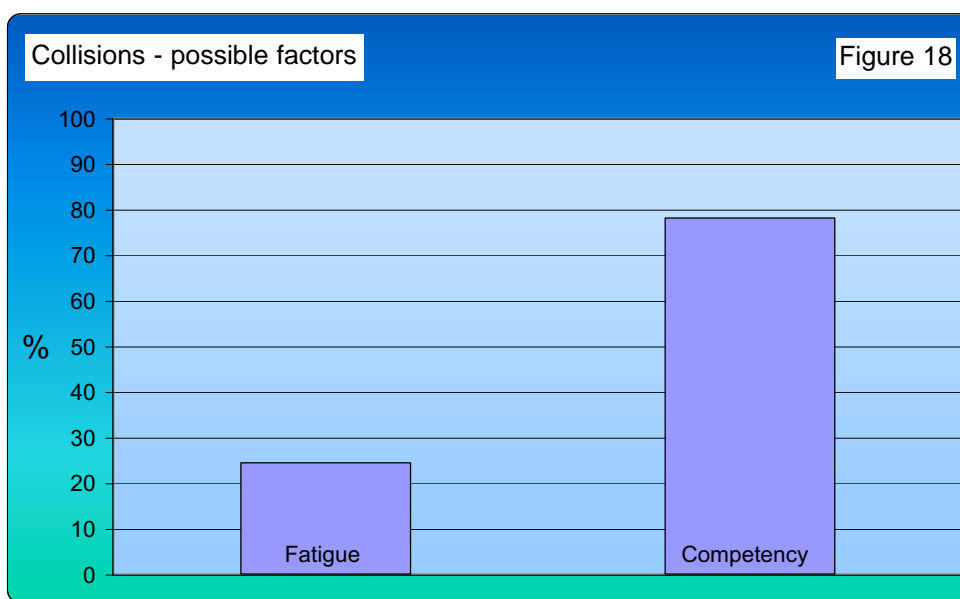
It is also evident, however, that the bridges of 19 vessels were manned in accordance with the provisions for lookout, as set out in STCW 95, yet still failed to maintain a proper lookout. There are several possible reasons for this, and **Figure 18** illustrates that competency may be more contributory in this respect than fatigue. Importantly, however, in the MAIB's experience, poor visual lookout can also be linked to the poor employment of ratings on the bridge. On many ships, although ratings are usually available to provide an additional lookout, they are rarely used for this purpose during daylight. A common view encountered is that ratings are generally of little value on the bridge and are of more use working on the deck. Additionally, although many ships use an additional lookout on the bridge at night, his presence is often seen as a token gesture aimed at meeting regulatory requirements. There is evidence that some OOWs do not even speak to the rating on watch with them, particularly when differing nationalities are involved.
