MARINE INVESTIGATION REPORT

M98N0001

BREAK-UP AND SINKING

THE BULK CARRIER "FLARE"

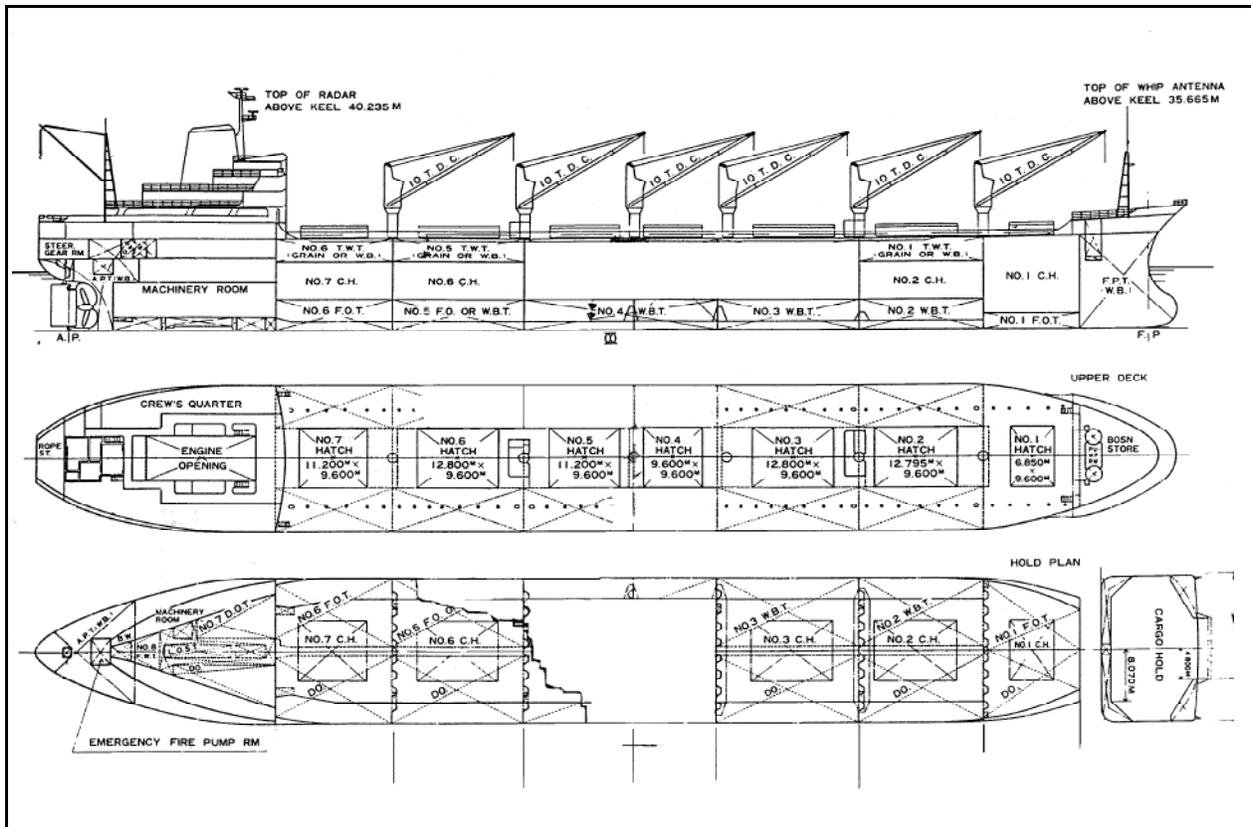
holds and the engine-room. The main deck, upper wing tanks, inner bottom and bottom shell plating throughout the length of the cargo holds were framed longitudinally, while the side shell plating inside the holds was

framed transversely.

Figure 1 - Outline General Arrangement	2
Figure 2 - Typical Cross section	3
Chart 1 - Atlantic Crossing.....	4
Chart 2 - Occurrence Area.....	5
Figure 3 - Structural Separation Location	17
