MISLE Incident Investigation Report For

SLNC GOODWILL / Loss of Life

On 05Aug2020 00:42:00 EDT

Diesel Generator Failure Investigation

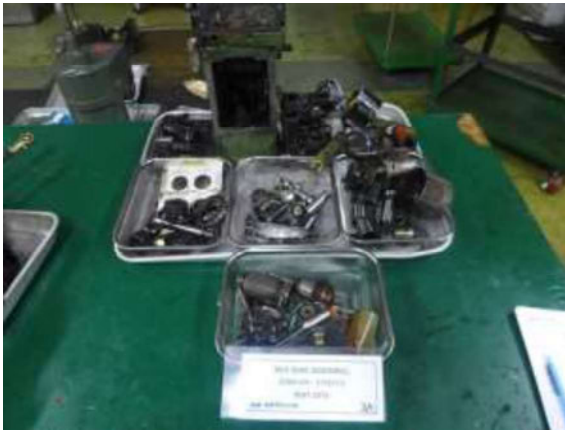
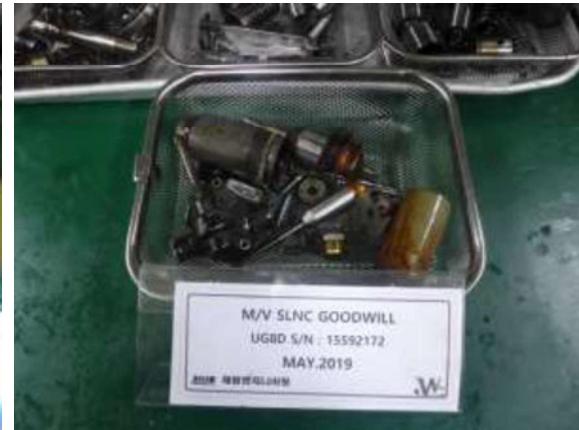
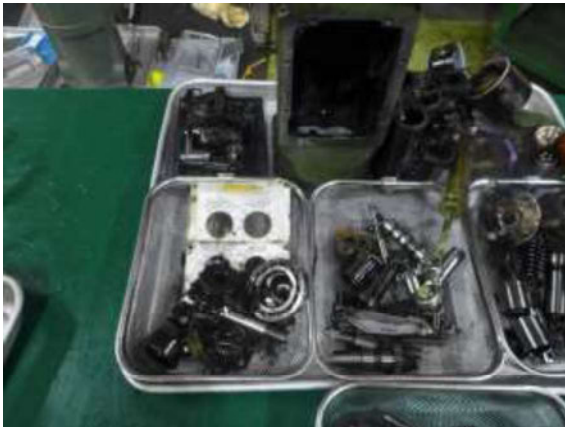
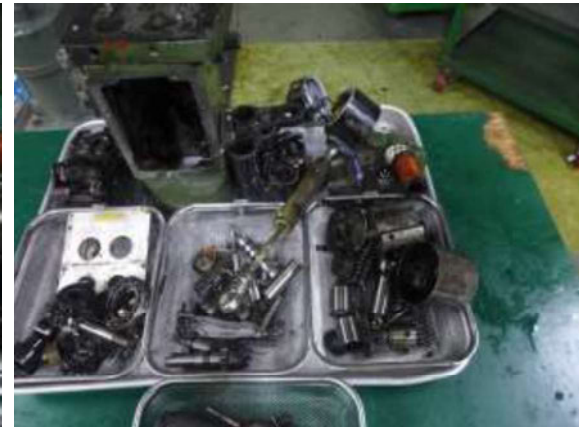
1. 20TH.MAY.2019, receive governor from the agent of M/V SLNC GOODWILL at JEWON ENGINEERING
2. Carried out governor overhaul.
 - 2-1. Disassembled governor : Contaminated by oil

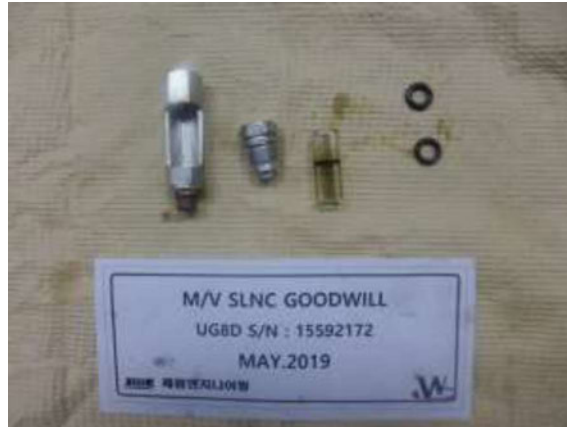
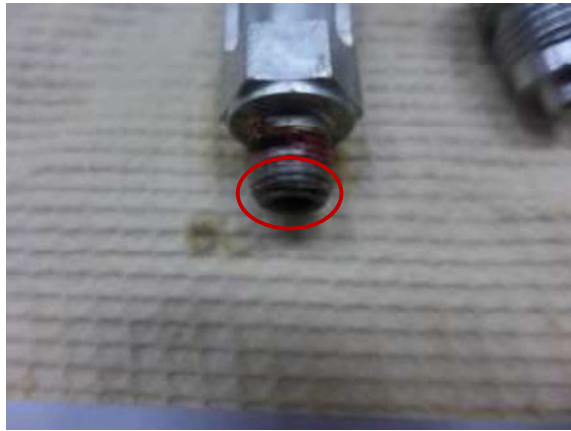
c) SIGHT OIL GAUGE : Sight oil gauge wear and break. (Oil leakage)

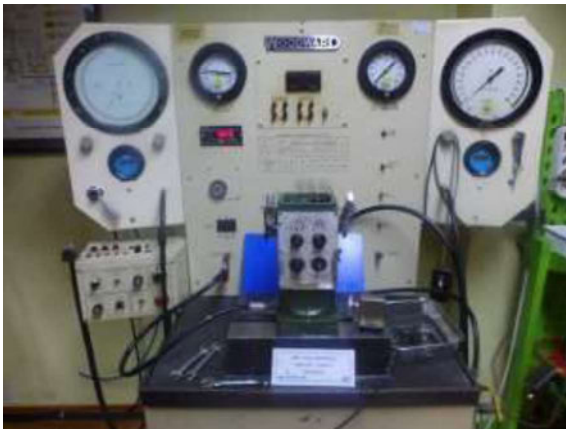
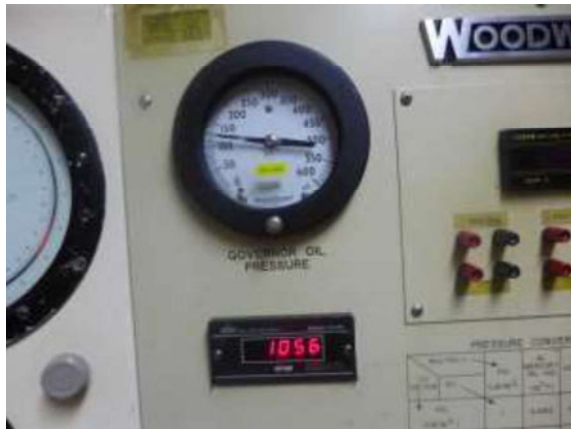
2-4. Governor test : test the governor on the woodward test stand.

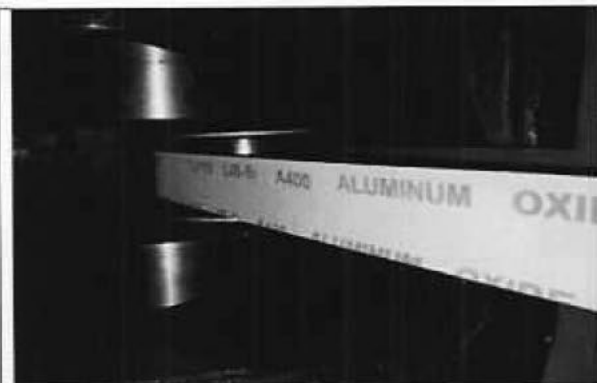
Crank pin being polished

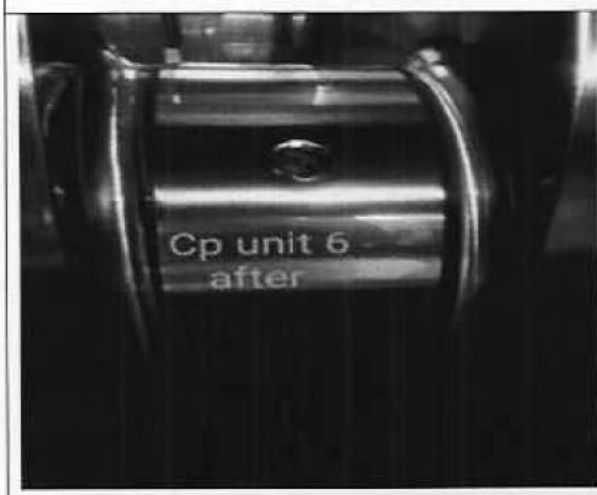
Crank pin after polished

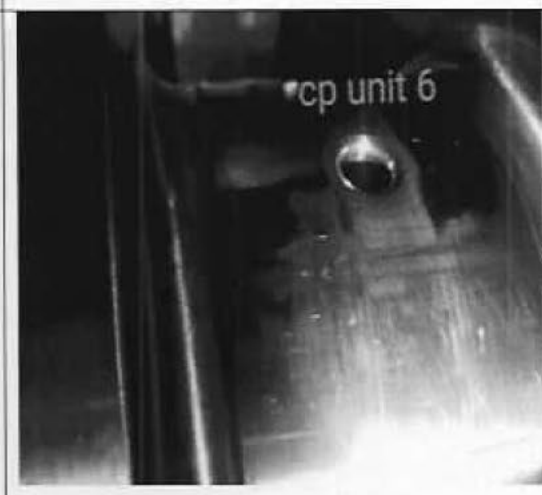
Crank pin before polish

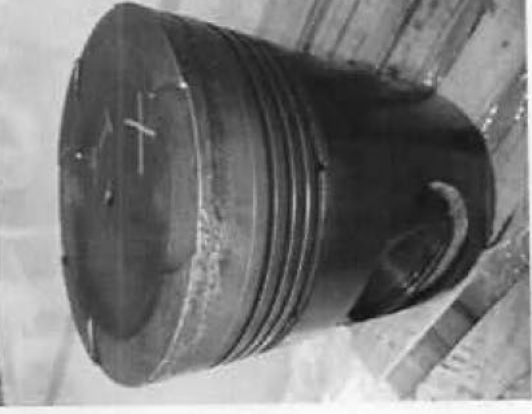
<p>Piston crown #4 condition (found cavitation)</p>	<p>Piston crown #6 condition (found cavitation)</p>

Corrosion cavitations on piston no. 4 & 6

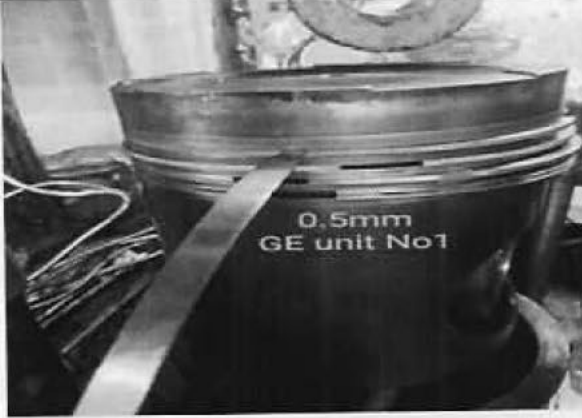
Unit No-1 top ring groove was found already exceeding wear limit, we have renewed with new piston crown

<p>0.5mm GE unit No1</p>

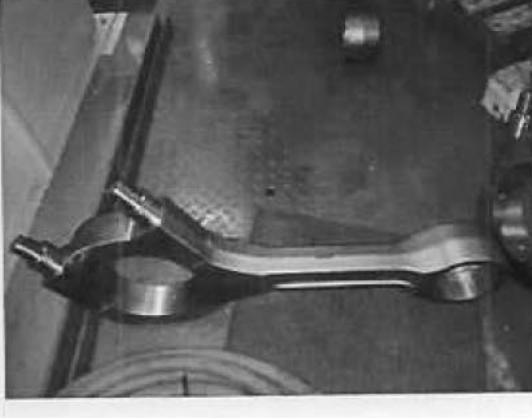
Remarks (if any): Cylinder liner was found all units look very shining there was No sign of running surface wave roughness for oil film

<p>Cylinder liner condition Before honing</p>	<p>New Connecting rod being cleaned</p>

Strongly recommended for Honing all units

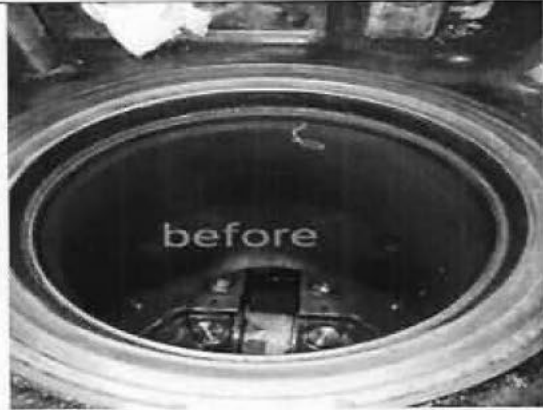
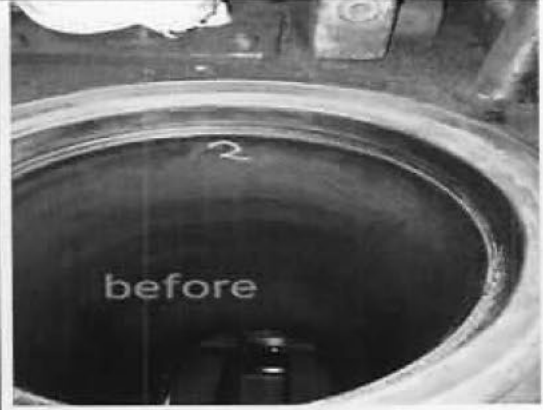
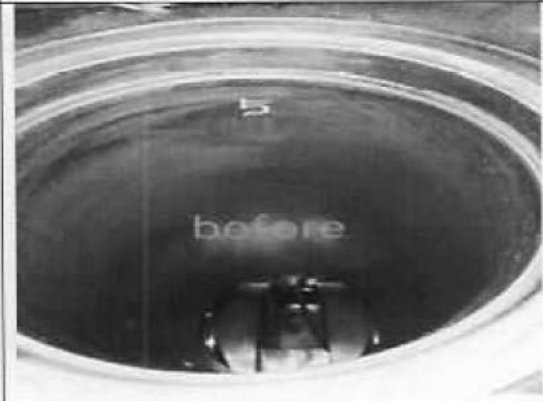
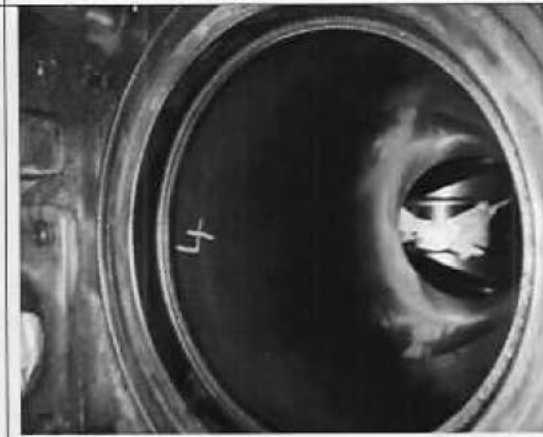
Before honing

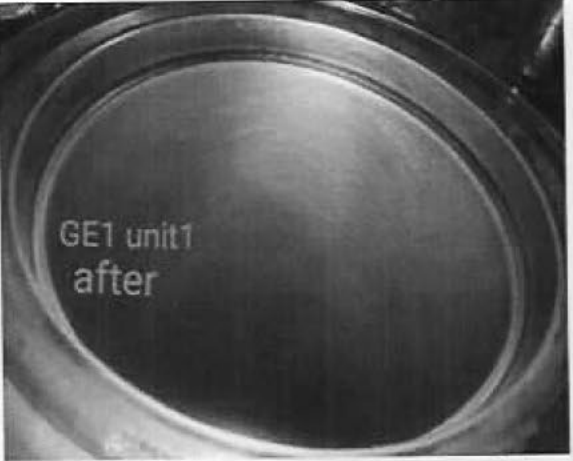
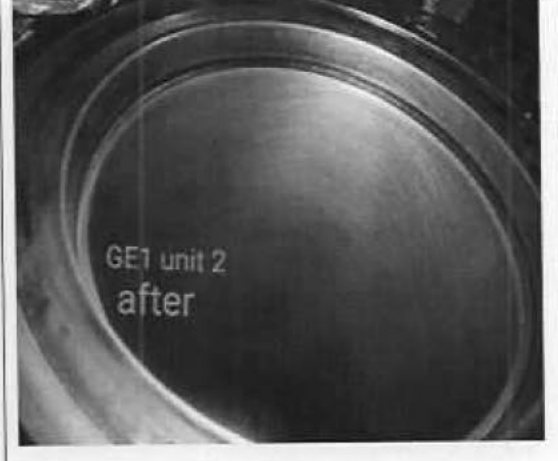
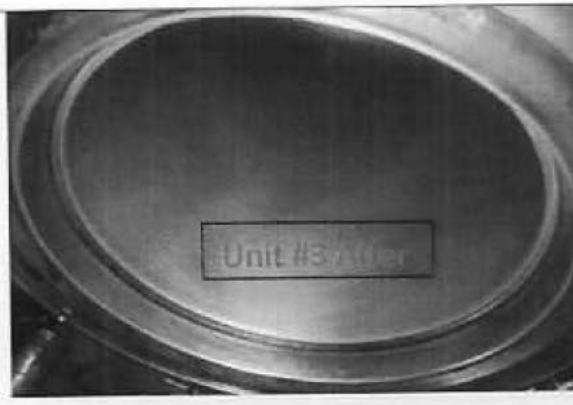
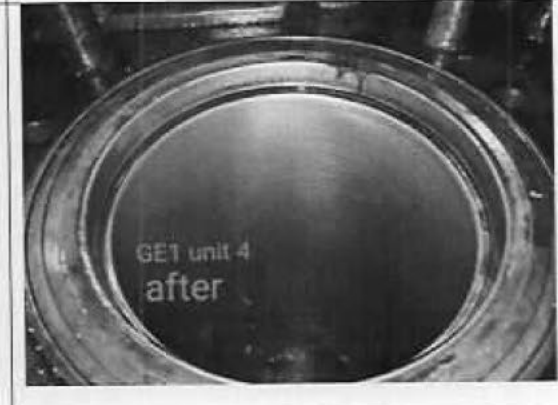
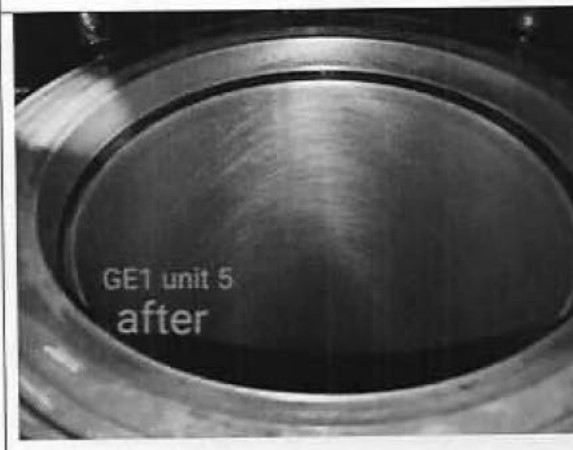
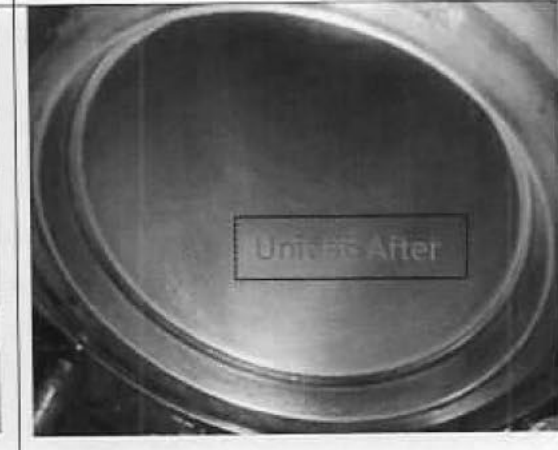
Remarks (if any): Cylinder liner was done honing in order and found satisfactory required roughness on the running surface for station of oil film

<p>GE1 unit 1 after</p>

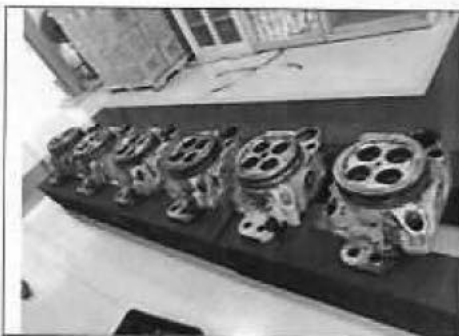
- Complete disassembled, clean all components.
- Extract out all valve seats due to corroded with worn step. Performed Dye Penetrant Inspection valve seat pockets and combustion surface, no crack detected. Inserted new valve seats inlet 12pcs & exhaust 12pcs.
- Extract out all 24pcs existing valve guides and inserted new valve guides.
- Removed all 6pcs cooling water jacket, cleaned and Dye checked. Refitted all cooling water jacket with new o-rings.
- Removed unit no.5 injector sleeve to renew o-ring
- Carried out hydro-test all 6 cylinder head at pressure 7kg/cm², no leak detected.
- Renewed all 24pcs valve due to worn at lid surface.
- 5pcs of valve rotators were renewed due to wear on ball seat, remaining 19pcs reused. All 24 sets of valve springs were reused.
- Assembled components as per maker's specification.

Extracted all valve seats

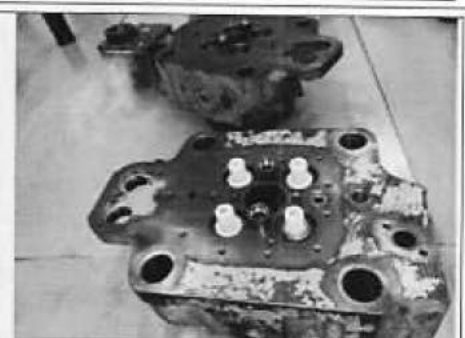
New valve guide insert

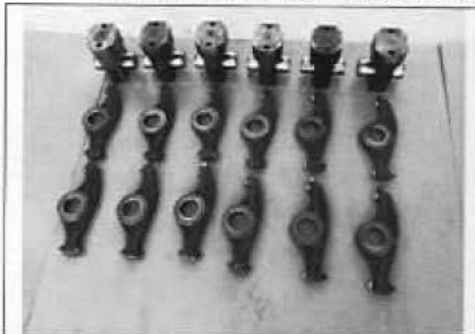
- Disassembled rocker arm, clean and inspect bearings and shaft. All the shaft journal found slightly worn at bottom, however clearance found within limit, 0.13-0.15 mm by feeler gauge.

Rocker arm after disassembly

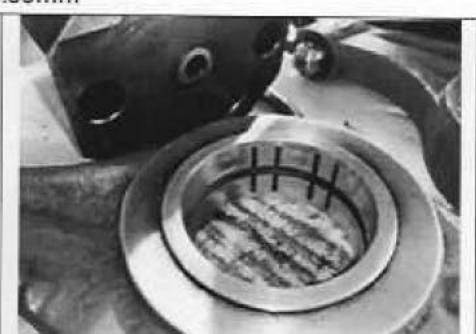
Bottom of the shaft journal

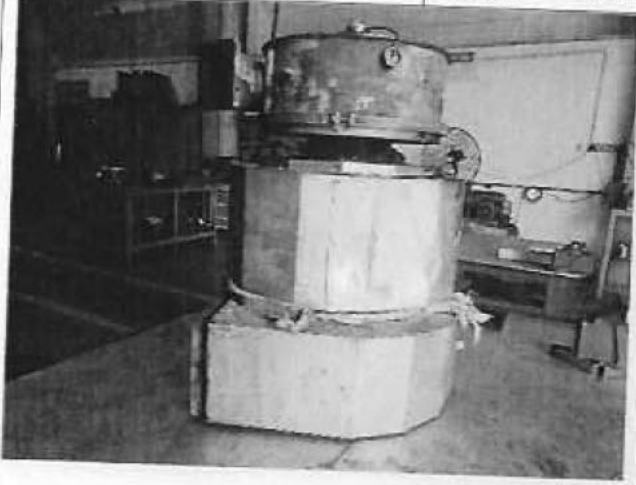
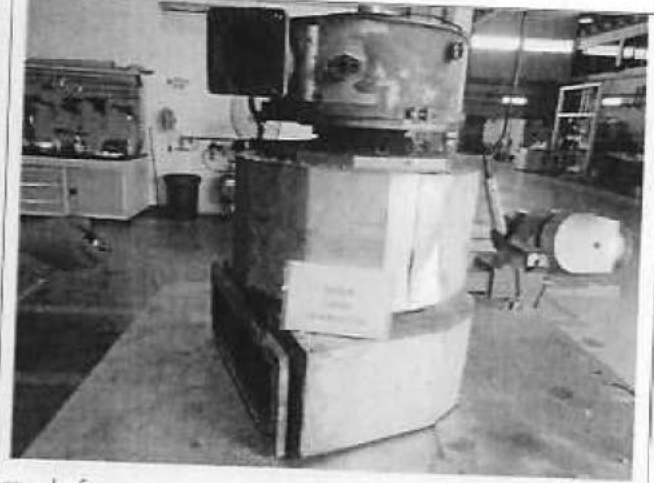
Condition of turbocharger before overhaul

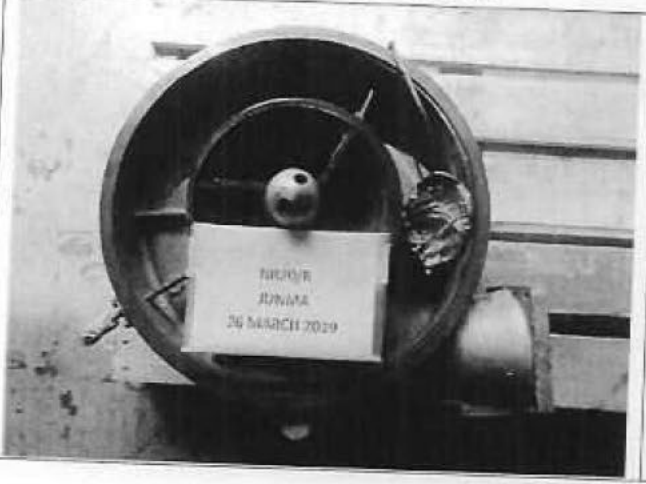
Air casing before cleaning

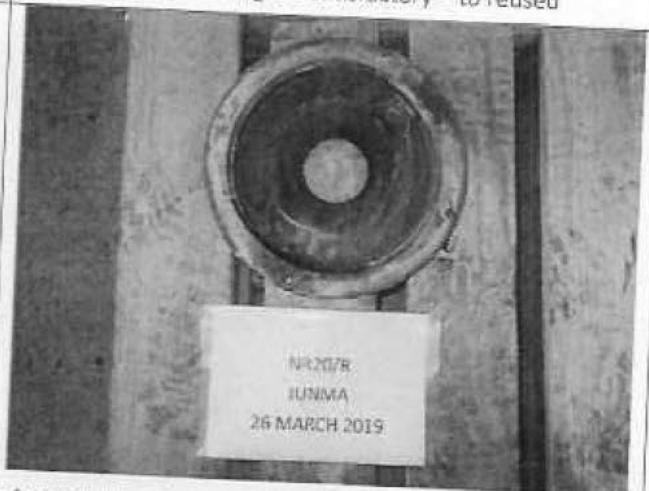
Nozzle ring good condition – to ash blast

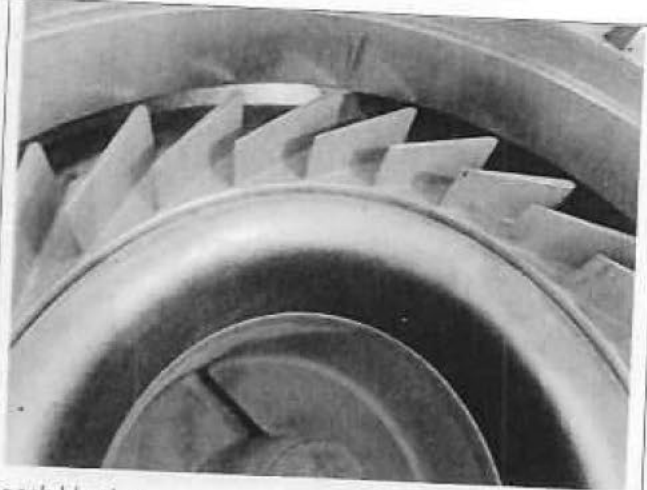
Nozzle ring after ash blasting

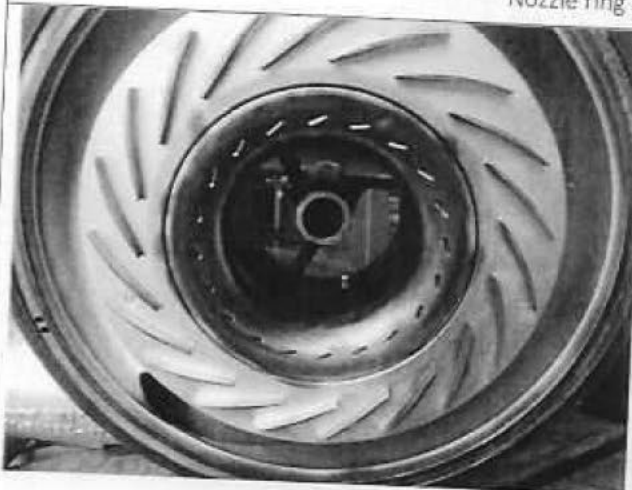
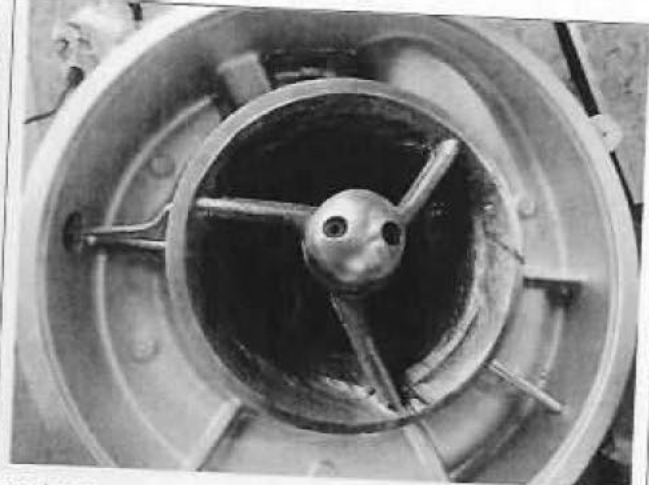
Air casing after cleaning

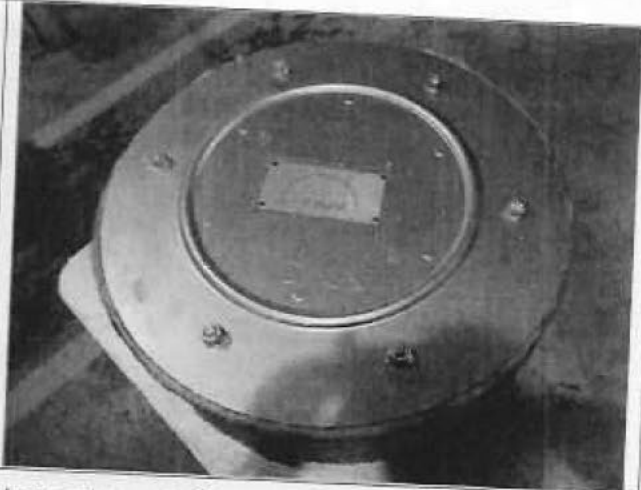
Filter silencer after chemical clean and new air filter mat

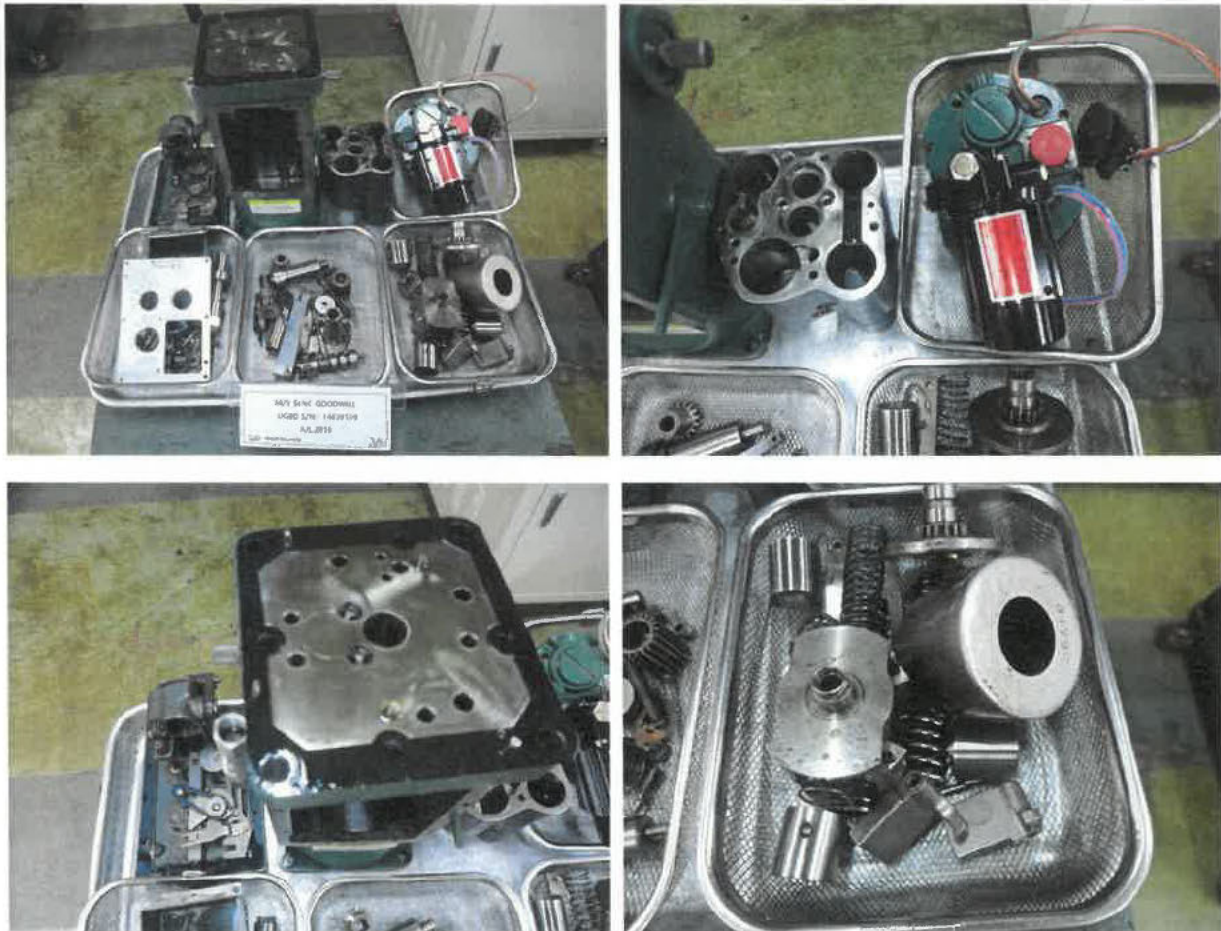
- 1. Jul.08th.2019. Visit agent office at Po-hang, Rep. of Korea, and received the UG-8D governor for M/V SLNC GOODWILL (1 set)
- 2. Disassembled governor
 - 2-1 Disassembled governor

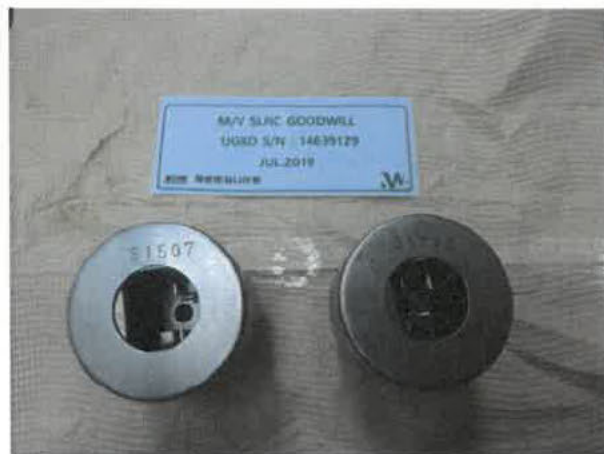
4.1. Ballhead A'ssy

Part name	Part No.	Number	unit	Remark
DIAL PLATE	3099-935	1	EA	
BALLHEAD ASSEMBLY	31507	1	SET	Spare parts needed for modifying.
DIAL PANEL ASSEMBLY	34535	1	SET	
NEEDLE VALVE	30009	1	EA	Defective part.

1. The spare parts for modifying of governor were used.
2. Because no have new spare parts in my company and the delivery date takes a long time.

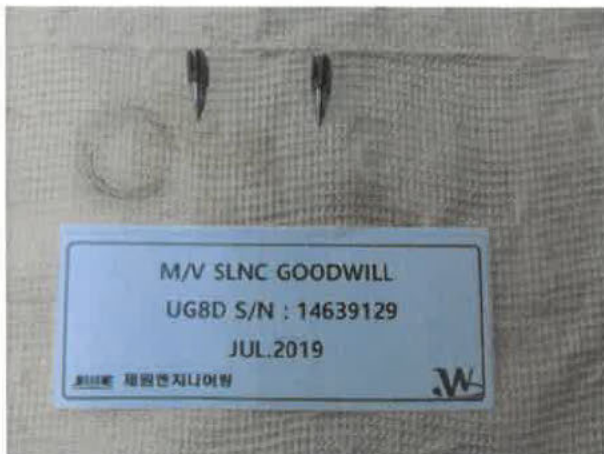
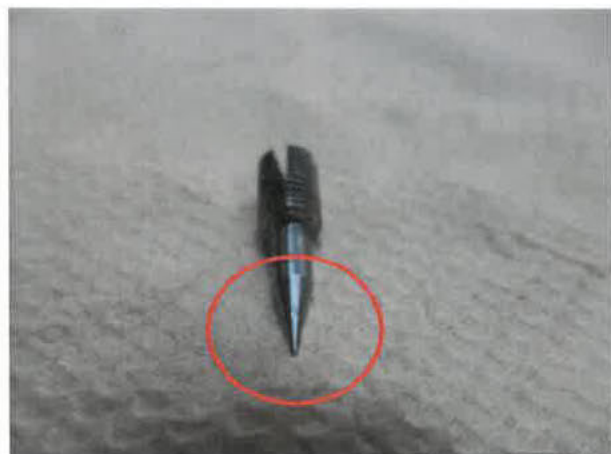
4.4. Needle valve : Mark point was were down.

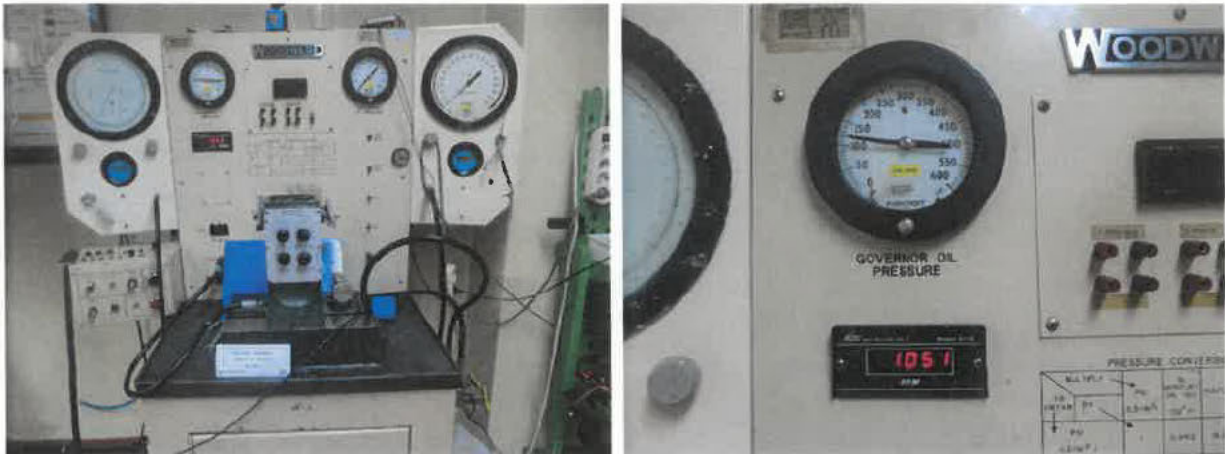
5. Tested governor on test stand

6. 2019.07.22 onboard to M/V SLNC GOODWILL at Busan, Rep. of Korea for exchange the governor.
7. Exchange the governor of No.2 generator engine after conference with the ship's crew.
8. Test governor with ship's crew. And found good condition.
